Play Area / Equipment Operational Inspection

LLANHARRY COMMUNITY COUNCIL

Client / Site Llanharry Recreation Ground

Conducted on 04.04.2024 07:18 BST

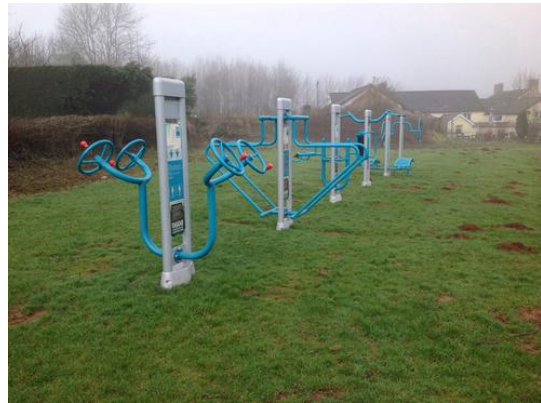
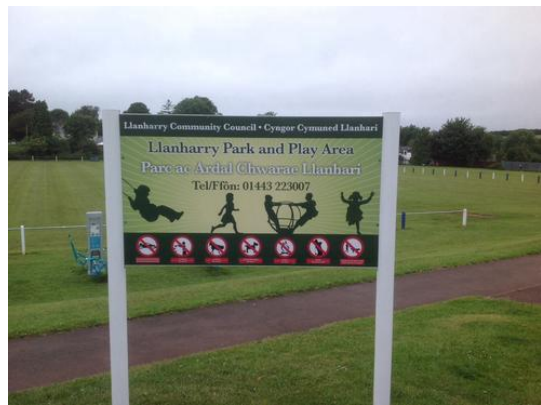
The recreation ground consists of a play area fenced by steel bow top fencing with self closing gates
 A MUGA kick about area and a youth shelter
 Both areas are accessed by Tarmac pathways
 Benches and picnic tables are located within the play area and also outside the play area boundary

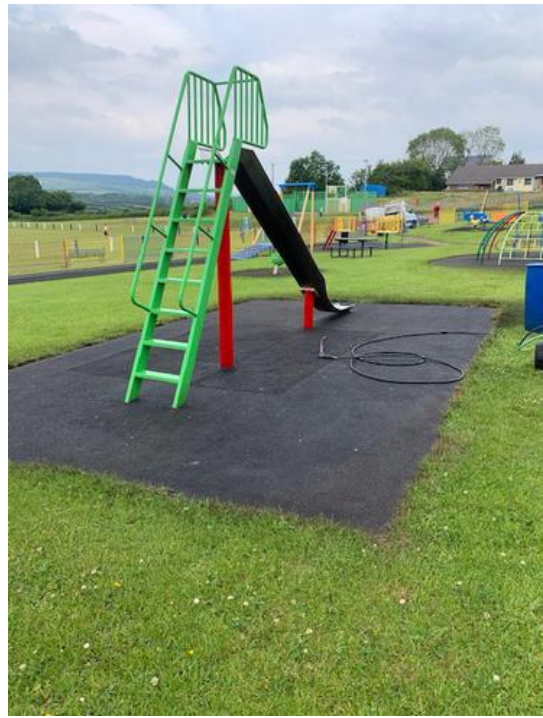
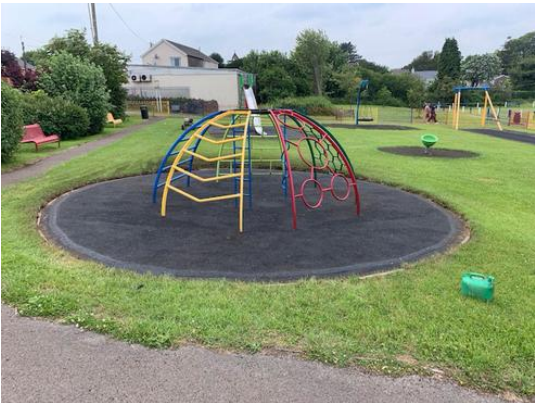
All items of play equipment are located on wet pour rubber safety surfacing

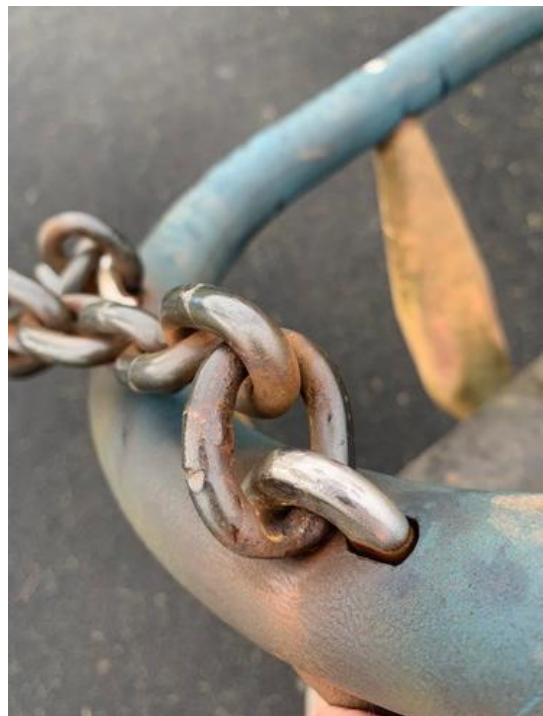
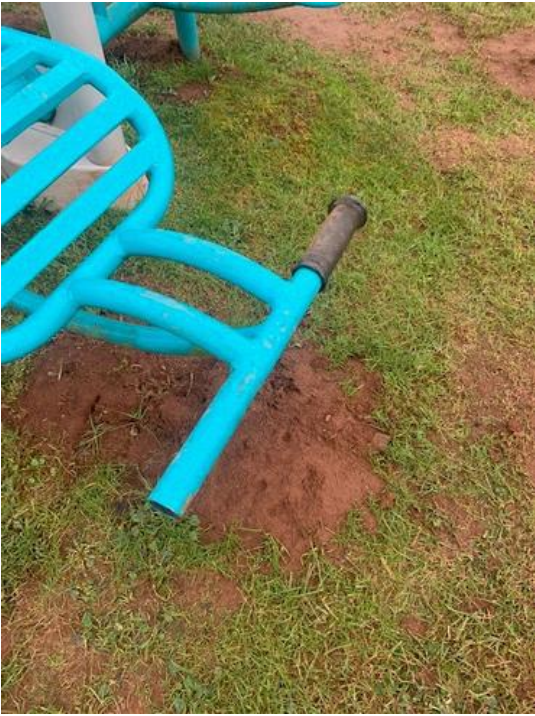
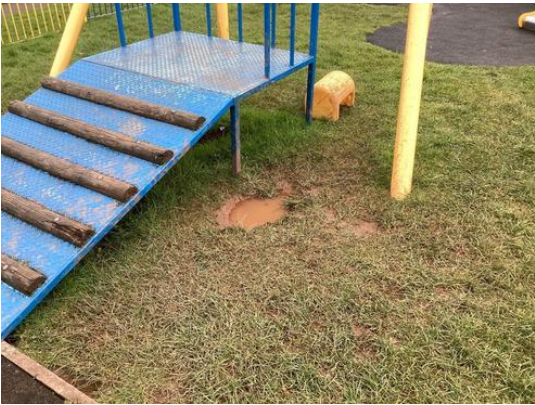
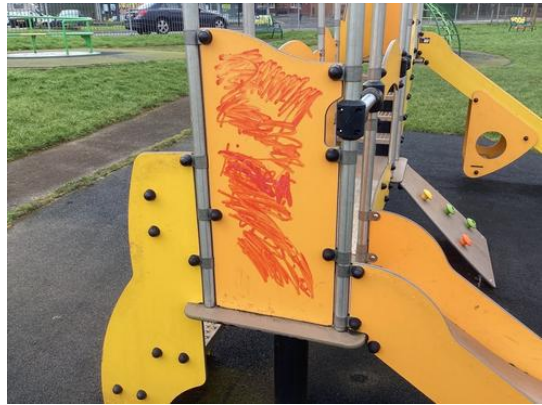
There is some wear on the toddler swing chains, monitor and plan for replacement in the future
Footplate on the air skier fitness item has severe corrosion and needs some work

There is a rubber cover missing from one of the sit up benches

The timber foot treads on the cable ride ramp are starting to deteriorate

There is a muddy hole next to the cable ride ramp

There is some graffiti on the multiplay unit panel

monitor timber treads on cable ride ramp

Replace or repair tread on air skier asap

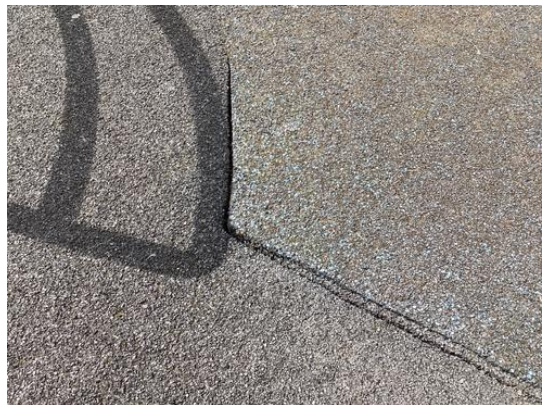
At the time of inspection all surfaces were found to be in a safe and useable condition although there are some areas of joint separation which should be monitored

The basket swing surface has been treated to remove grass growth

One corner of the roundabout surfacing has been subsiding over the years and continues to drop

A spray application of moss killer was applied during visit, reapply during May visit

Schedule to treat rubber surface with moss killer first dry opportunity when we have a dry spell!!!
