Play Area / Equipment Operational Inspection

LLANHARRY COMMUNITY COUNCIL

Score	8 / 8 (100%)	Flagged items	0	Actions	0
Document No.					000078
Audit Title					LLANHARRY COMMUNITY COUNCIL
Client / Site					Llanharry Recreation Ground
Conducted on					30.04.2025 08:00 BST
Prepared by					Jerry Widdas
Location					Llanharry
Personnel					
					Jerry Widdas

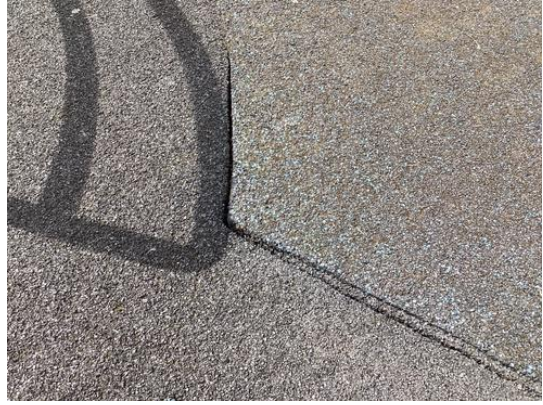
Photo 30

One corner of the roundabout surfacing has been subsiding over the years and continues to drop monitor

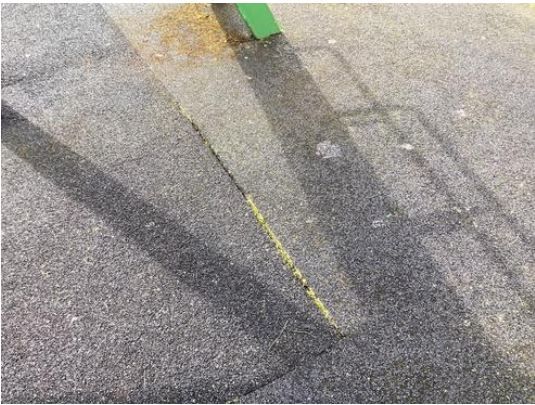
Photo 31

Some algae growth, suggest chemical treatment in early spring.
