Play Area / Equipment Operational Inspection

LLANHARRY COMMUNITY COUNCIL

Score	8 / 8 (100%)	Flagged items	0	Actions	0
Document No.					000078
Audit Title					LLANHARRY COMMUNITY COUNCIL
Client / Site					Llanharry Recreation Ground
Conducted on					09.08.2024 20:30 BST
Prepared by					Jerry Widdas
Location					Llanharry
Personnel					
Jerry Widdas

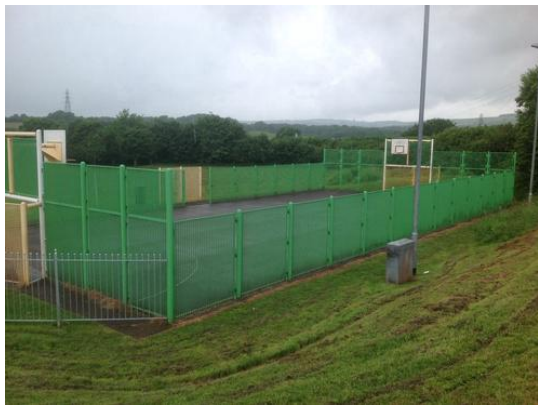
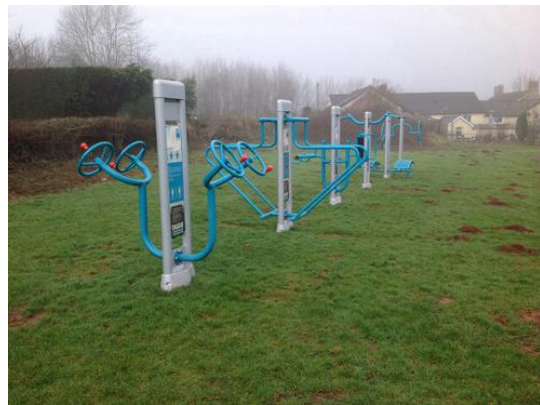
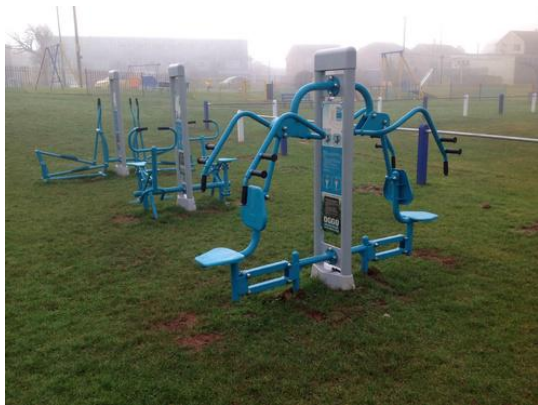
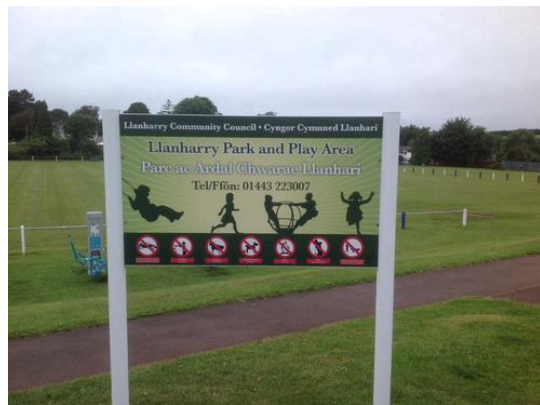
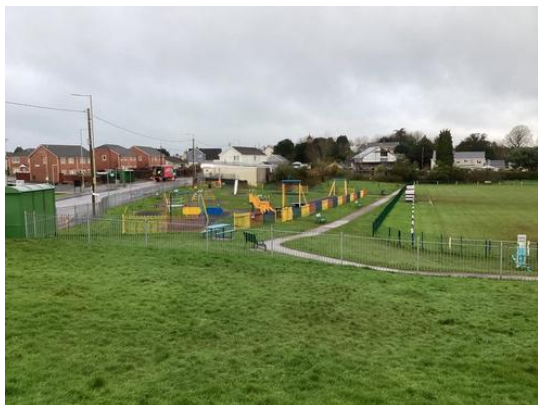
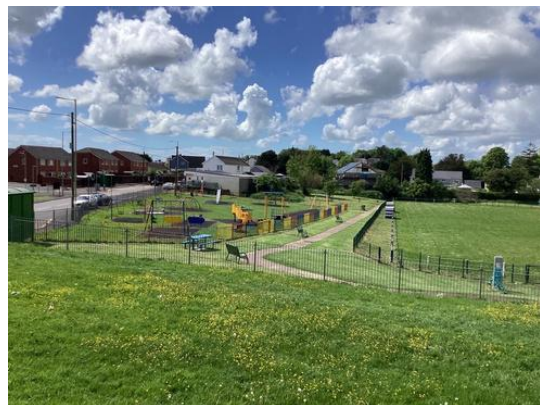
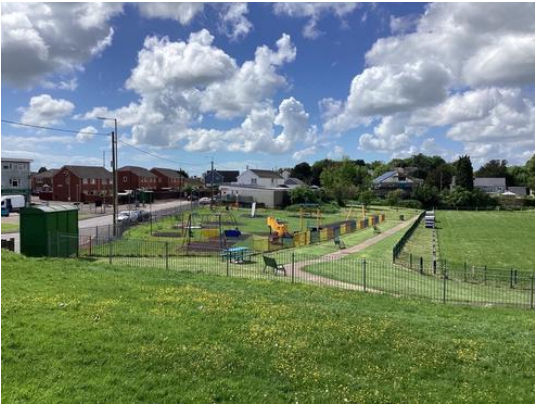
The recreation ground consists of a play area fenced by steel bow top fencing with self closing gates
 A MUGA kick about area and a youth shelter
 Both areas are accessed by Tarmac pathways
 Benches and picnic tables are located within the play area and also outside the play area boundary

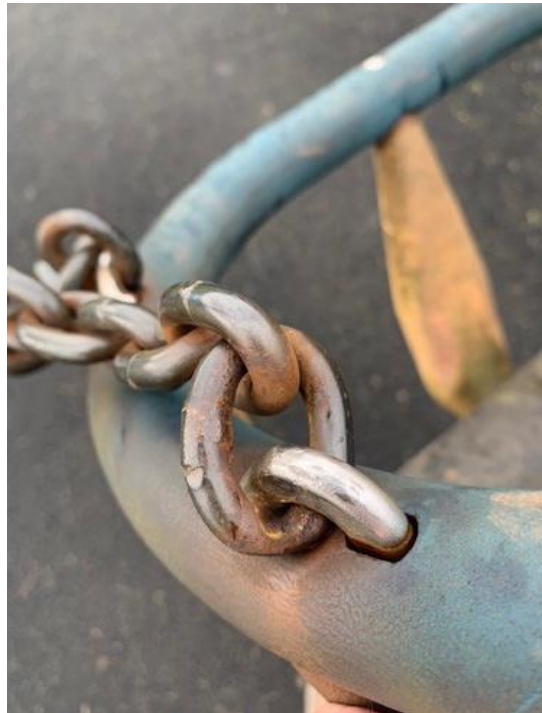
There is some wear on the toddler swing chains, monitor and plan for replacement in the future
Footplate on the air skier fitness item has severe corrosion and needs some work

There is a rubber cover missing from one of the sit up benches

The timber foot treads on the cable ride ramp are starting to deteriorate

There is a muddy hole next to the cable ride ramp

There is some graffiti on the multiplay unit panel

monitor timber treads on cable ride ramp

Replace or repair tread on air skier asap

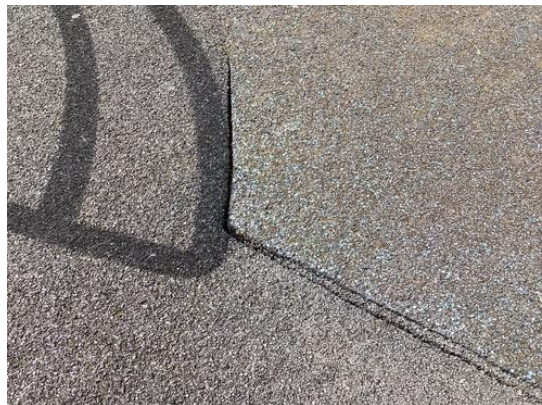
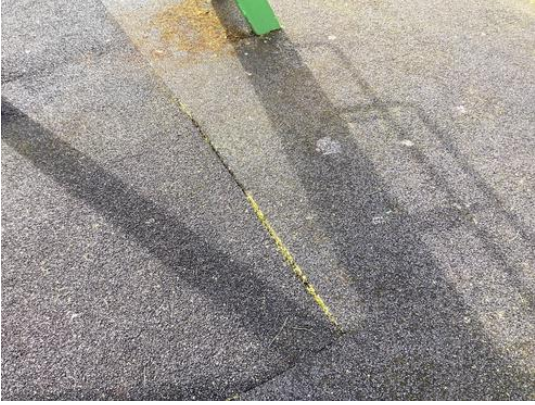
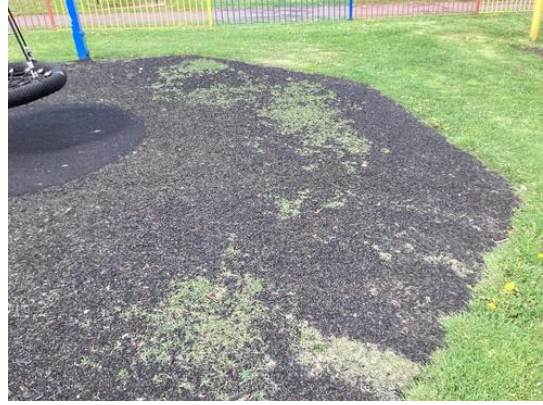
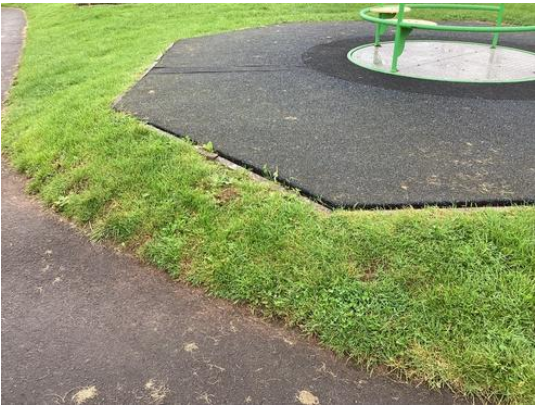
At the time of inspection all surfaces were found to be in a safe and useable condition
although there are some areas of joint separation which should be monitored

The basket swing surface has been treated to remove grass growth

One corner of the roundabout surfacing has been subsiding over the years and continues to drop
