Play Area / Equipment Operational Inspection

LLANHARRY COMMUNITY COUNCIL

Score	8 / 8 (100%)	Flagged items	0	Actions	0
Document No.					000078
Audit Title					LLANHARRY COMMUNITY COUNCIL
Client / Site					Llanharry Recreation Ground
Conducted on					07.12.2023 14:40 GMT
Prepared by					Jerry Widdas
Location					Llanharry
Personnel					
					Jerry Widdas

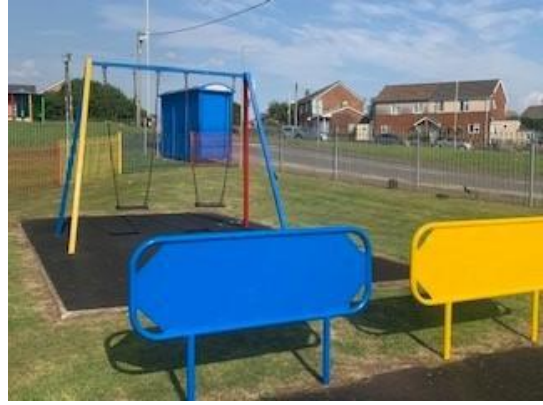
At the time of inspection all the equipment was found to be in a safe and useable condition

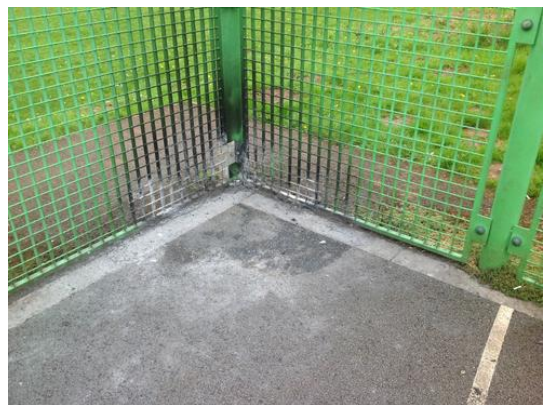
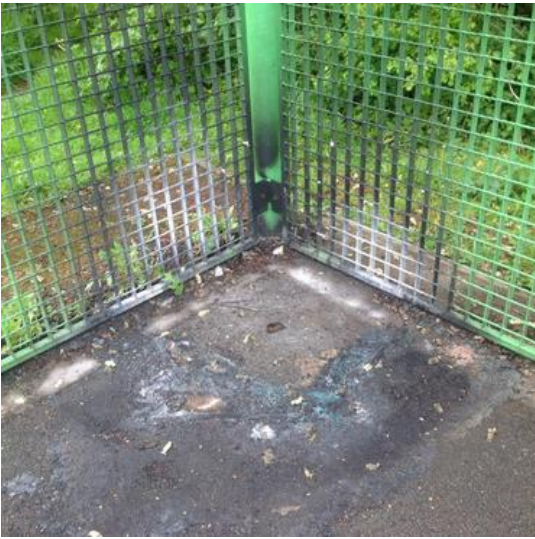
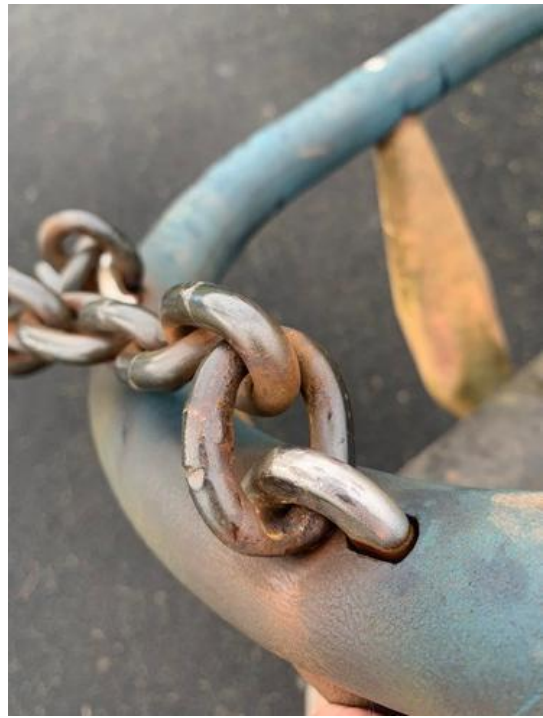
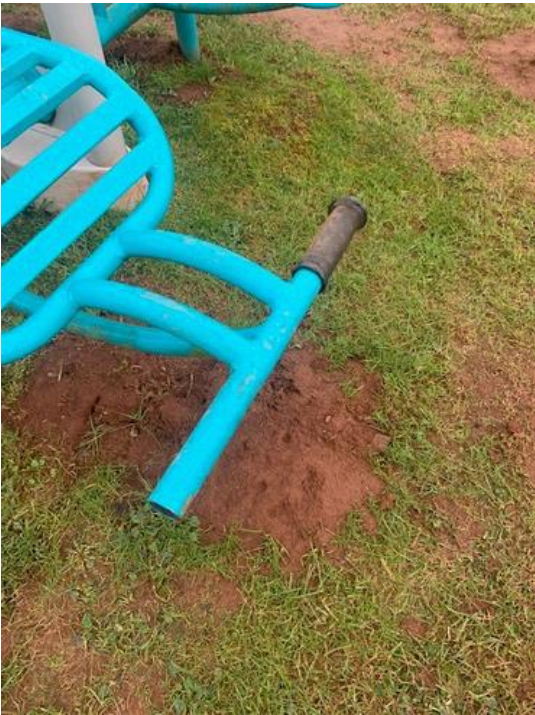
One of the basket swing suspension ropes has been wrapped, monitor

A small fire has caused minor damage to the ball court surface, an additional fire in the opposite corner has caused minor damage to the ball court surface and paintwork on the steel grid

There is some wear on the toddler swing chains, monitor and plan for replacement in the future

There is a rubber cover missing from one of the sit up benches

monitor items noted

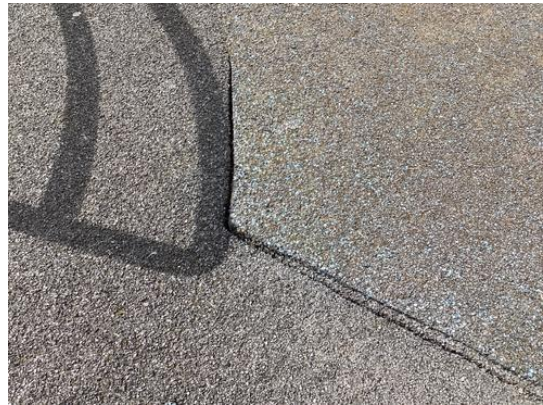
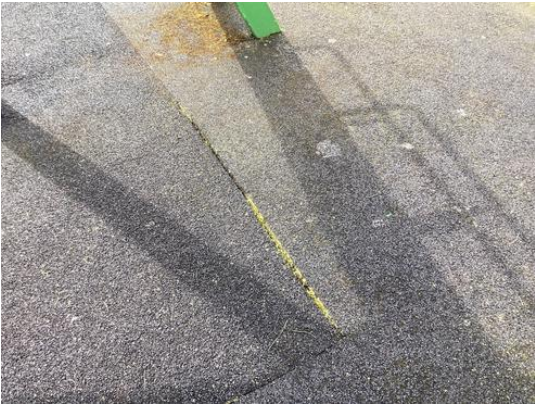
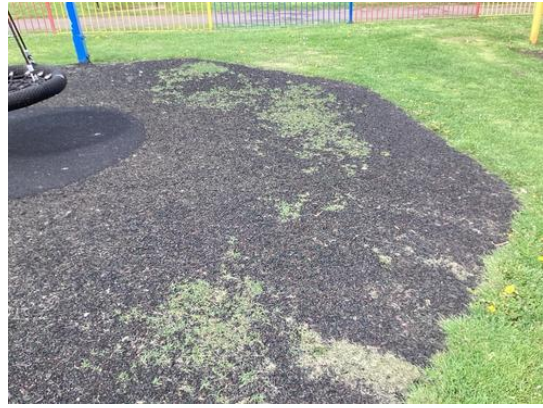
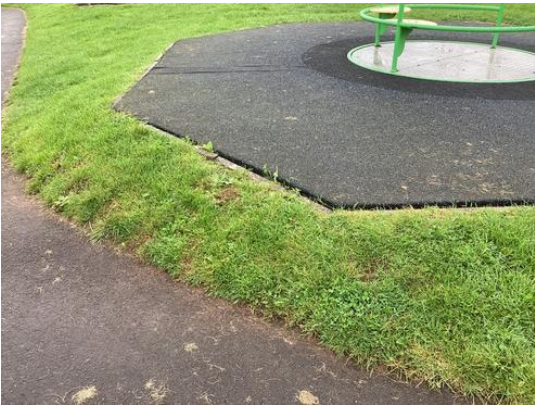
At the time of inspection all surfaces were found to be in a safe and useable condition although there are some areas of joint separation which should be monitored

The basket swing area has some self seeded grass growth that could be treated if possible while it is still manageable

One corner of the roundabout surfacing has been subsiding over the years and continues to drop
