# Play Area / Equipment Operational Inspection

LLANHARRY COMMUNITY COUNCIL

<b>Score</b>	8 / 8 (100%)	<b>Flagged items</b>	0	<b>Actions</b>	0
<b>Document No.</b>					000078
<b>Audit Title</b>					LLANHARRY COMMUNITY COUNCIL
<b>Client / Site</b>					Llanharry Recreation Ground
<b>Conducted on</b>					23.12.2024 08:40 GMT
<b>Prepared by</b>					Jerry Widdas
<b>Location</b>					Llanharry
<b>Personnel</b>					
Jerry Widdas

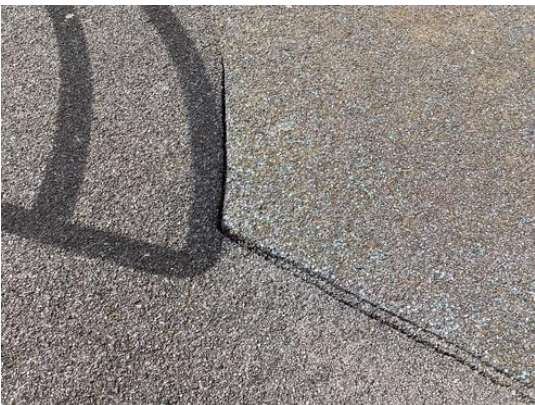
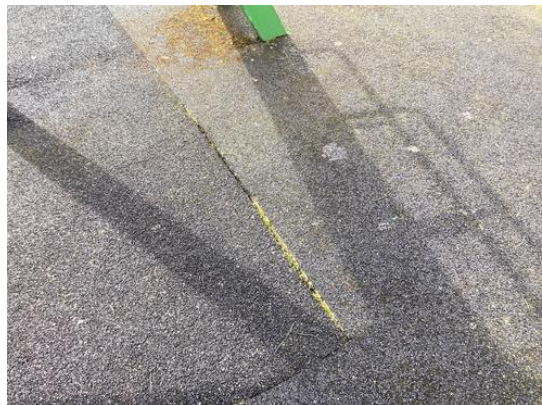
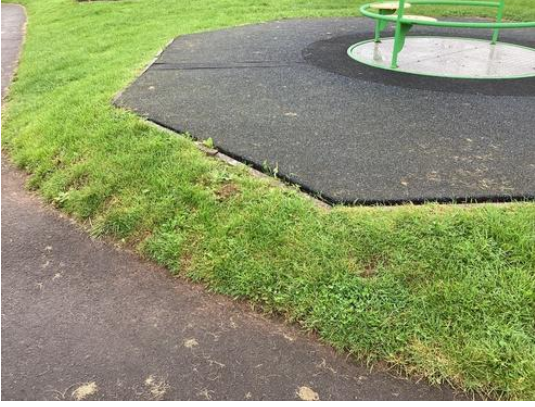
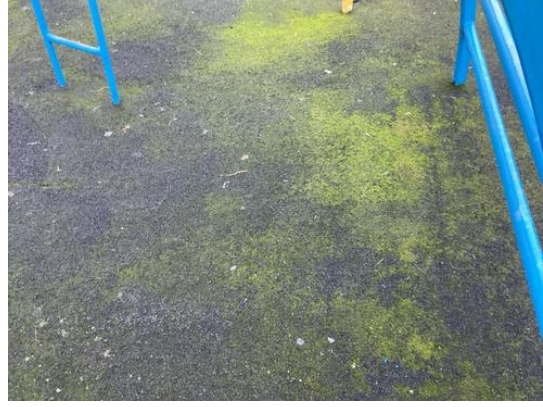
At the time of inspection all surfaces were found to be in a safe and useable condition although there are some areas of joint separation which should be monitored

One corner of the roundabout surfacing has been subsiding over the years and continues to drop monitor

Some algae growth, suggest chemical treatment in early spring.
