Play Area / Equipment Operational Inspection

LLANHARRY COMMUNITY COUNCIL

Score	8 / 8 (100%)	Flagged items	0	Actions	0
Document No.					000078
Audit Title					LLANHARRY COMMUNITY COUNCIL
Client / Site					Llanharry Recreation Ground
Conducted on					28.02.2025 09:35 GMT
Prepared by					Jerry Widdas
Location					Llanharry
Personnel					
					Jerry Widdas

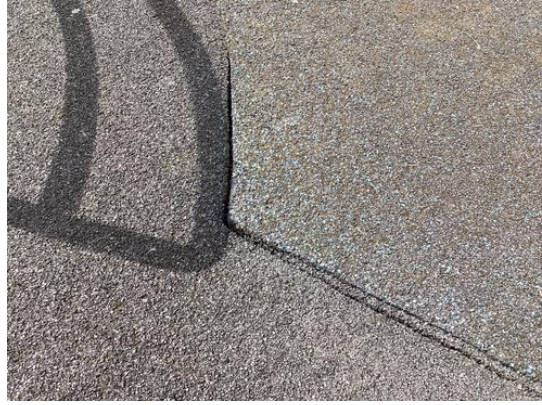
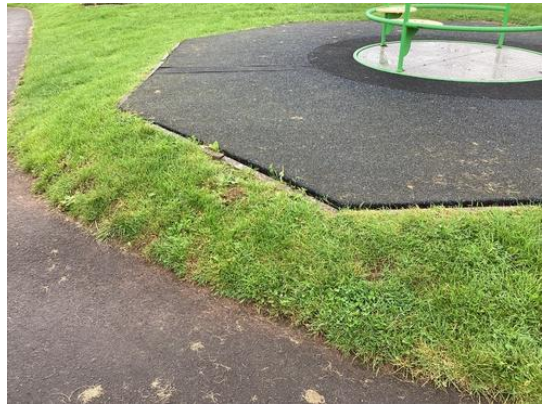
At the time of inspection all surfaces were found to be in a safe and useable condition although there are some areas of joint separation which should be monitored

One corner of the roundabout surfacing has been subsiding over the years and continues to drop monitor

Some algae growth, suggest chemical treatment in early spring.
