# Play Area / Equipment Operational Inspection

LLANHARRY COMMUNITY COUNCIL

Score	100%	Failed items	0	Actions	0
Document No.					000078
Audit Title	LLANHARRY COMMUNITY COUNCIL				
Client / Site	Llanharry Recreation Ground				
Conducted on	1 Feb 2022 08:30 GMT				
Prepared by	Jerry Widdas				
Location	Llanharry				
Personnel	Jerry Widdas

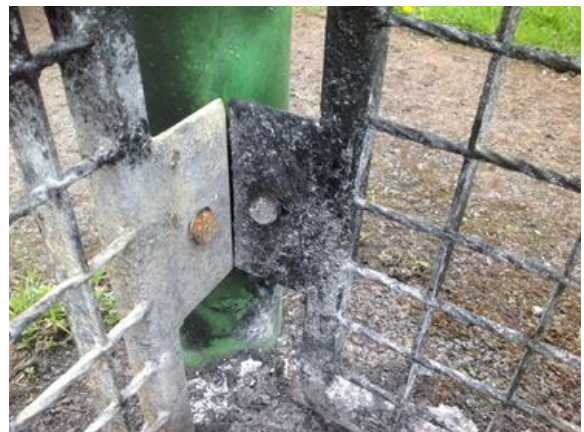
Photo 30

One corner of the roundabout edging has subsided exposing the concrete foundation and causing one concrete edge to sink slightly  
 The metal stairway on the multiplay unit is starting to corrode and get thin in places, this could have a steel plate welded in to prolong its life  
 The flat seats on the swing are starting to show the steel insert, monitor for further deterioration and replace  
 One of the basket swing suspension ropes has been wrapped, monitor  
 A small fire has caused minor damage to the ball court surface, an additional fire in the opposite corner has caused minor damage to the ball court surface and paintwork on the steel grid  
 The Spring stopper at the end of the cable ride has broken, this is not currently a safety issue but may deteriorate further with time, monitor and plan to replace at convenient time in the future.  
 There is some wear on the toddler swing chains, monitor and plan for replacement in the future

There is a rubber cover missing from one of the sit up benches  
 The three round litter bins surrounding the football field have advanced corrosion

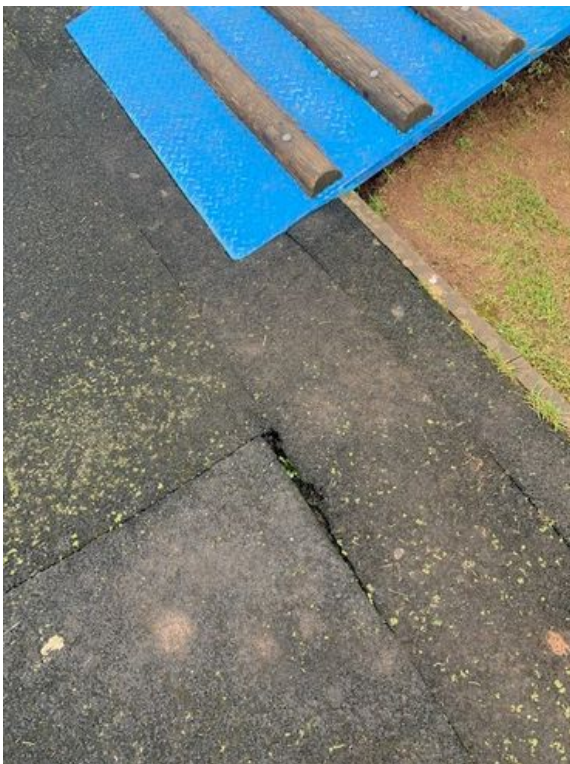
Photo 43

A rubber joint has lifted slightly on the cable ride surfacing  
 Moss and algae is again starting to appear on the rubber surfacing, suggest spray treatment with a new chemical that is now available (chemical has been applied to small multiplay and large slide rubber area as a test)
