Play Area / Equipment Operational Inspection

LLANHARRY COMMUNITY COUNCIL

Score	8 / 8 (100%)	Flagged items	0	Actions	0
Document No.					000078
Audit Title					LLANHARRY COMMUNITY COUNCIL
Client / Site					Llanharry Recreation Ground
Conducted on					02.01.2024 09:39 GMT
Prepared by					Jerry Widdas
Location					Llanharry
Personnel					
					Jerry Widdas

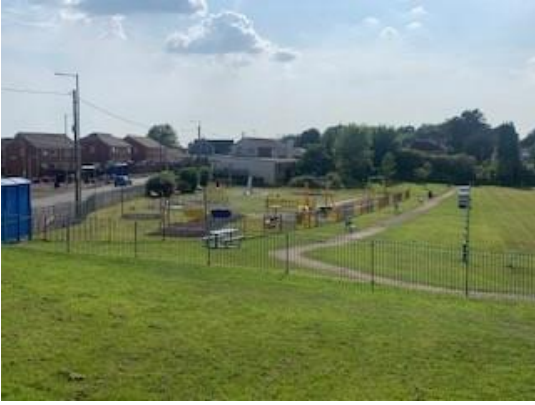
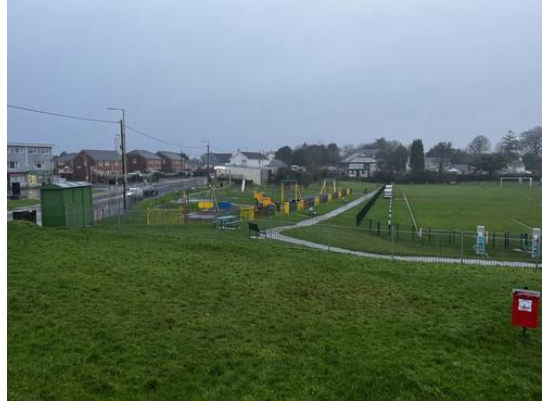
The recreation ground consists of a play area fenced by steel bow top fencing with self closing gates
 A MUGA kick about area and a youth shelter
 Both areas are accessed by Tarmac pathways
 Benches and picnic tables are located within the play area and also outside the play area boundary

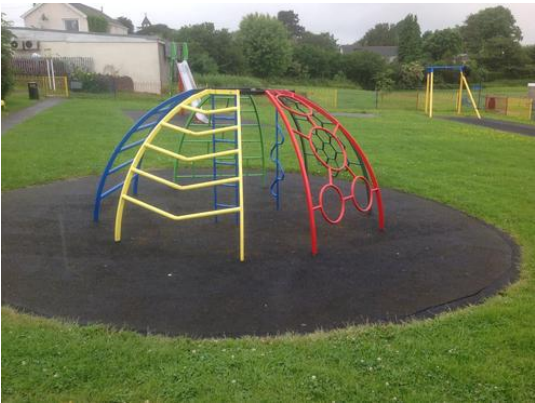
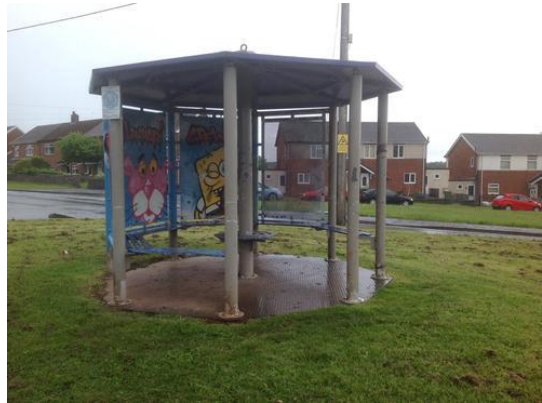
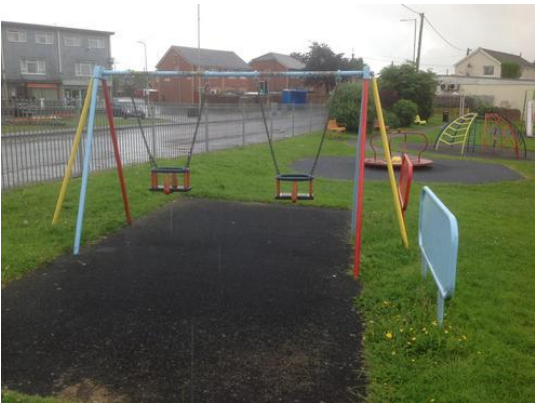
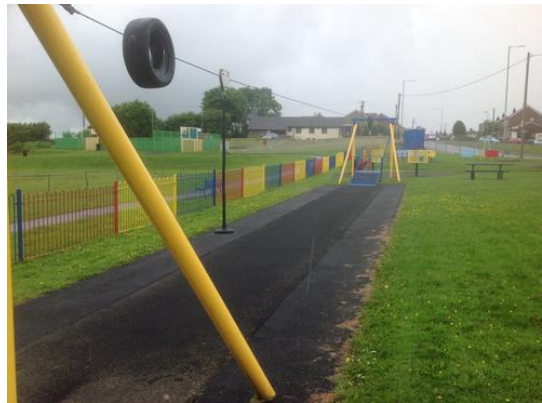
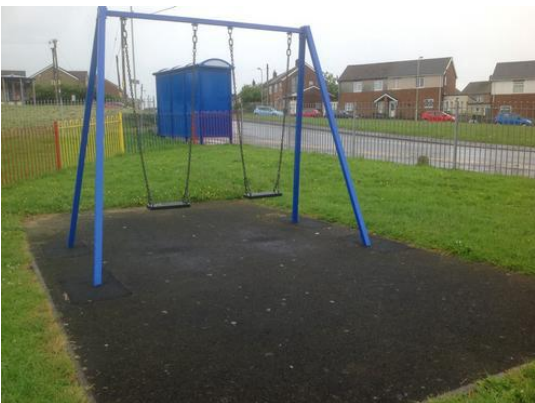
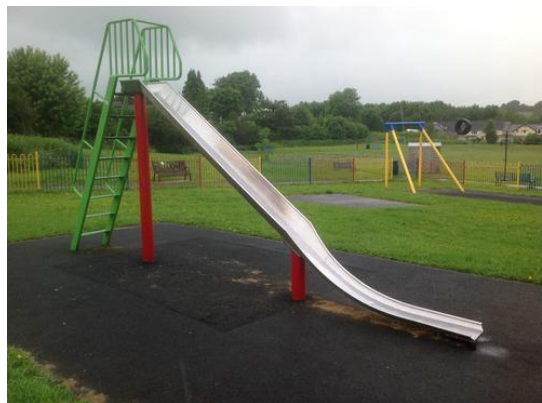
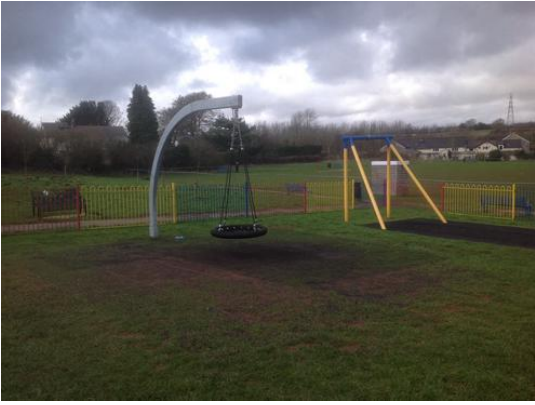
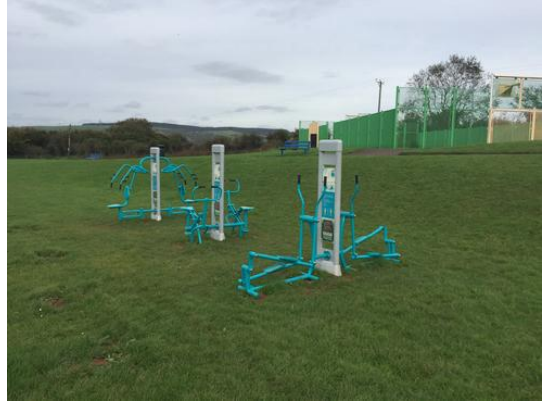
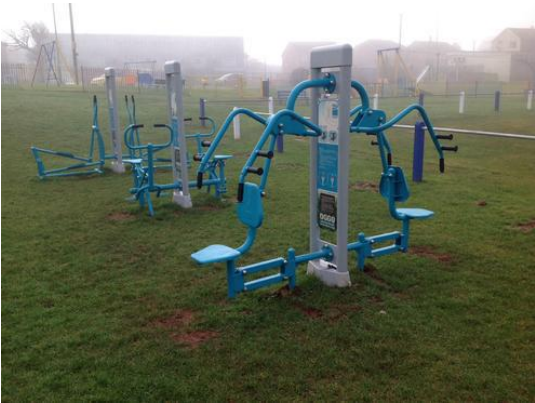
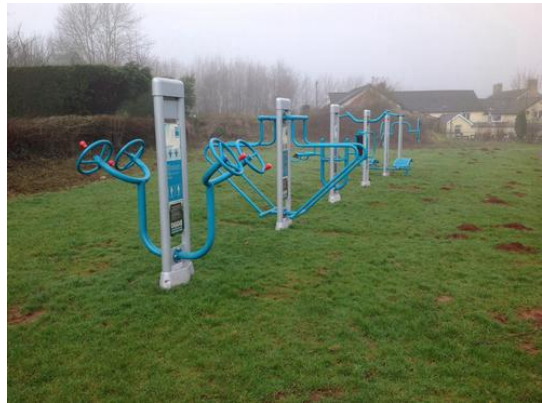
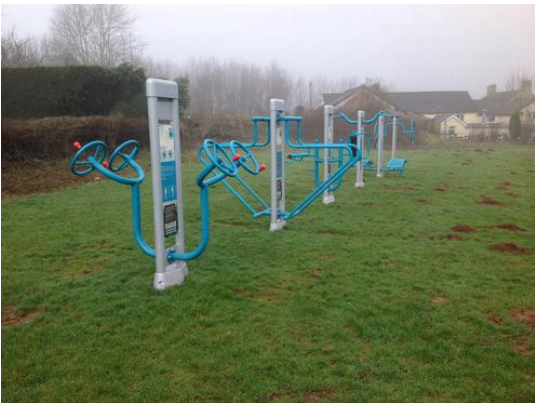
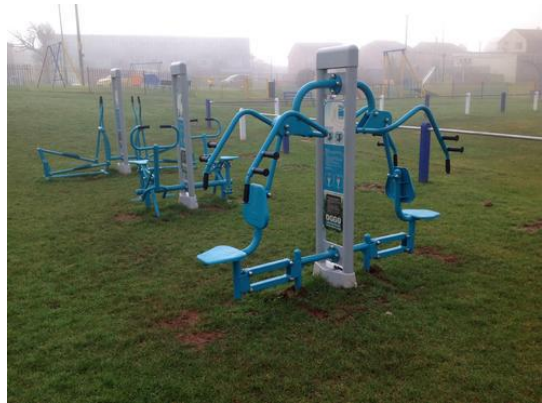
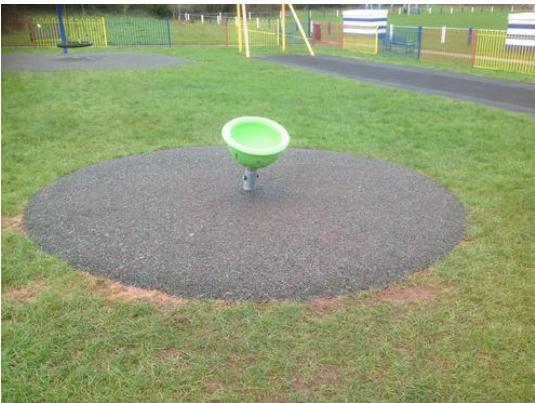
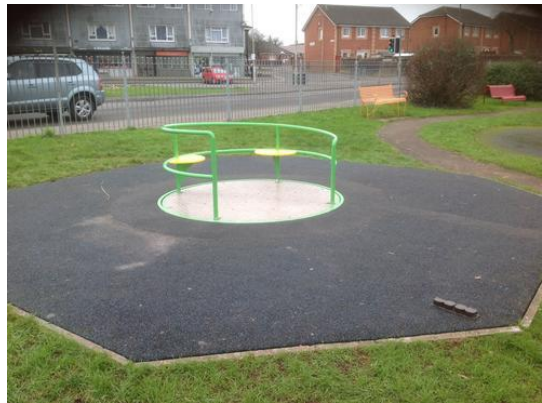
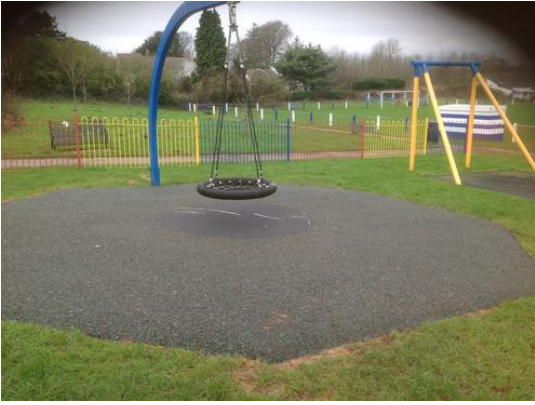
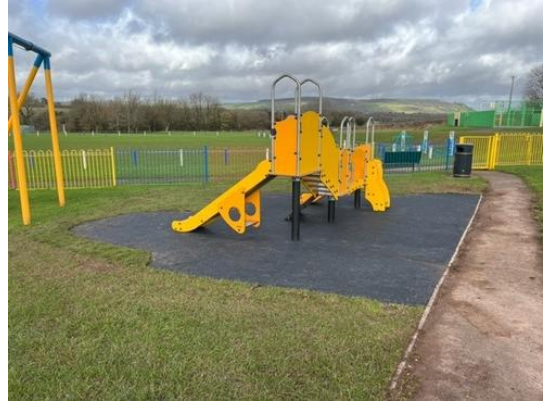
MUGA area supplied by PPL date unknown
 1 X 2 seat swing supplied and installed by Urban Recreation in 2016
 1 X Traditional cradle seat swing Wicksteed Leisure
 1 X Traditional Igloo climber Wicksteed Leisure
 1 X Wheelchair roundabout supplied and installed Urban Recreation Dec 2018
 1 X Multiplayer Unit Proludic installed Feb 2022
 1 X Steel cable ride Record Play
 1 X Freestanding slide Record Play
 2 X Spring animals Fahr Industries installed Feb 2022
 1 X Teen Shelter David Ogilvie Engineering
 1 X Cantilever Swing supplied Urban Recreation 2016
 9 X Fitness Items supplied Urban Recreation October 2017
 1 X Spinning Cup supplied and installed Urban Recreation Dec 2018

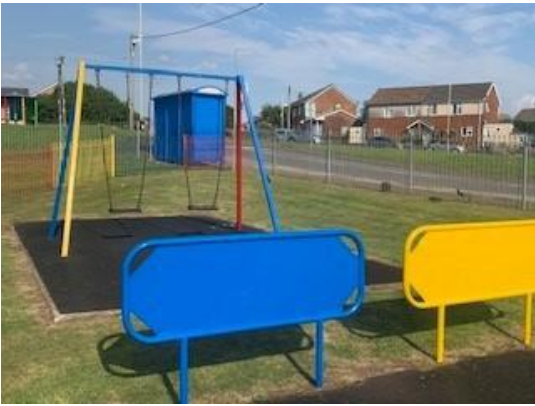
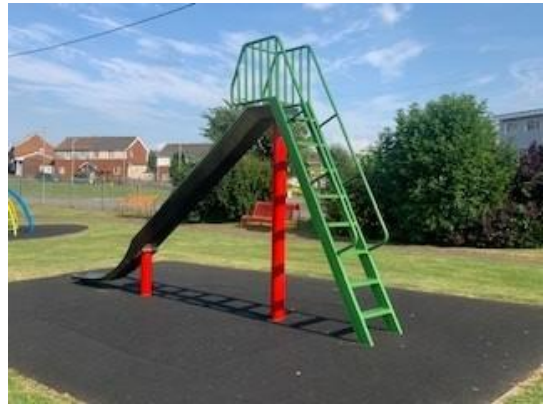
At the time of inspection all the equipment was found to be in a safe and useable condition

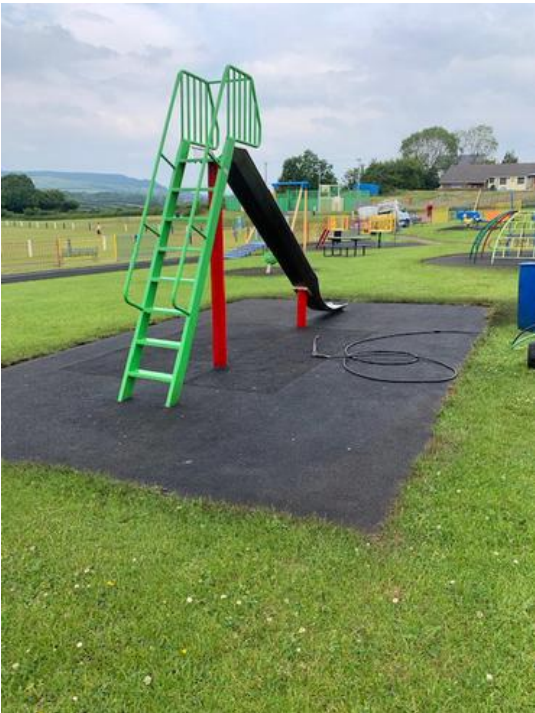
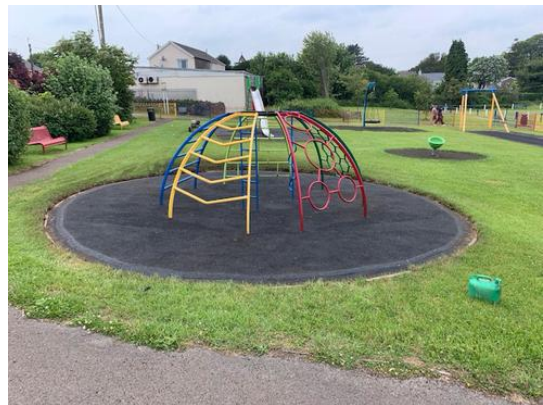
All items of play equipment are located on wet pour rubber safety surfacing

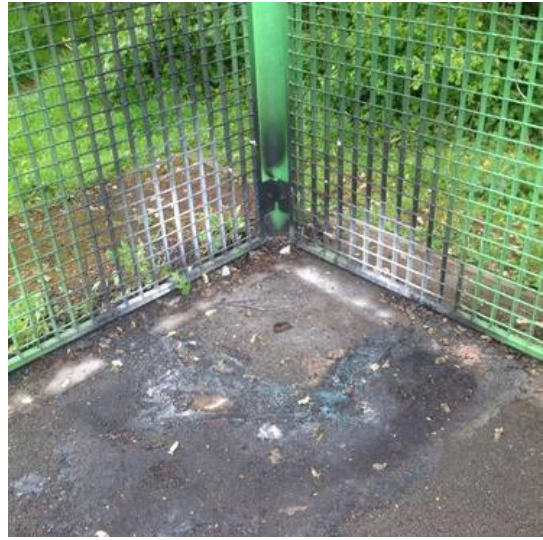
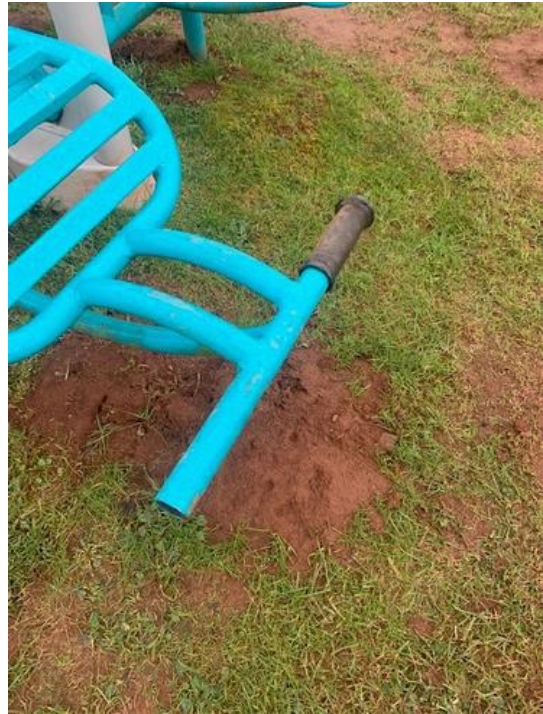
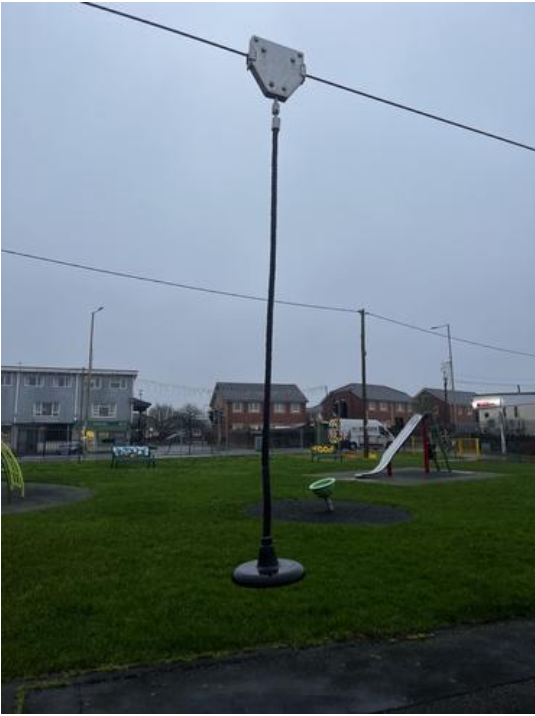
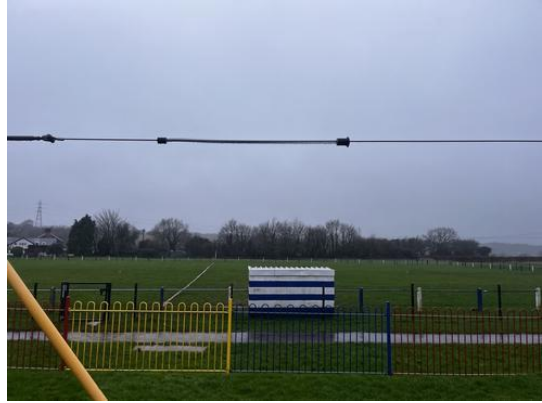
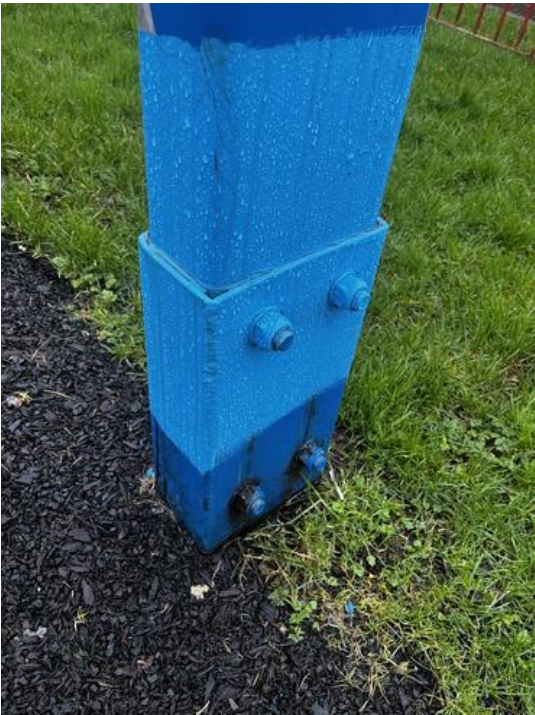
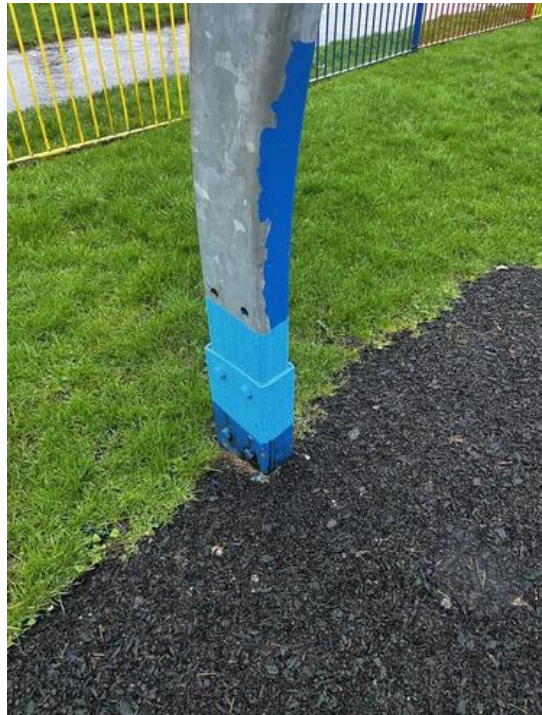
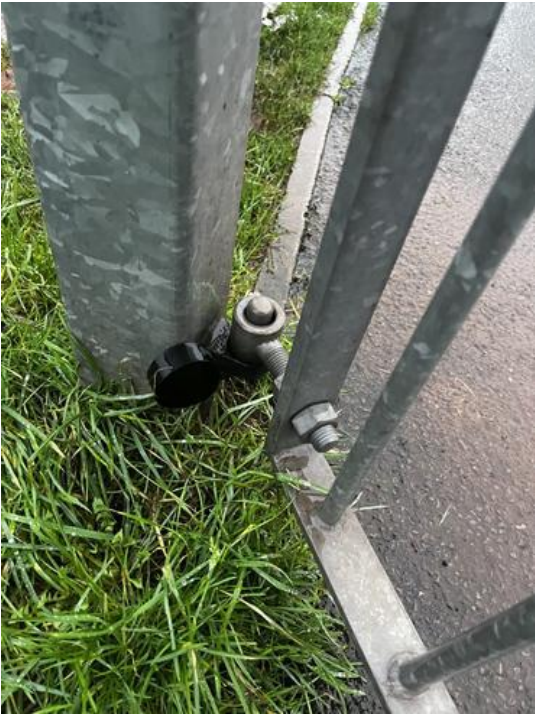
One of the basket swing suspension ropes has been wrapped, monitor

A small fire has caused minor damage to the ball court surface, an additional fire in the opposite corner has caused minor damage to the ball court surface and paintwork on the steel grid

There is some wear on the toddler swing chains, monitor and plan for replacement in the future

There is a rubber cover missing from one of the sit up benches

The cable ride spring has been changed for heavy duty

The pendulum seat has been changed for a rope suspension

The cantilever basket swing has had the post fixings tightened and the seam has been welded

The access gate by car park has had a rubber buffer attached to remove the crush point

monitor items noted

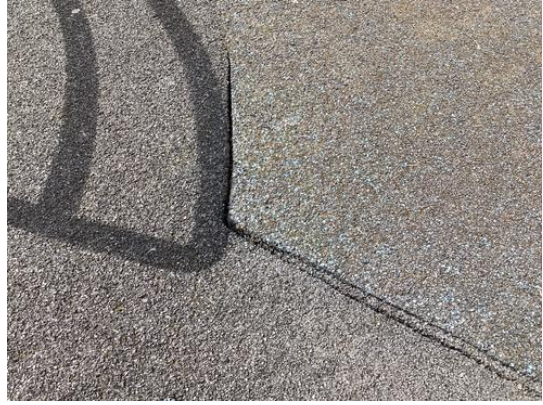
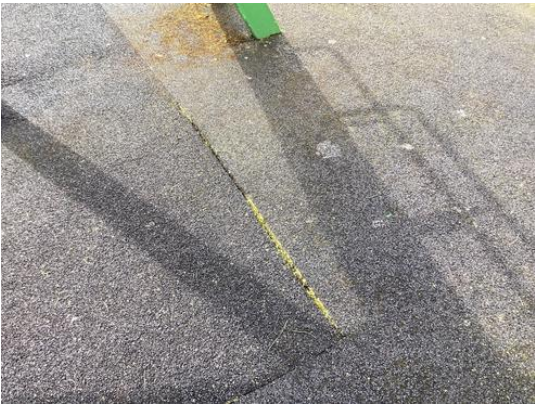
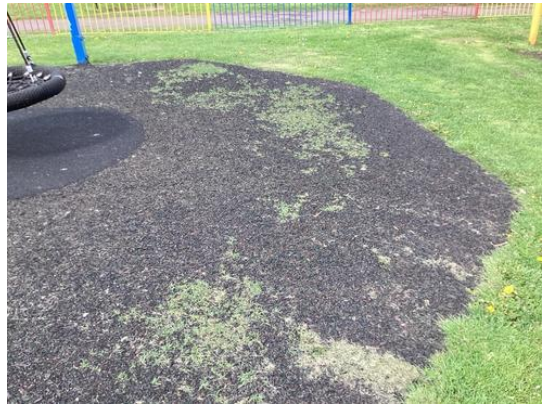
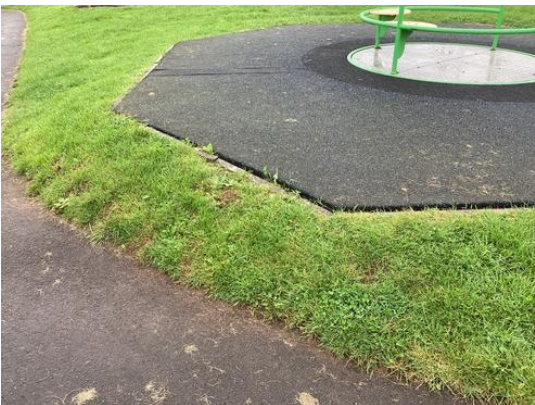
At the time of inspection all surfaces were found to be in a safe and useable condition although there are some areas of joint separation which should be monitored

The basket swing surface has been treated to remove grass growth

One corner of the roundabout surfacing has been subsiding over the years and continues to drop
