Play Area / Equipment Operational Inspection

LLANHARRY COMMUNITY COUNCIL

Score	8 / 8 (100%)	Flagged items	0	Actions	0
Document No.					000078
Audit Title					LLANHARRY COMMUNITY COUNCIL
Client / Site					Llanharry Recreation Ground
Conducted on					15.07.2024 11:50 BST
Prepared by					Jerry Widdas
Location					Llanharry
Personnel					
					Jerry Widdas

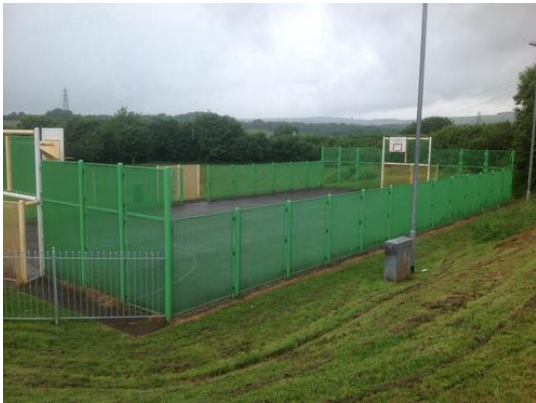
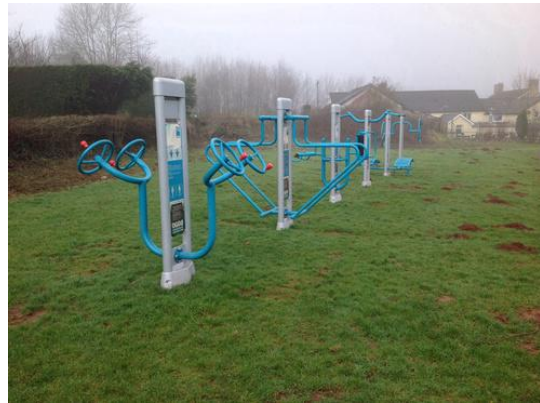
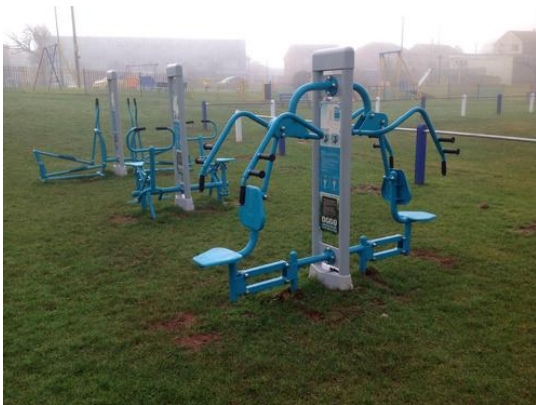
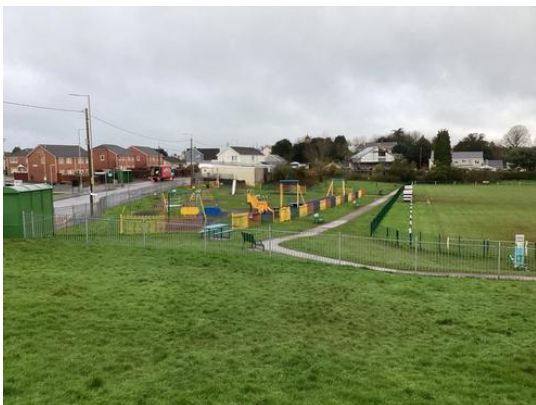
The recreation ground consists of a play area fenced by steel bow top fencing with self closing gates
 A MUGA kick about area and a youth shelter
 Both areas are accessed by Tarmac pathways
 Benches and picnic tables are located within the play area and also outside the play area boundary

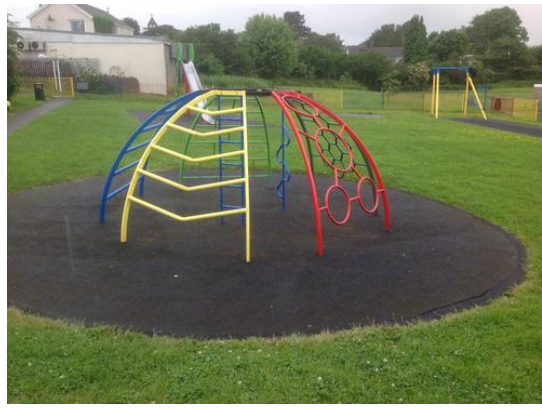
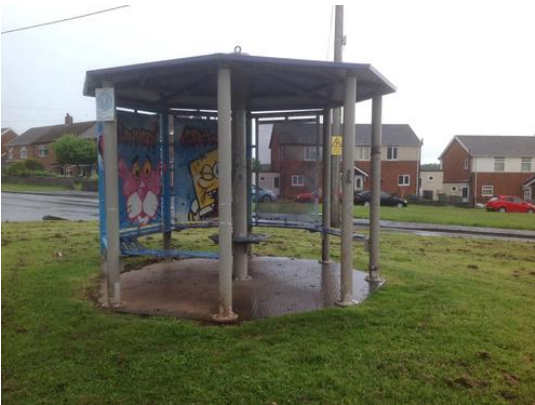
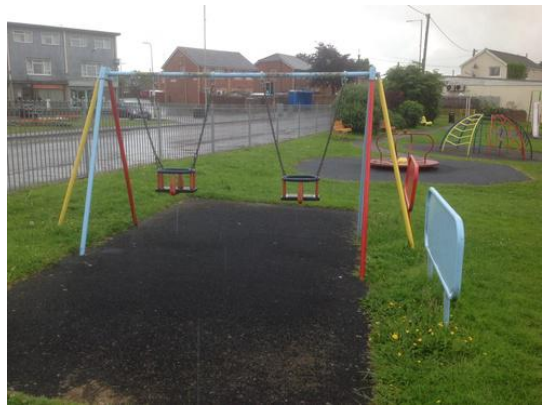
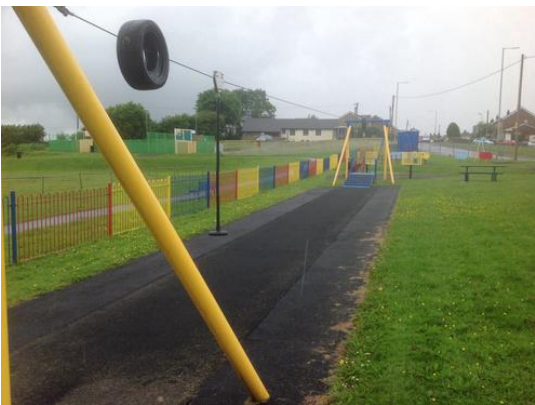
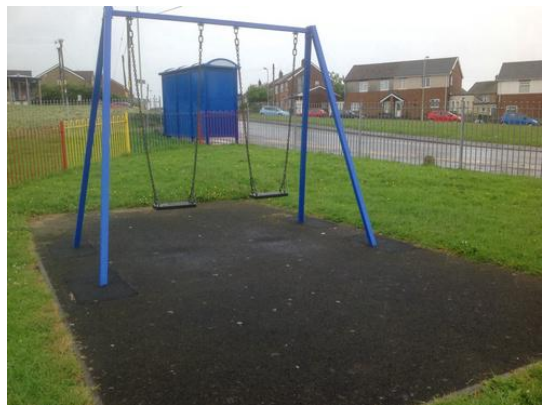
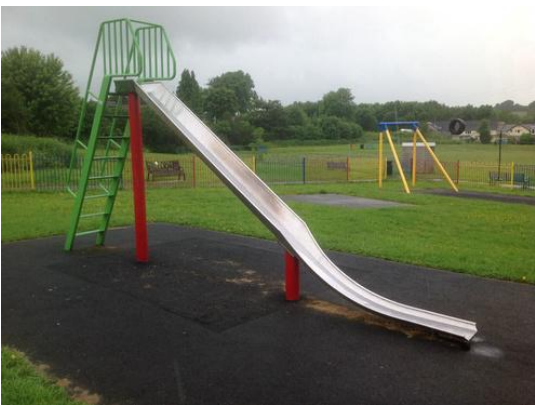
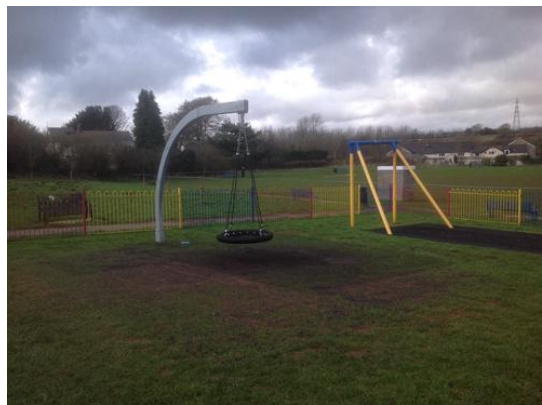
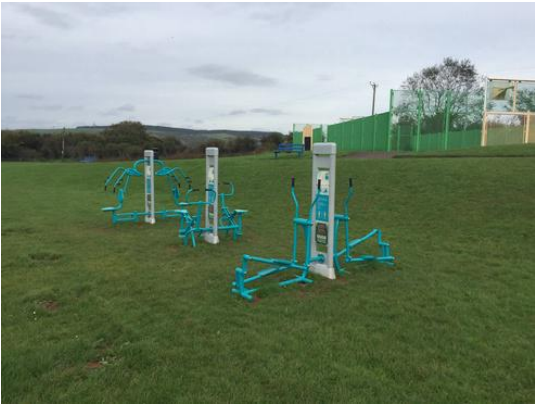
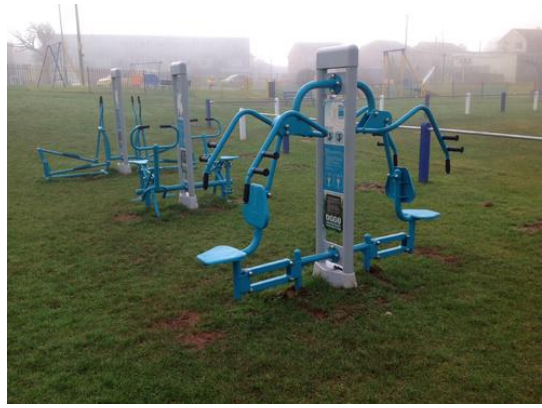
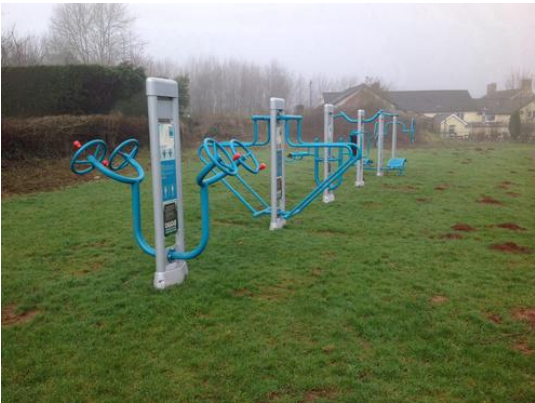
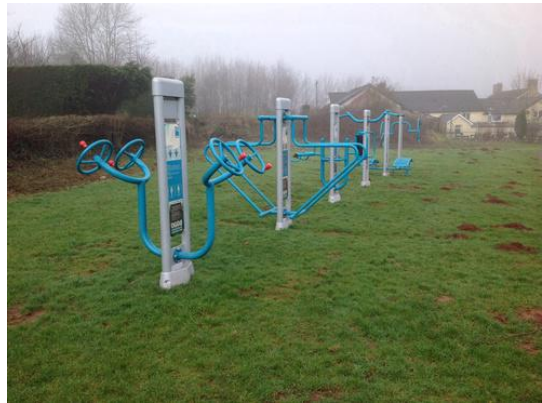
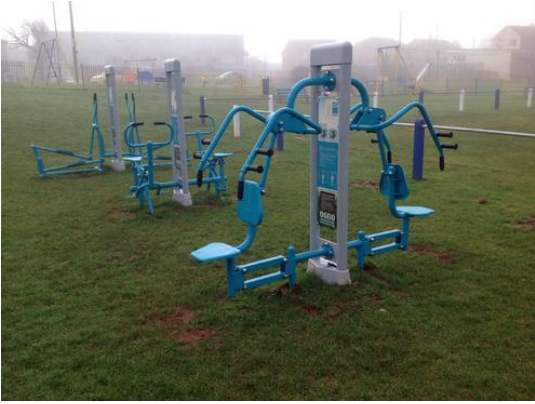
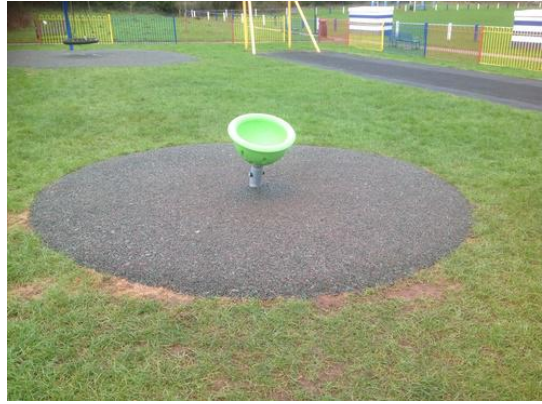
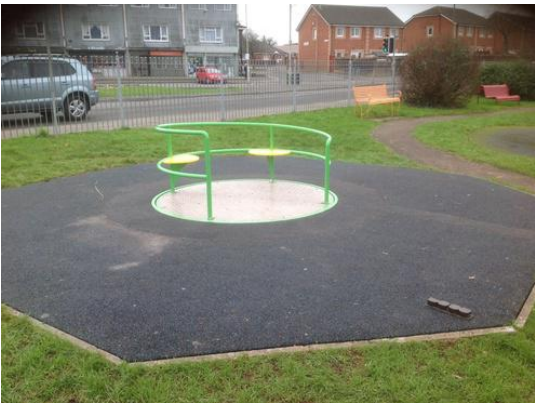
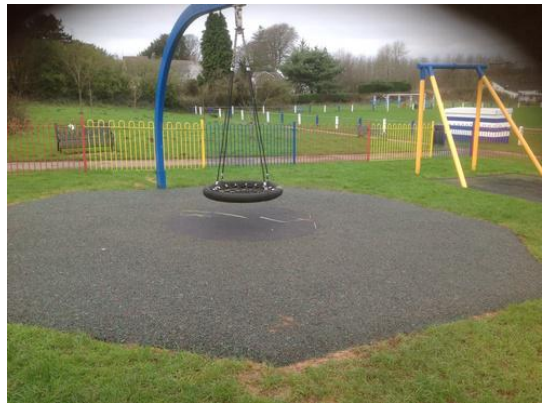
MUGA area supplied by PPL date unknown
 1 X 2 seat swing supplied and installed by Urban Recreation in 2016
 1 X Traditional cradle seat swing Wicksteed Leisure
 1 X Traditional Igloo climber Wicksteed Leisure
 1 X Wheelchair roundabout supplied and installed Urban Recreation Dec 2018
 1 X Multiplayer Unit Proludic installed Feb 2022
 1 X Steel cable ride Record Play
 1 X Freestanding slide Record Play
 2 X Spring animals Fahr Industries installed Feb 2022
 1 X Teen Shelter David Ogilvie Engineering
 1 X Cantilever Swing supplied Urban Recreation 2016
 9 X Fitness Items supplied Urban Recreation October 2017
 1 X Spinning Cup supplied and installed Urban Recreation Dec 2018

At the time of inspection all the equipment was found to be in a safe and useable condition

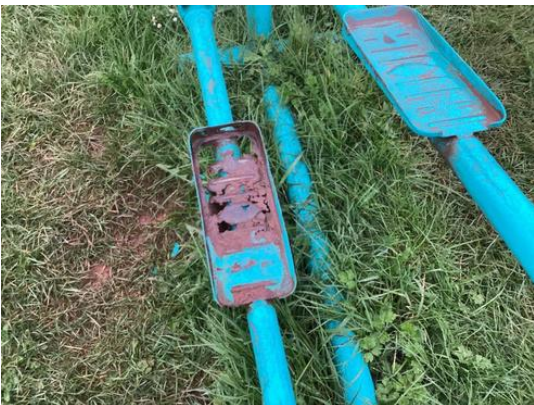
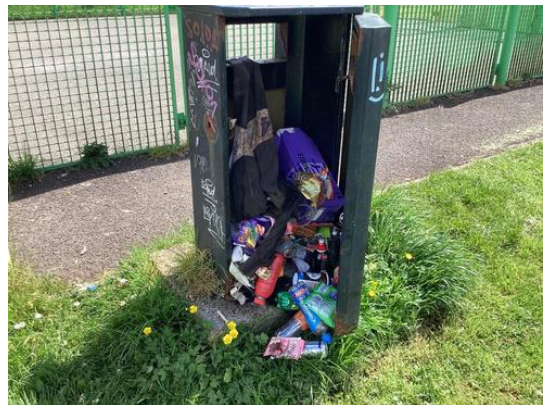
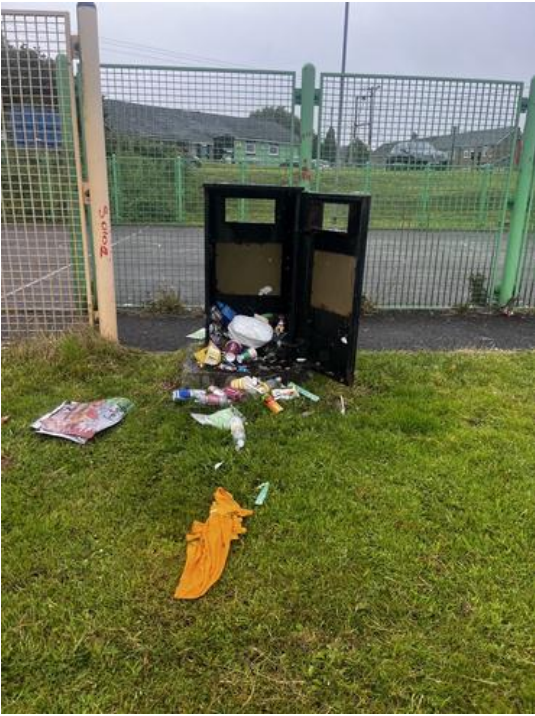
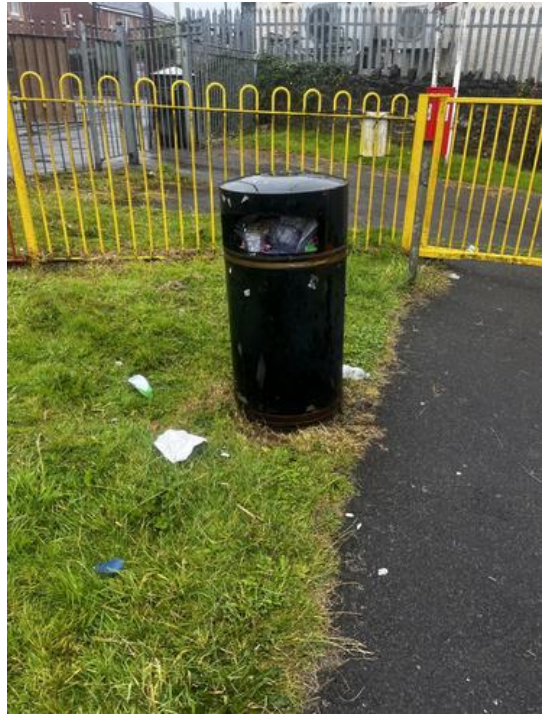
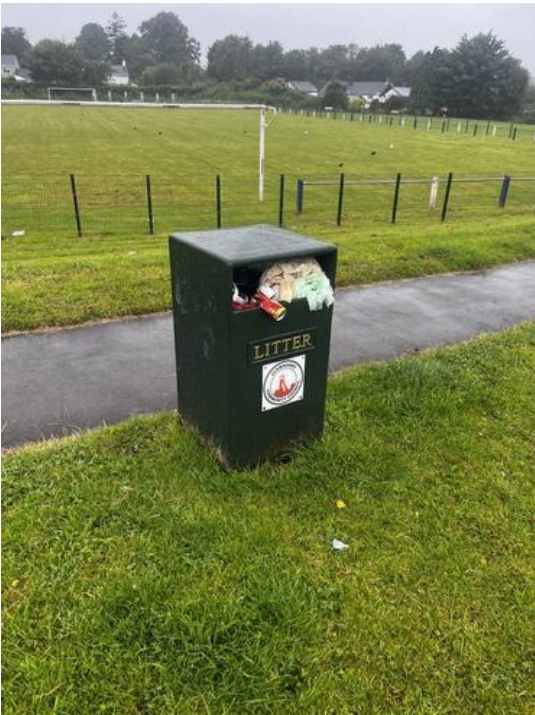
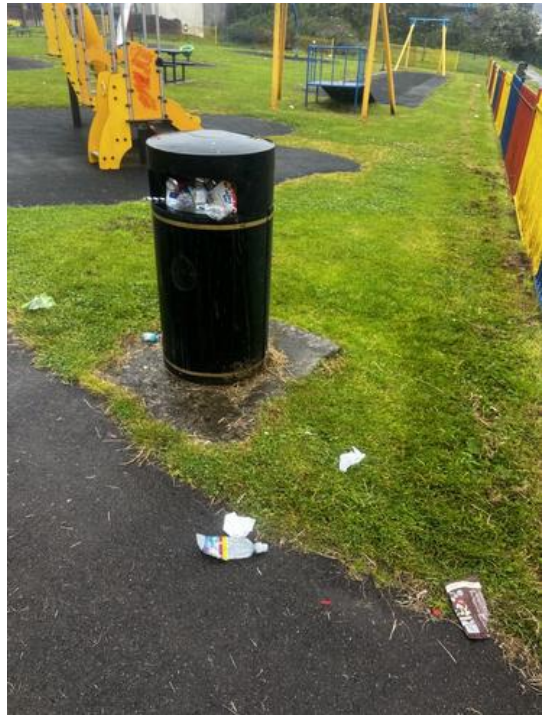
There is some wear on the toddler swing chains, monitor and plan for replacement in the future
Footplate on the air skier fitness item has severe corrosion and needs some work

There is a rubber cover missing from one of the sit up benches

The timber foot treads on the cable ride ramp are starting to deteriorate

There is a muddy hole next to the cable ride ramp

There is some graffiti on the multiplay unit panel

All bins are full and overflowing

monitor timber treads on cable ride ramp

Replace or repair tread on air skier asap

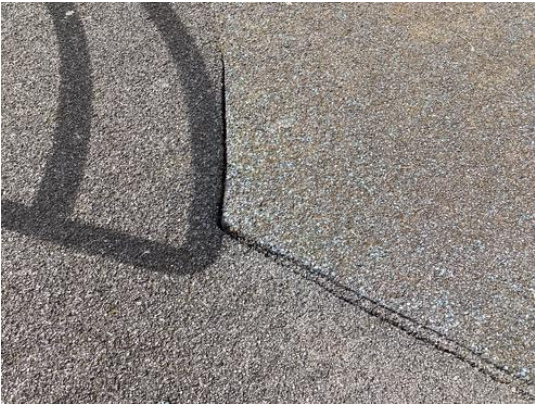
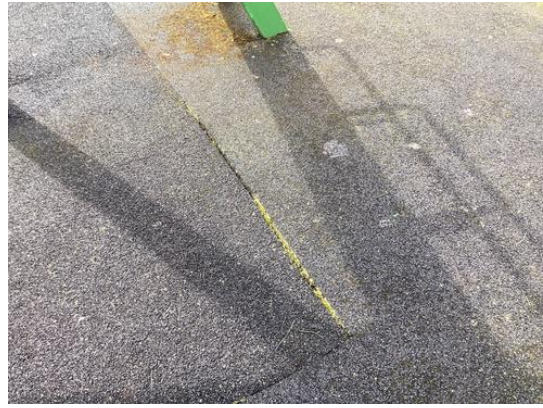
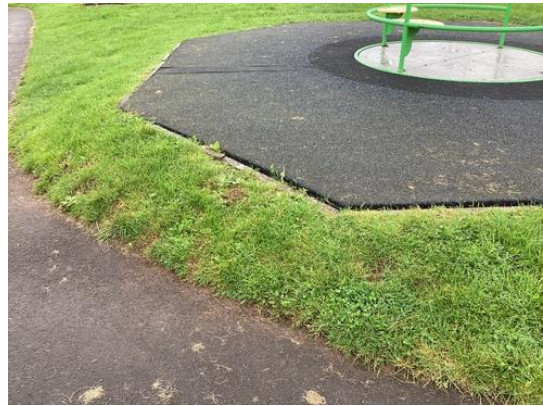
At the time of inspection all surfaces were found to be in a safe and useable condition although there are some areas of joint separation which should be monitored

The basket swing surface has been treated to remove grass growth

One corner of the roundabout surfacing has been subsiding over the years and continues to drop

A spray application of moss killer was applied during visit, reapply during May visit

Schedule to treat rubber surface in July
