Play Area / Equipment Operational Inspection

LLANHARRY COMMUNITY COUNCIL

Client / Site Llanharry Recreation Ground

Conducted on 13.06.2024 13:01 BST

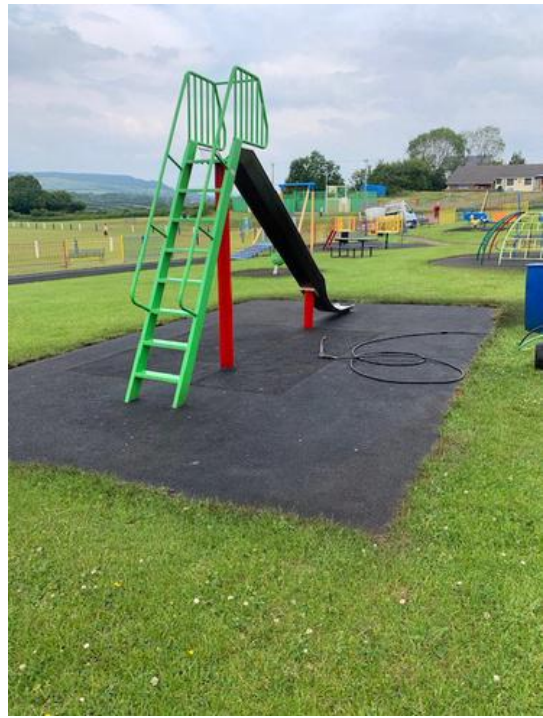
All items of play equipment are located on wet pour rubber safety surfacing

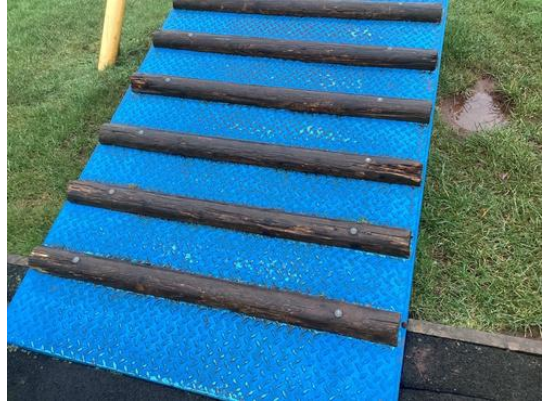
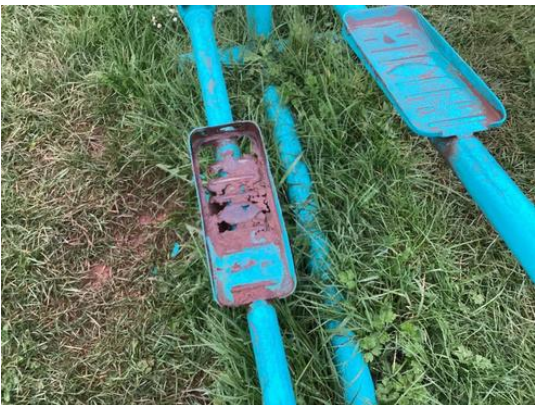
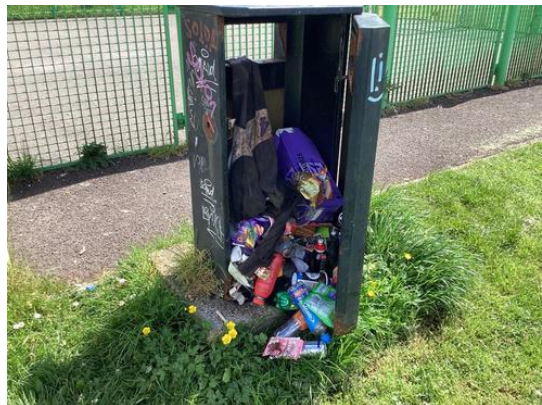
There is some wear on the toddler swing chains, monitor and plan for replacement in the future
Footplate on the air skier fitness item has severe corrosion and needs some work

There is a rubber cover missing from one of the sit up benches

The timber foot treads on the cable ride ramp are starting to deteriorate

There is a muddy hole next to the cable ride ramp

There is some graffiti on the multiplay unit panel

The litter bin by the muga is full and overflowing as the door can not be closed

monitor timber treads on cable ride ramp

Replace or repair tread on air skier asap

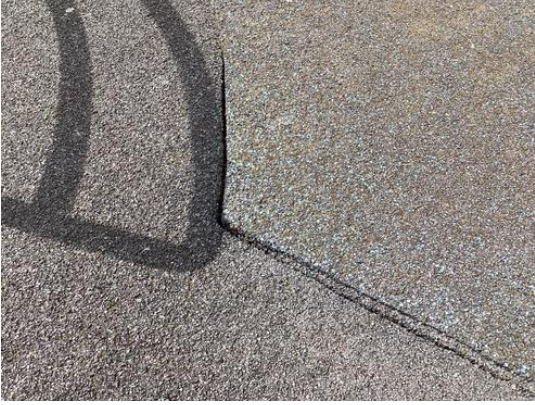
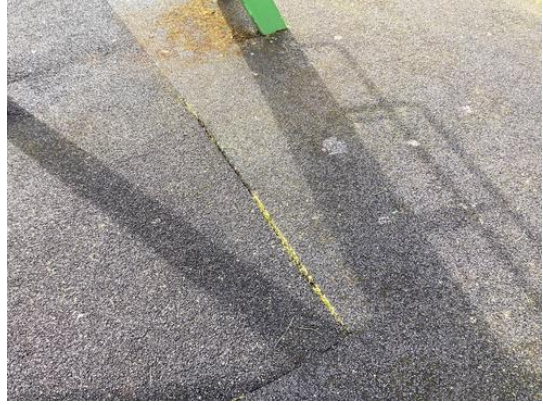
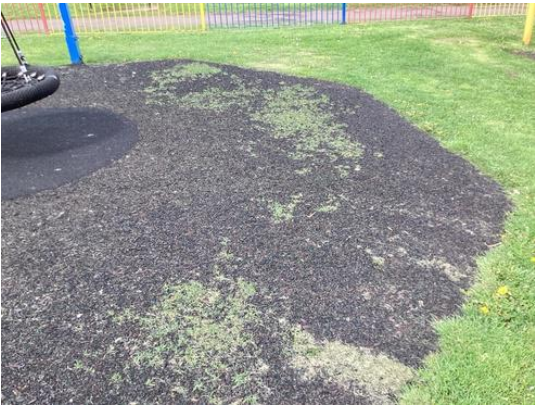
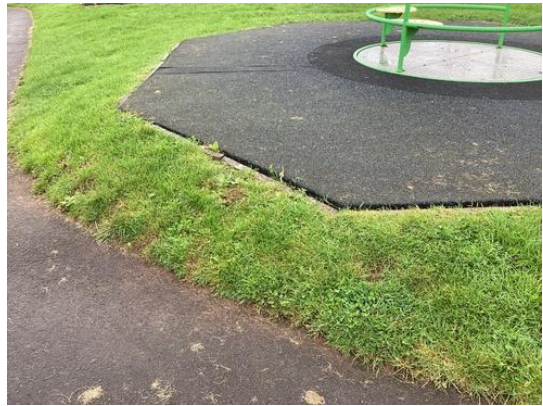
At the time of inspection all surfaces were found to be in a safe and useable condition although there are some areas of joint separation which should be monitored

The basket swing surface has been treated to remove grass growth

One corner of the roundabout surfacing has been subsiding over the years and continues to drop

A spray application of moss killer was applied during visit, reapply during May visit

Schedule to treat rubber surface in July
