Play Area / Equipment Operational Inspection

LLANHARRY COMMUNITY COUNCIL

Score	8 / 8 (100%)	Flagged items	0	Actions	0
Document No.					000078
Audit Title					LLANHARRY COMMUNITY COUNCIL
Client / Site					Llanharry Recreation Ground
Conducted on					23.01.2025 08:30 GMT
Prepared by					Jerry Widdas
Location					Llanharry
Personnel					
					Jerry Widdas

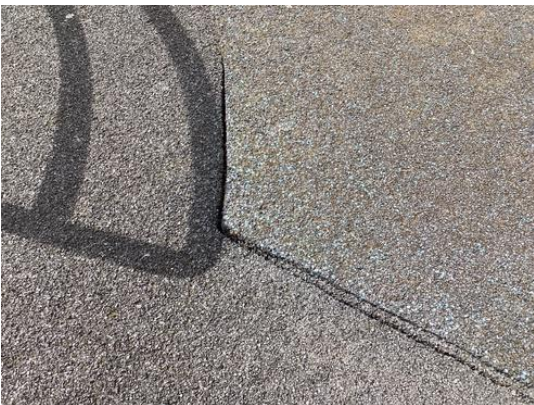
Photo 29

At the time of inspection all surfaces were found to be in a safe and useable condition although there are some areas of joint separation which should be monitored

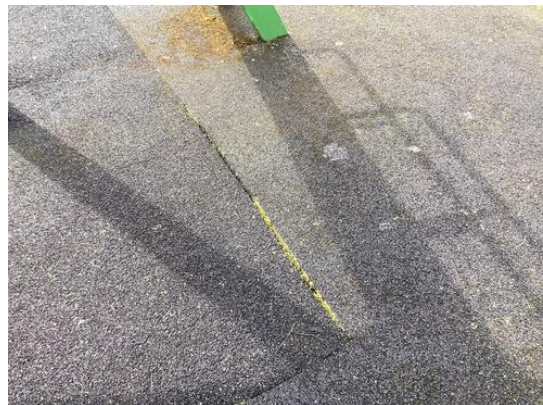
Photo 30

One corner of the roundabout surfacing has been subsiding over the years and continues to drop monitor
