Play Area / Equipment Operational Inspection

LLANHARRY COMMUNITY COUNCIL

Score	100%	Failed items	0	Actions	0
Document No.					000078
Audit Title	LLANHARRY COMMUNITY COUNCIL				
Client / Site	Llanharry Recreation Ground				
Conducted on	10 Jan 2022 14:30 GMT				
Prepared by	Jerry Widdas				
Location	Llanharry				
Personnel	Jerry Widdas

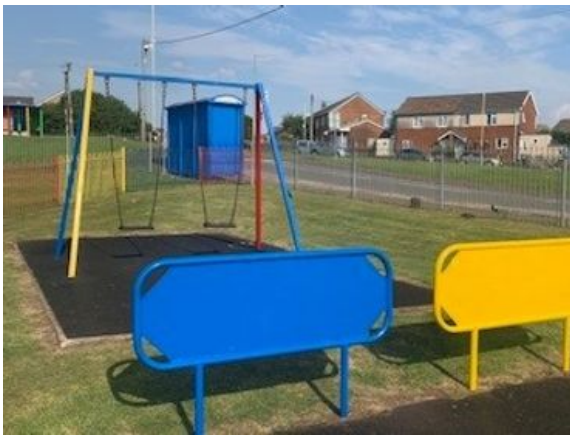
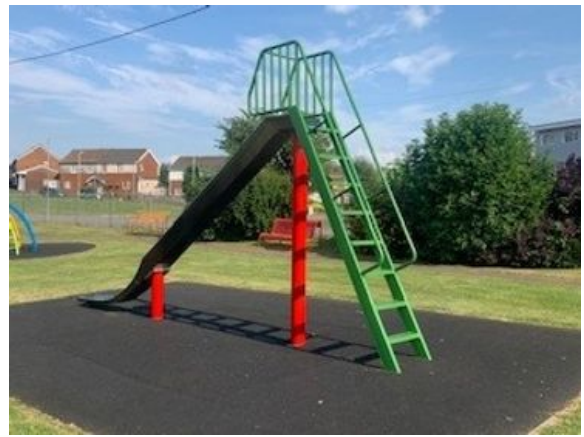
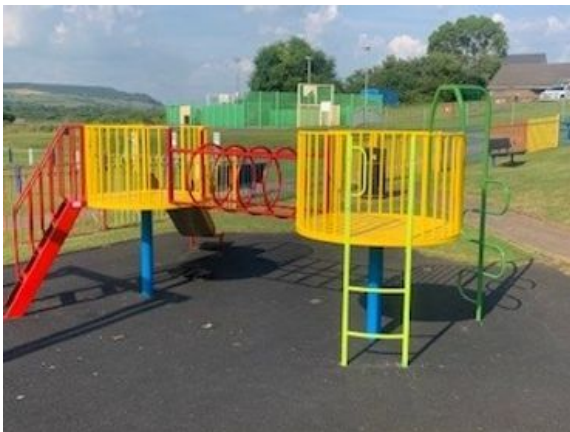
At the time of inspection all the equipment was found to be in a safe and useable condition
All equipment has been freshly painted

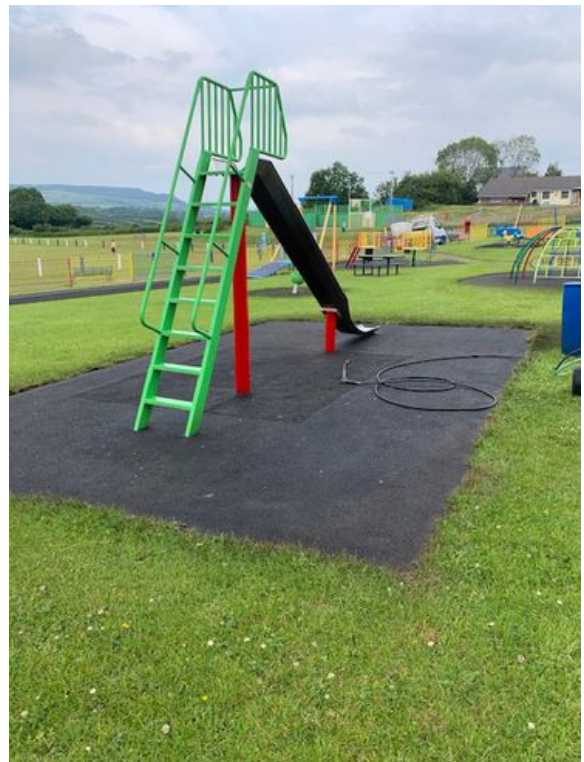
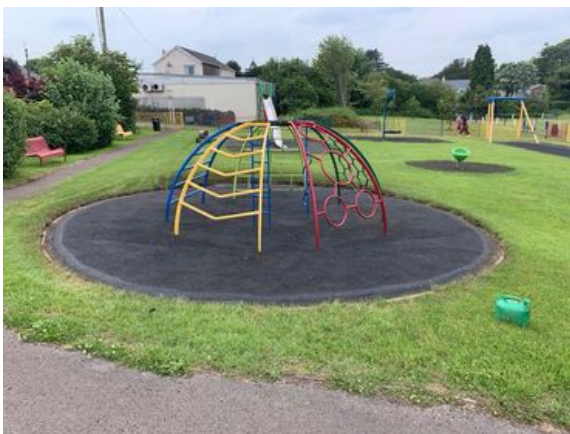
All items of play equipment are located on wet pour rubber safety surfacing

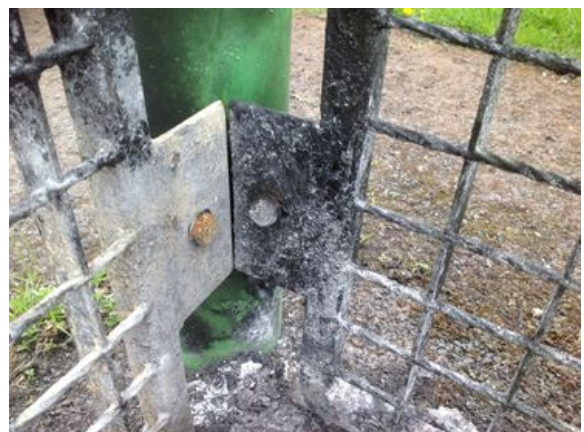
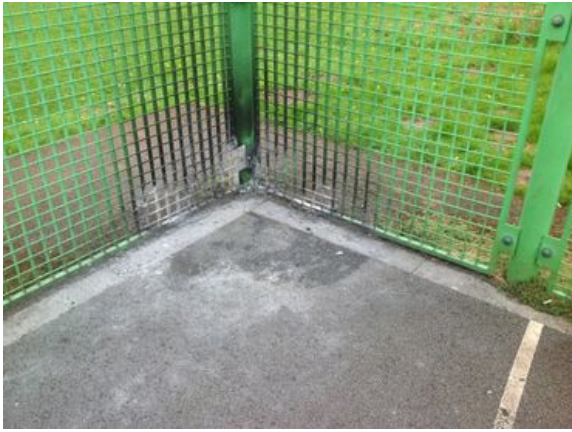
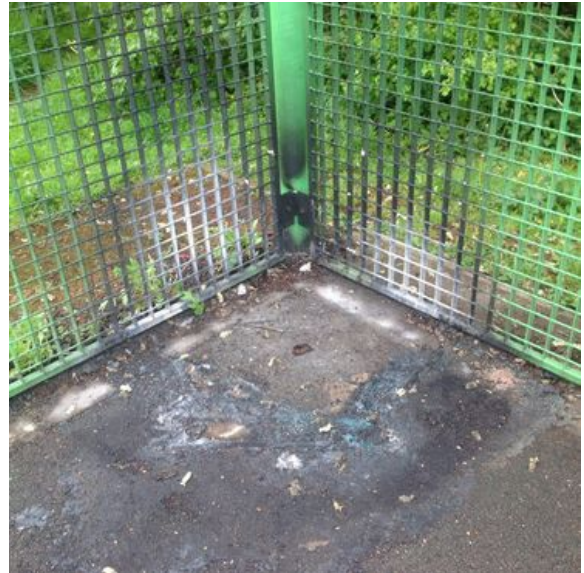
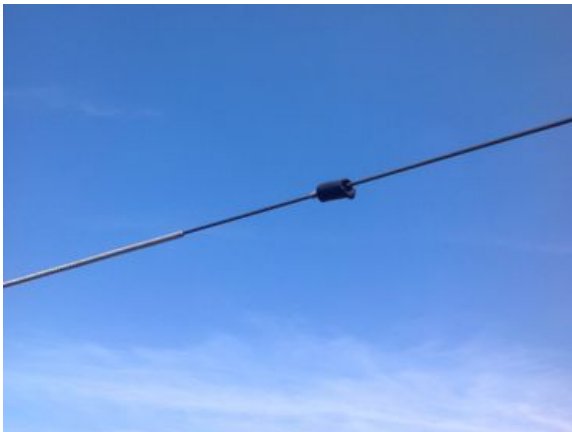
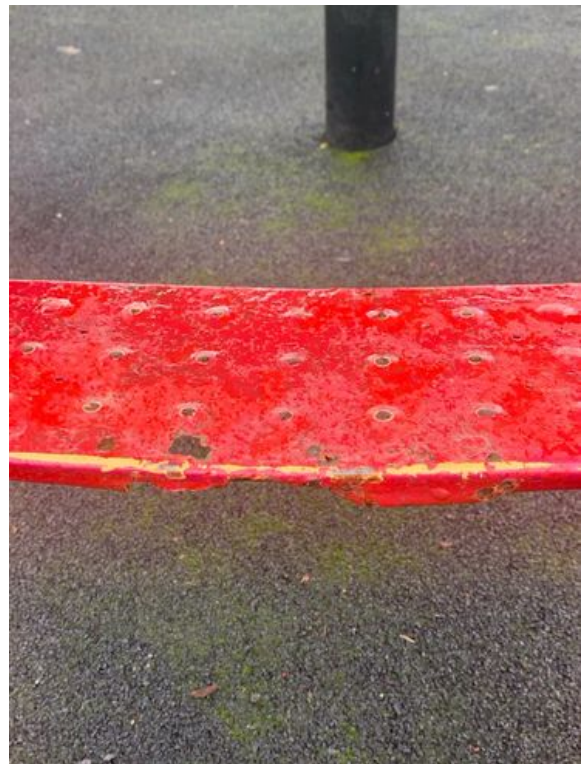
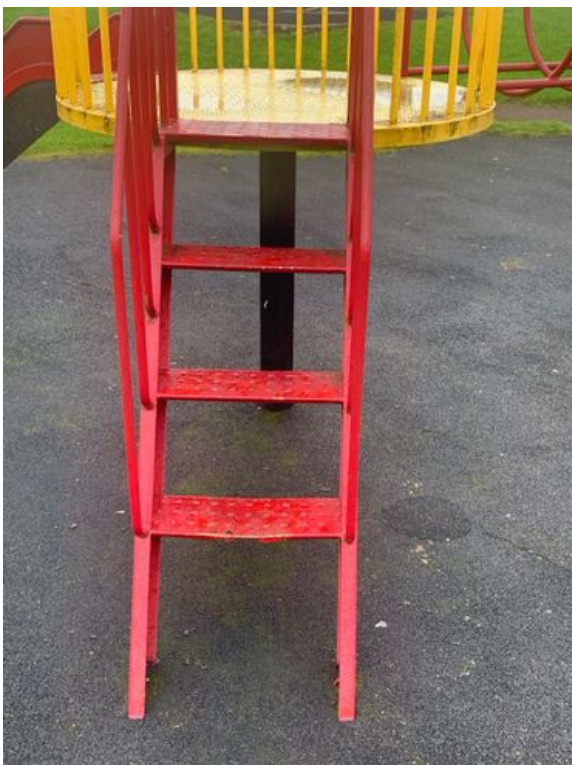
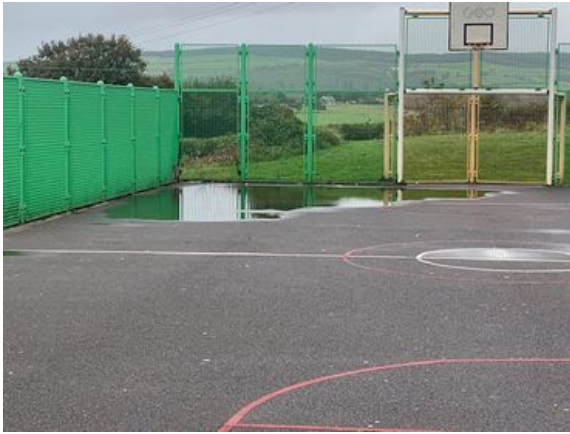
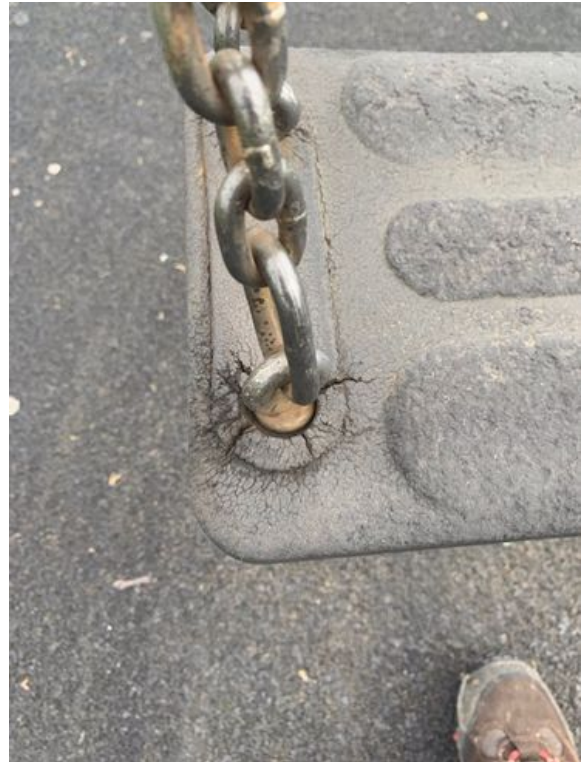
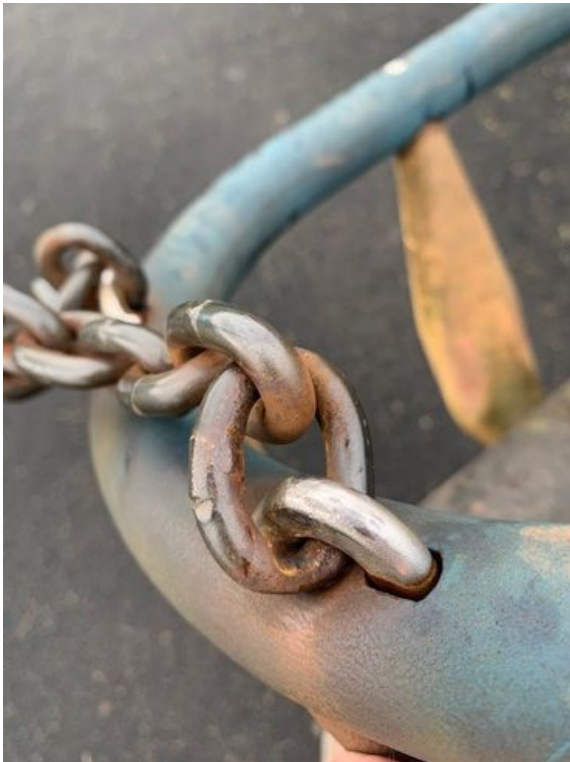
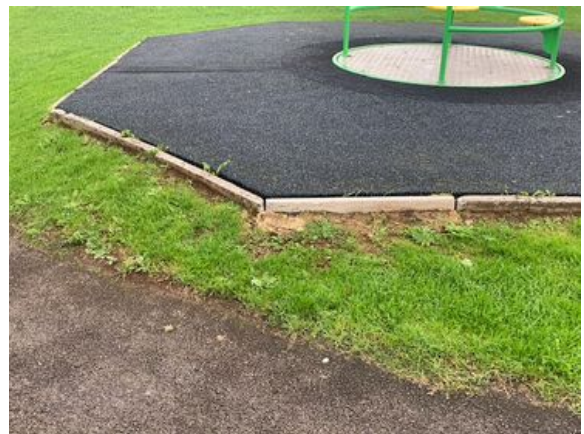
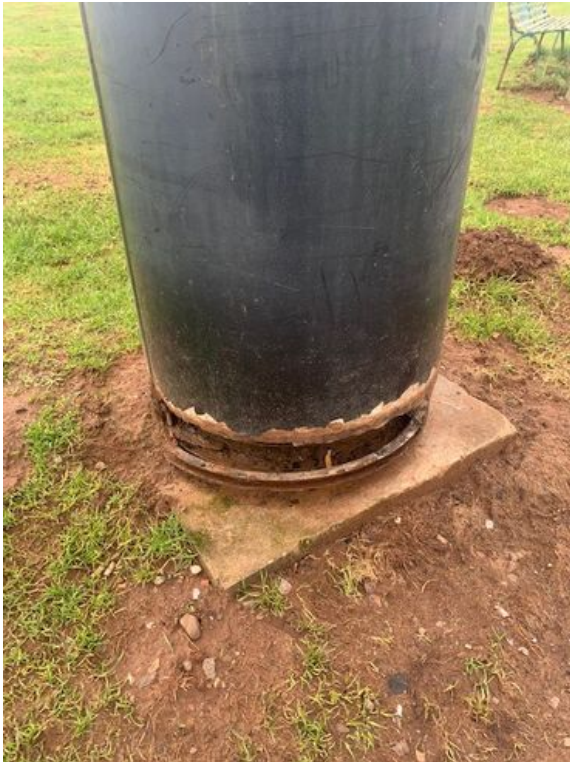
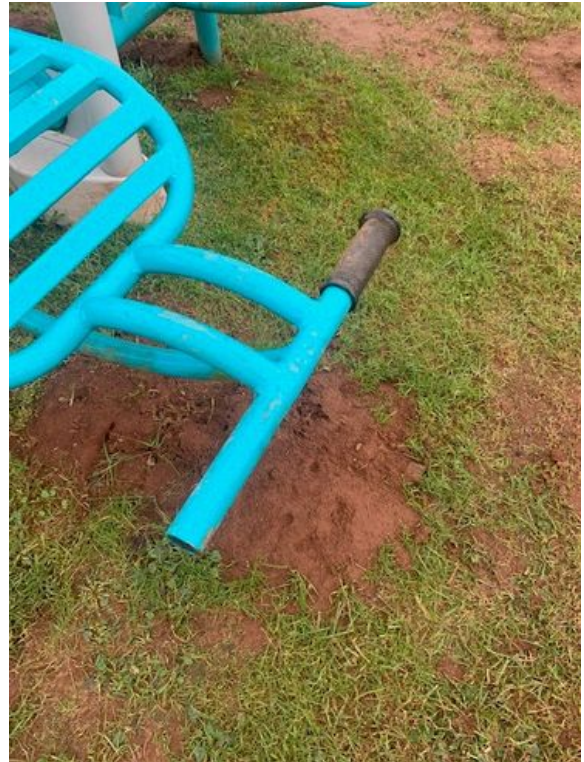
One corner of the roundabout edging has subsided exposing the concrete foundation and causing one concrete edge to sink slightly
 The metal stairway on the multiplay unit is starting to corrode and get thin in places, this could have a steel plate welded in to prolong its life
 The flat seats on the swing are starting to show the steel insert, monitor for further deterioration and replace
 One of the basket swing suspension ropes has been wrapped, monitor
 A small fire has caused minor damage to the ball court surface, an additional fire in the opposite corner has caused minor damage to the ball court surface and paintwork on the steel grid
 The Spring stopper at the end of the cable ride has broken, this is not currently a safety issue but may deteriorate further with time, monitor and plan to replace at convenient time in the future.
 There is some wear on the toddler swing chains, monitor and plan for replacement in the future

There is a rubber cover missing from one of the sit up benches
 The three round litter bins surrounding the football field have advanced corrosion

monitor items noted

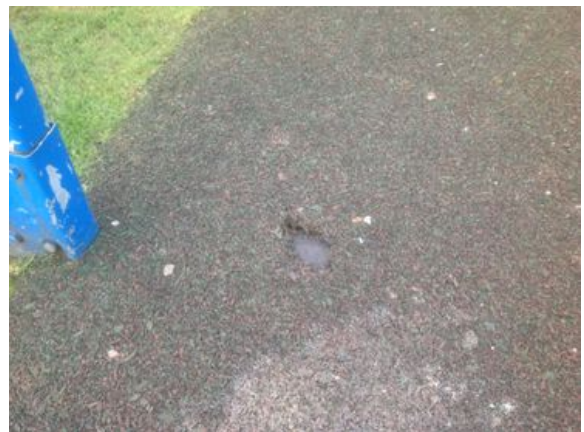
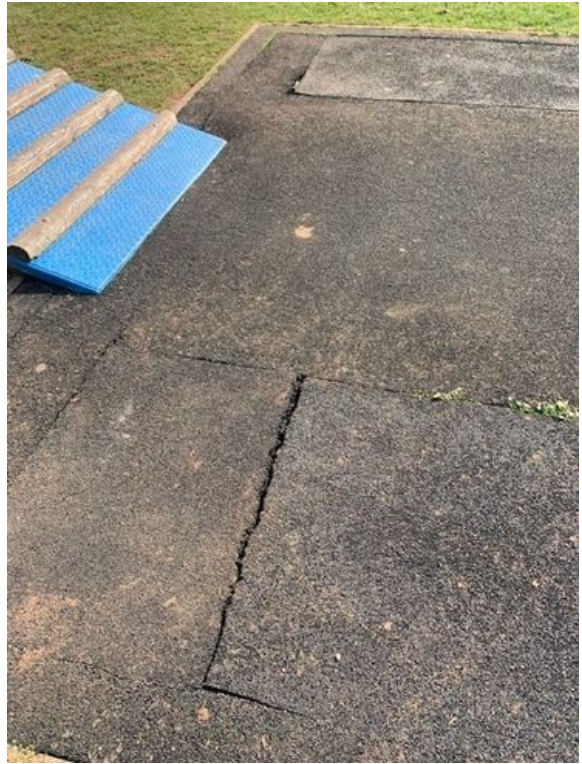
A rubber joint has lifted slightly on the cable ride surfacing
 Moss and algae is again starting to appear on the rubber surfacing, suggest spray treatment with a new chemical that is now available (chemical has been applied to small multiplay and large slide rubber area as a test)
