Play Area / Equipment Operational Inspection

LLANHARRY COMMUNITY COUNCIL

Score	8 / 8 (100%)	Flagged items	0	Actions	0
Document No.					000078
Audit Title					LLANHARRY COMMUNITY COUNCIL
Client / Site					Llanharry Recreation Ground
Conducted on					31.07.2025 10:00 BST
Prepared by					Jerry Widdas
Location					Llanharry
Personnel					
					Jerry Widdas

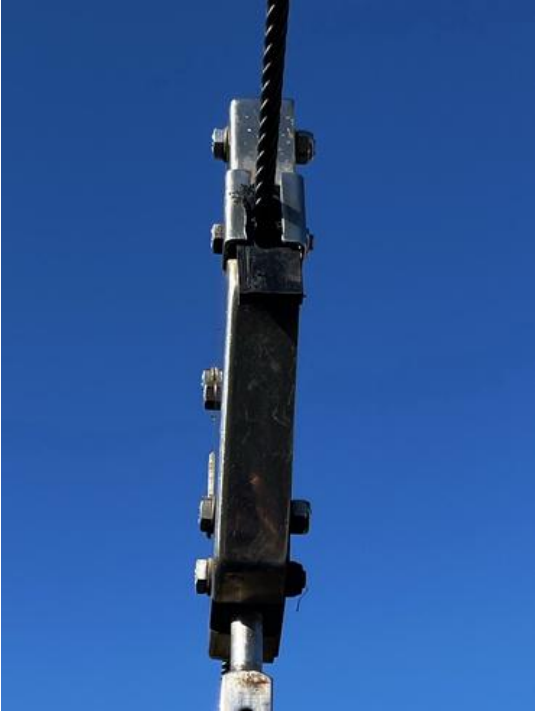
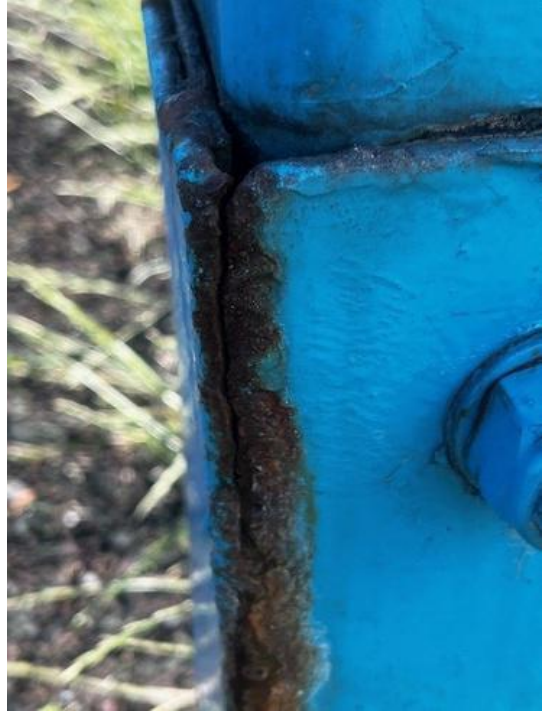
There is some wear on the toddler swing chains, monitor and plan for replacement in the future

There is a rubber cover missing from one of the sit up benches

The timber foot treads on the cable ride ramp are starting to deteriorate

There is a muddy hole next to the cable ride ramp

There is some graffiti on the multiplay unit panel

One of the finger guards on the cableway trolley is very worn and will need replacing in the near future

Weld has cracked on the base of the cantilever swing

Fitness item damper needs repair

monitor timber treads on cable ride ramp
Weld base on cantilever swing
Fix damper on fitness unit

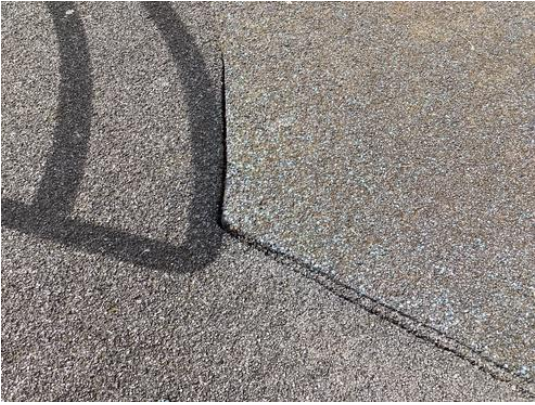
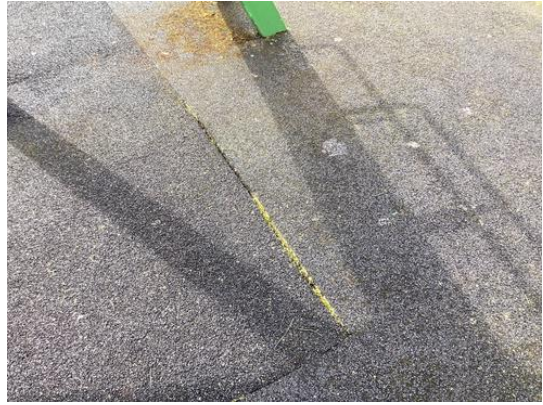
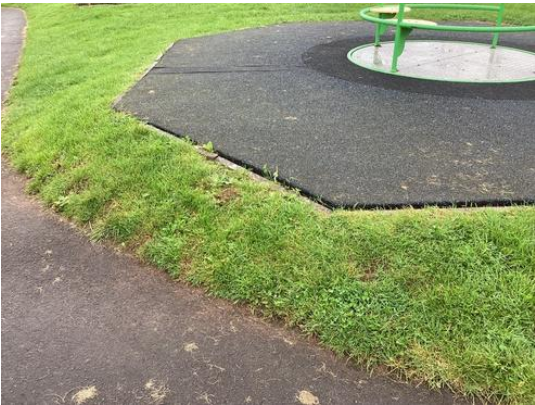
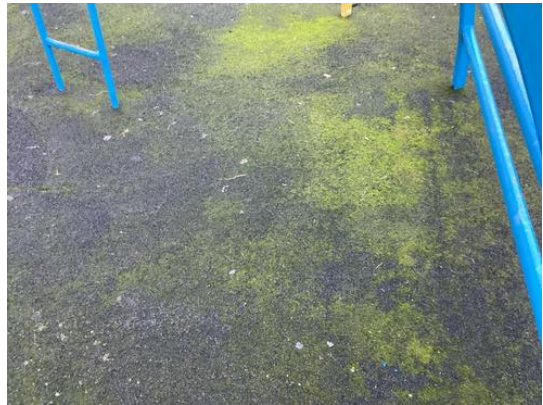
At the time of inspection all surfaces were found to be in a safe and useable condition although there are some areas of joint separation which should be monitored

One corner of the roundabout surfacing has been subsiding over the years and continues to drop monitor
