Play Area / Equipment Operational Inspection

LLANHARRY COMMUNITY COUNCIL

Score	8 / 8 (100%)	Flagged items	0	Actions	0
Document No.					000078
Audit Title					LLANHARRY COMMUNITY COUNCIL
Client / Site					Llanharry Recreation Ground
Conducted on					30.06.2025 16:00 BST
Prepared by					Jerry Widdas
Location					Llanharry
Personnel					
					Jerry Widdas

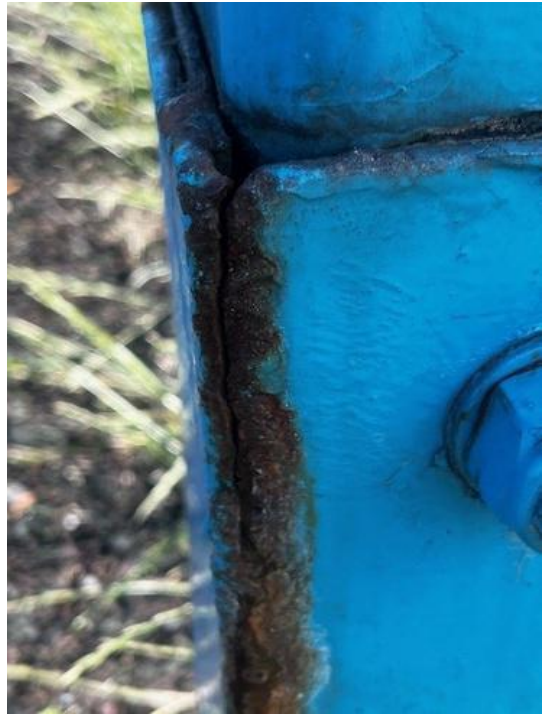
There is some wear on the toddler swing chains, monitor and plan for replacement in the future

There is a rubber cover missing from one of the sit up benches

The timber foot treads on the cable ride ramp are starting to deteriorate

There is a muddy hole next to the cable ride ramp

There is some graffiti on the multiplay unit panel

One of the finger guards on the cableway trolley is very worn and will need replacing in the near future

Weld has cracked on the base of the cantilever swing

Fitness item damper needs repair

monitor timber treads on cable ride ramp
Weld base on cantilever swing
Fix damper on fitness unit

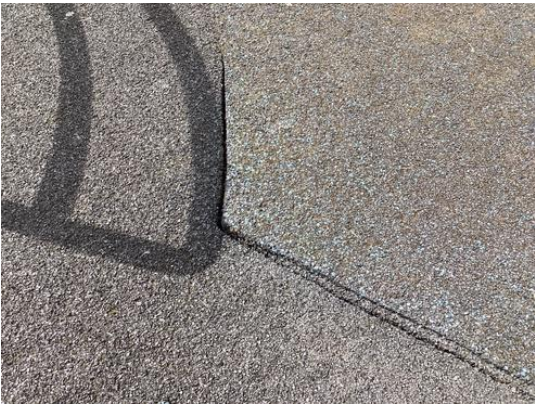
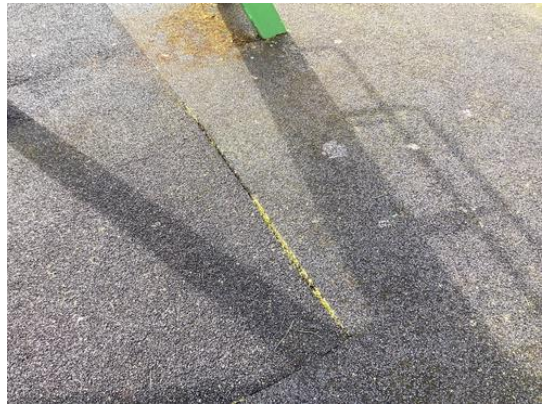
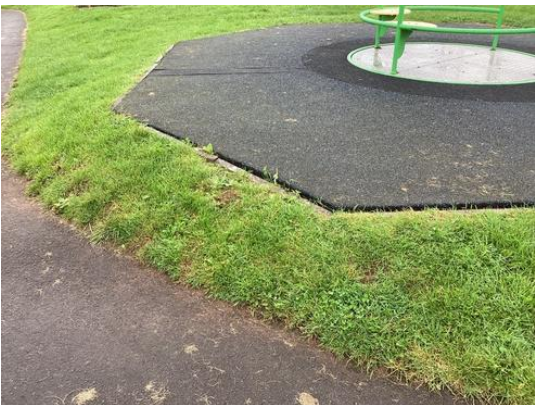
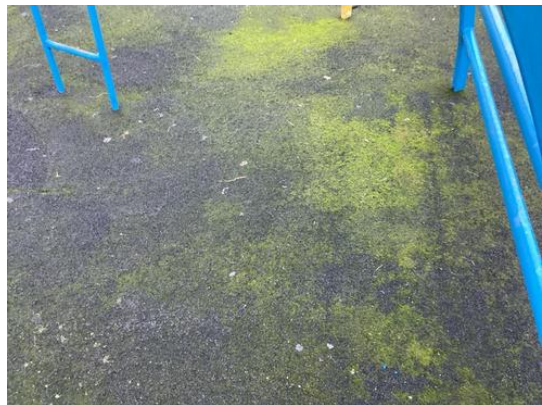
At the time of inspection all surfaces were found to be in a safe and useable condition although there are some areas of joint separation which should be monitored

One corner of the roundabout surfacing has been subsiding over the years and continues to drop monitor
