Play Area / Equipment Operational Inspection

LLANHARRY COMMUNITY COUNCIL

Score	100%	Failed items	0	Actions	0
Document No.					000078
Audit Title	LLANHARRY COMMUNITY COUNCIL				
Client / Site	Llanharry Recreation Ground				
Conducted on	2 Mar 2022 09:30 GMT				
Prepared by	Jerry Widdas				
Location	Llanharry				
Personnel	Jerry Widdas

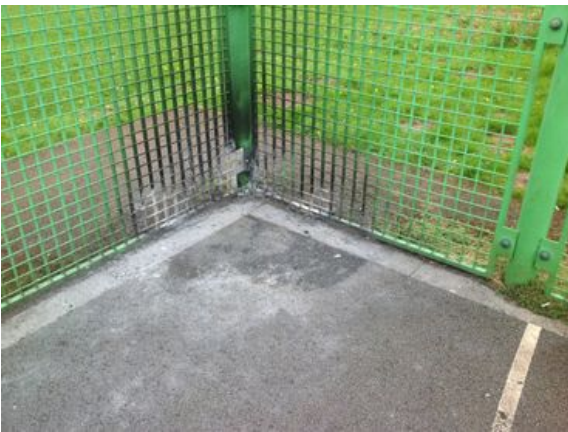
Photo 29

The flat seats on the swing are starting to show the steel insert, monitor for further deterioration and replace
 One of the basket swing suspension ropes has been wrapped, monitor
 A small fire has caused minor damage to the ball court surface, an additional fire in the opposite corner has caused minor damage to the ball court surface and paintwork on the steel grid
 The Spring stopper at the end of the cable ride has broken, this is not currently a safety issue but may deteriorate further with time, monitor and plan to replace at convenient time in the future.
 There is some wear on the toddler swing chains, monitor and plan for replacement in the future
 There is a rubber cover missing from one of the sit up benches
 The three round litter bins surrounding the football field have advanced corrosion

monitor items noted
