Play Area / Equipment Operational Inspection

LLANHARRY COMMUNITY COUNCIL

Score	8 / 8 (100%)	Flagged items	0	Actions	0
Document No.					000078
Audit Title					LLANHARRY COMMUNITY COUNCIL
Client / Site					Llanharry Recreation Ground
Conducted on					15.05.2024 13:32 BST
Prepared by					Jerry Widdas
Location					Llanharry
Personnel					
Jerry Widdas

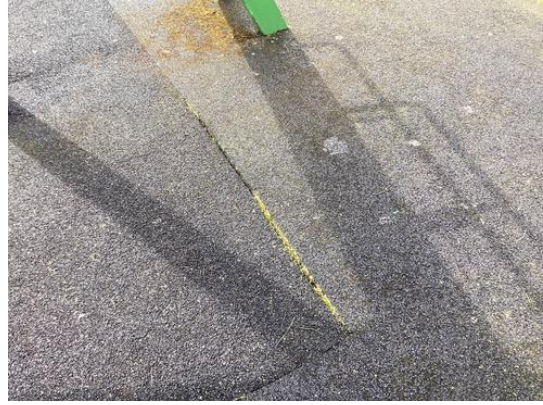
At the time of inspection all surfaces were found to be in a safe and useable condition although there are some areas of joint separation which should be monitored

The basket swing surface has been treated to remove grass growth

One corner of the roundabout surfacing has been subsiding over the years and continues to drop

A spray application of moss killer was applied during visit, reapply during May visit

Schedule to treat rubber surface with moss killer first dry opportunity when we have a dry spell!!!!
