Play Area / Equipment Operational Inspection

LLANHARRY COMMUNITY COUNCIL

Client / Site Llanharry Recreation Ground

Conducted on 28.05.2025 07:30 BST

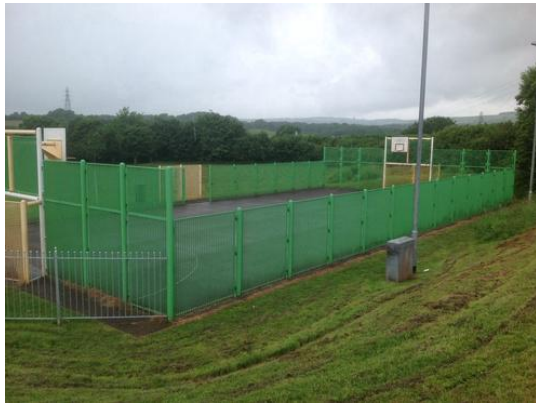
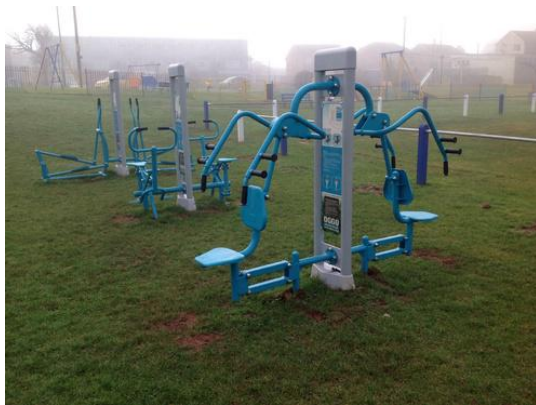
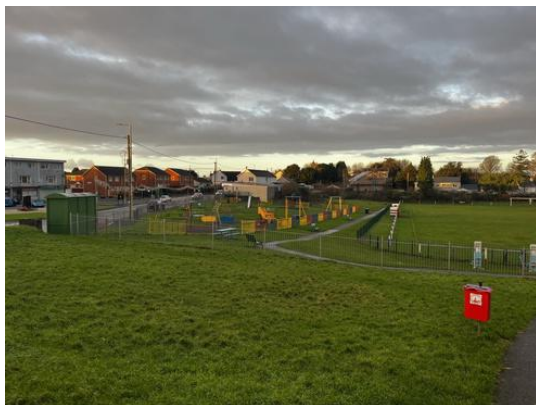
The recreation ground consists of a play area fenced by steel bow top fencing with self closing gates
 A MUGA kick about area and a youth shelter
 Both areas are accessed by Tarmac pathways
 Benches and picnic tables are located within the play area and also outside the play area boundary

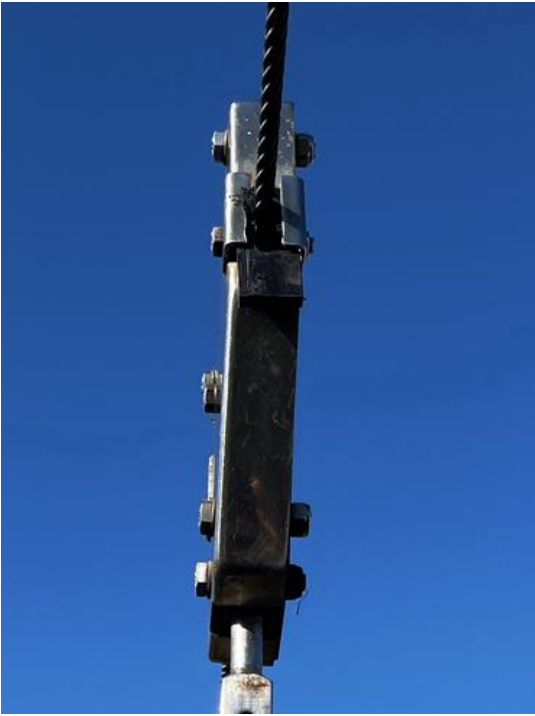
Photo 29

One of the finger guards on the cableway trolley is very worn and will need replacing in the near future

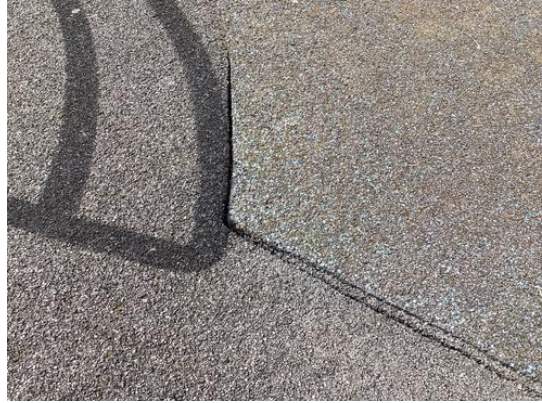
At the time of inspection all surfaces were found to be in a safe and useable condition although there are some areas of joint separation which should be monitored
