# Play Area / Equipment Operational Inspection

LLANHARRY COMMUNITY COUNCIL

<b>Score</b>	8 / 8 (100%)	<b>Flagged items</b>	0	<b>Actions</b>	0
<b>Document No.</b>					000078
<b>Audit Title</b>					LLANHARRY COMMUNITY COUNCIL
<b>Client / Site</b>					Llanharry Recreation Ground
<b>Conducted on</b>					29.11.2024 08:46 GMT
<b>Prepared by</b>					Jerry Widdas
<b>Location</b>					Llanharry
<b>Personnel</b>					
Jerry Widdas

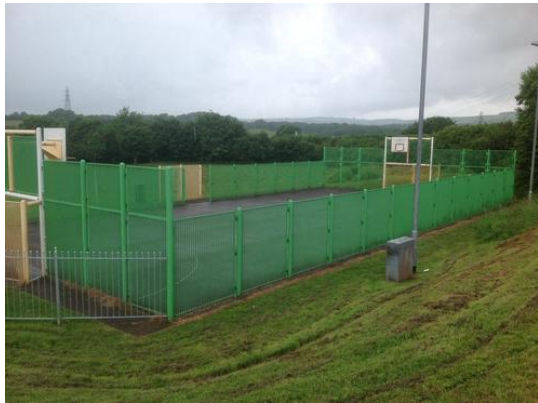
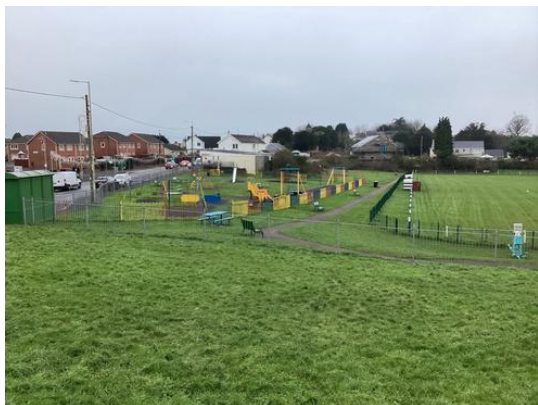
The recreation ground consists of a play area fenced by steel bow top fencing with self closing gates  
 A MUGA kick about area and a youth shelter  
 Both areas are accessed by Tarmac pathways  
 Benches and picnic tables are located within the play area and also outside the play area boundary

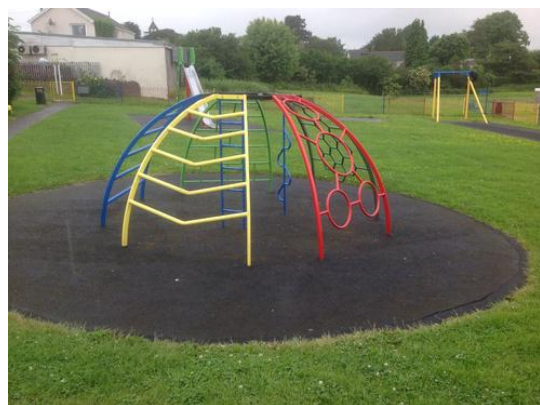
MUGA area supplied by PPL date unknown  
 1 X 2 seat swing supplied and installed by Urban Recreation in 2016  
 1 X Traditional cradle seat swing Wicksteed Leisure  
 1 X Traditional Igloo climber Wicksteed Leisure  
 1 X Wheelchair roundabout supplied and installed Urban Recreation Dec 2018  
 1 X Multiplayer Unit Proludic installed Feb 2022  
 1 X Steel cable ride Record Play  
 1 X Freestanding slide Record Play  
 2 X Spring animals Fahr Industries installed Feb 2022  
 1 X Teen Shelter David Ogilvie Engineering  
 1 X Cantilever Swing supplied Urban Recreation 2016  
 9 X Fitness Items supplied Urban Recreation October 2017  
 1 X Spinning Cup supplied and installed Urban Recreation Dec 2018

At the time of inspection all the equipment was found to be in a safe and useable condition

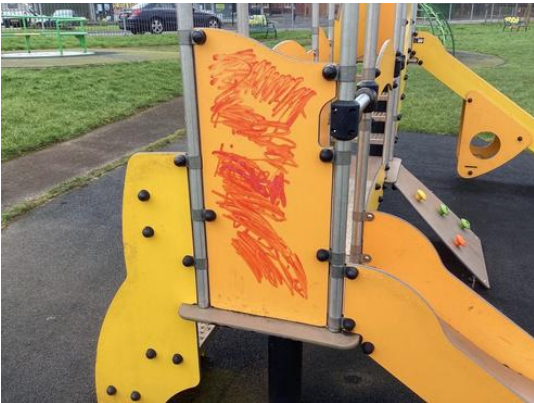
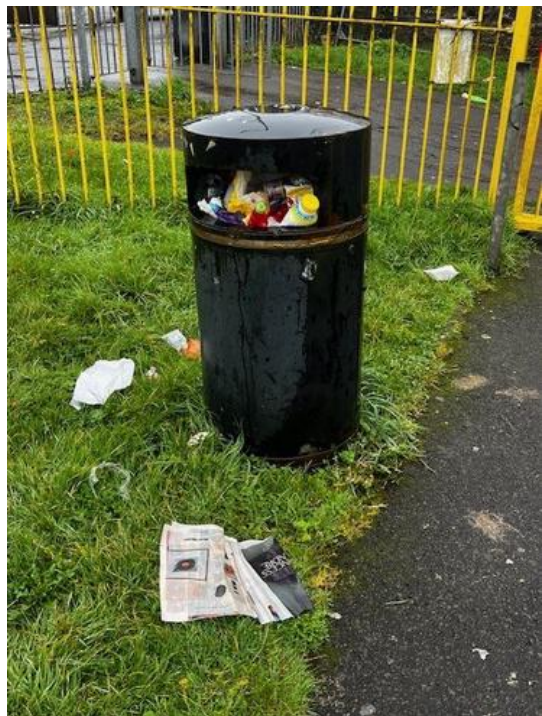
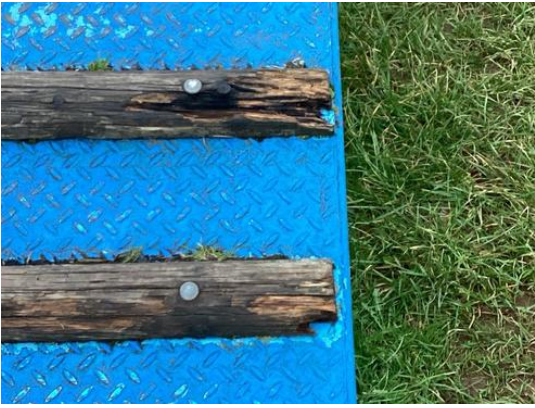
There is some wear on the toddler swing chains, monitor and plan for replacement in the future

There is a rubber cover missing from one of the sit up benches

The timber foot treads on the cable ride ramp are starting to deteriorate

There is a muddy hole next to the cable ride ramp

There is some graffiti on the multiplay unit panel

Bin was full and overflowing

monitor timber treads on cable ride ramp

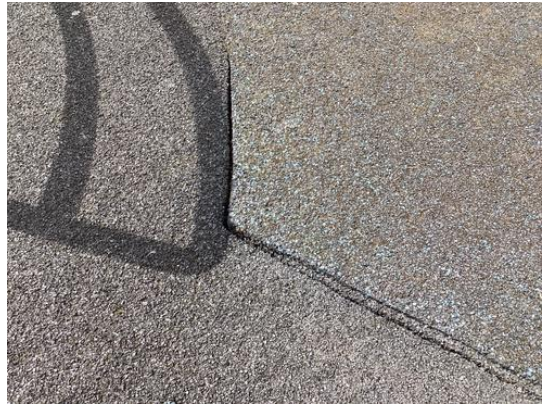
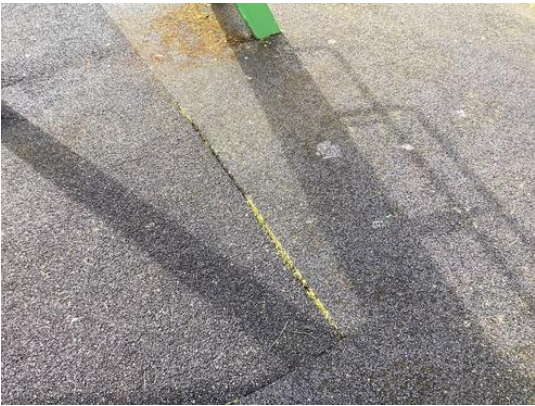
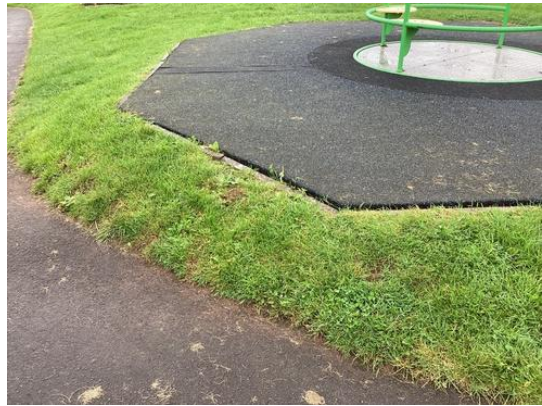
At the time of inspection all surfaces were found to be in a safe and useable condition although there are some areas of joint separation which should be monitored

One corner of the roundabout surfacing has been subsiding over the years and continues to drop monitor

Some algae growth, suggest chemical treatment in early spring.

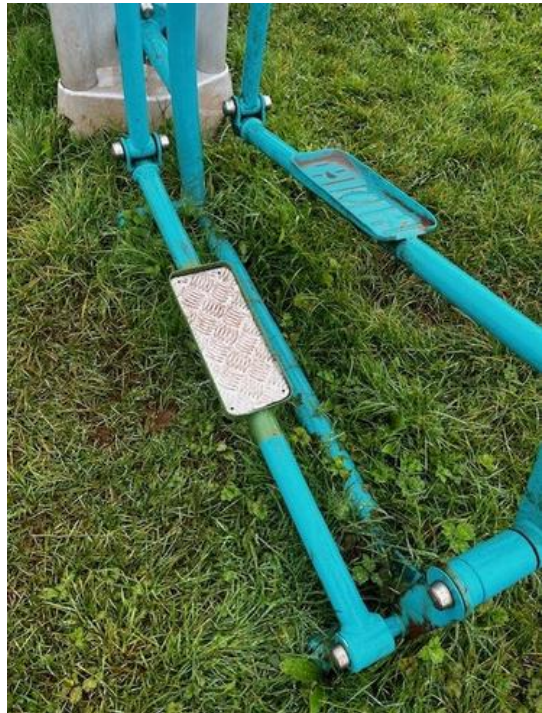
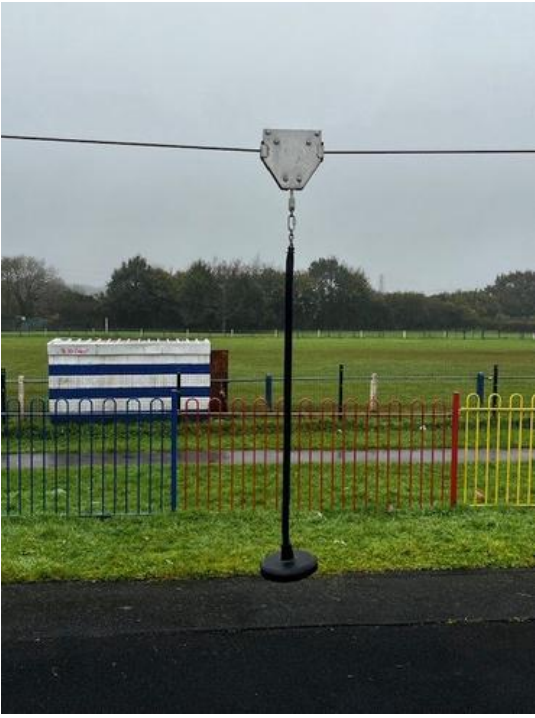
New footplate has been fitted to air skier

New pendulum seat fitted to cable ride and height adjusted
