# Play Area / Equipment Operational Inspection

LLANHARRY COMMUNITY COUNCIL

Score	8 / 8 (100%)	Flagged items	0	Actions	0
Document No.					000078
Audit Title					LLANHARRY COMMUNITY COUNCIL
Client / Site					Llanharry Recreation Ground
Conducted on					08.11.2023 12:51 GMT
Prepared by					Jerry Widdas
Location					Llanharry
Personnel					Jerry Widdas

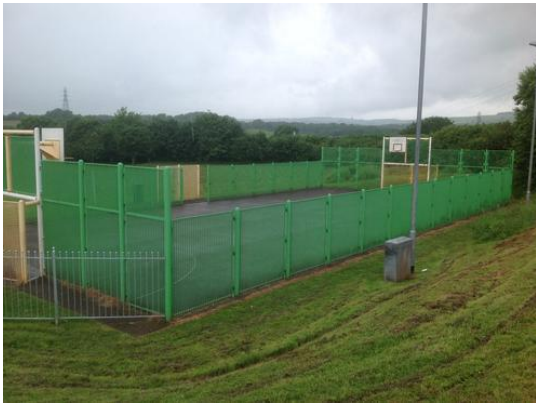
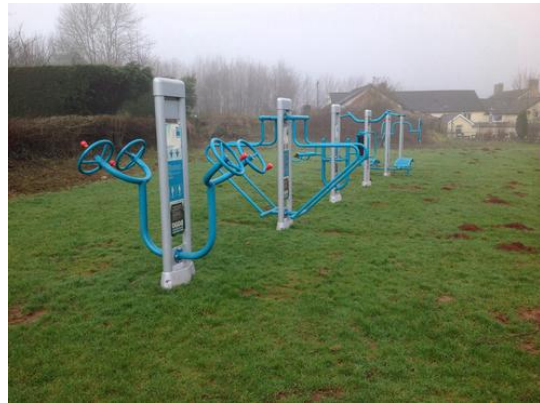
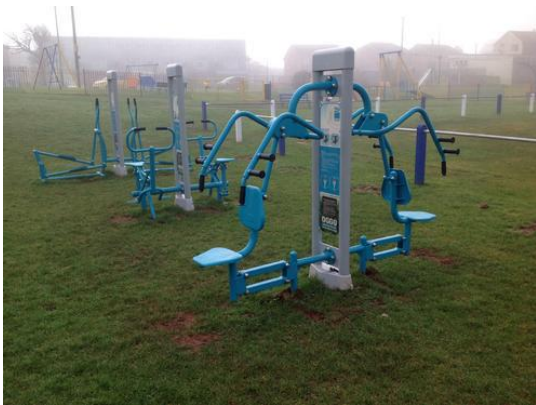
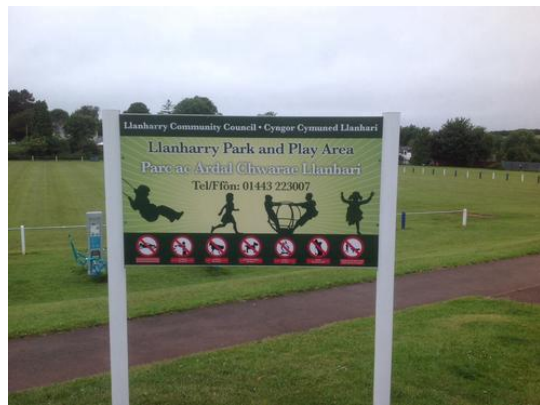
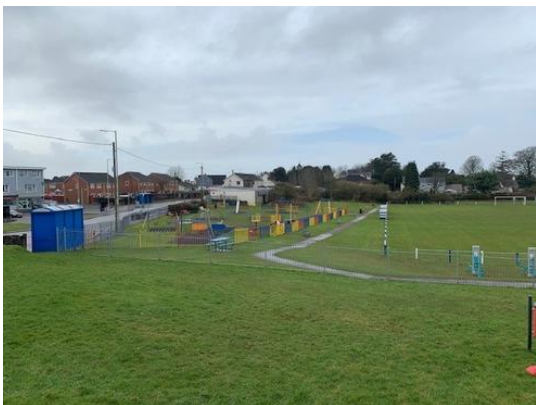
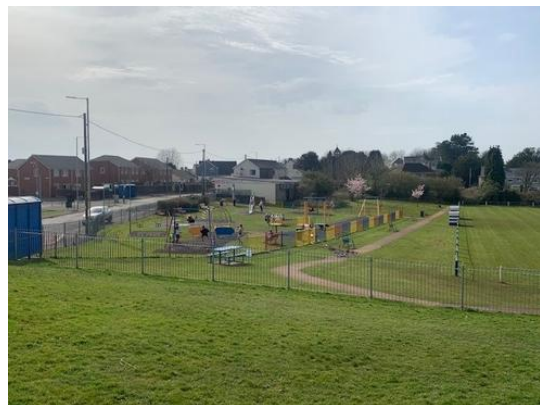
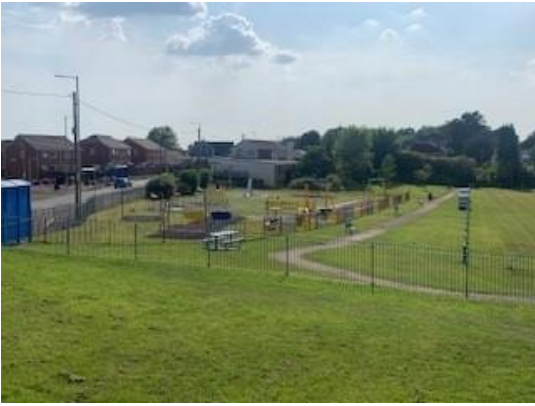
The recreation ground consists of a play area fenced by steel bow top fencing with self closing gates  
 A MUGA kick about area and a youth shelter  
 Both areas are accessed by Tarmac pathways  
 Benches and picnic tables are located within the play area and also outside the play area boundary

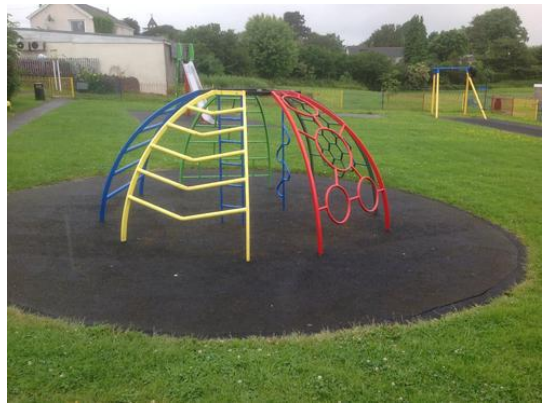
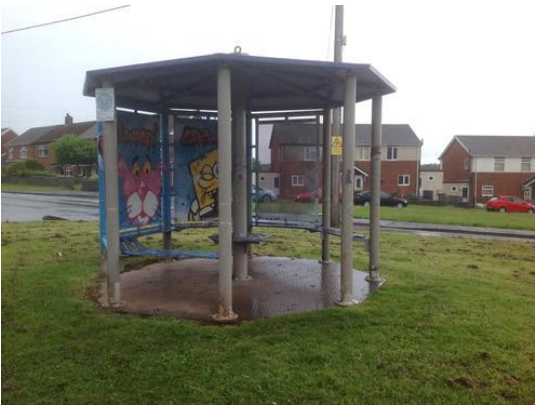
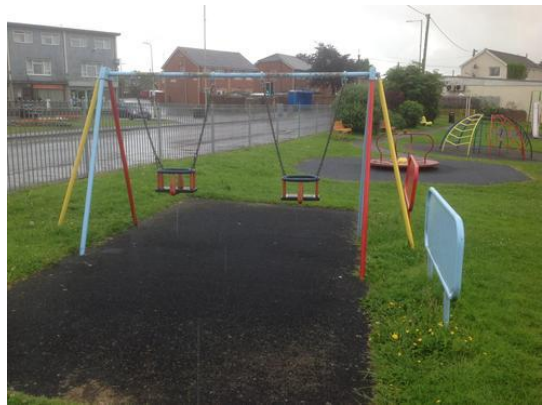
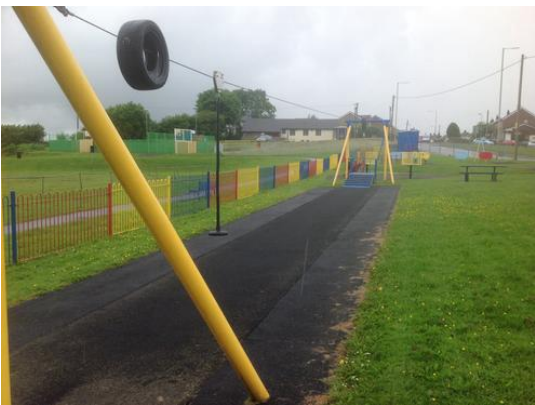
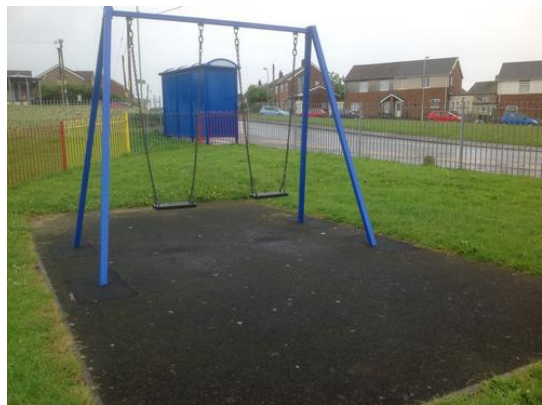
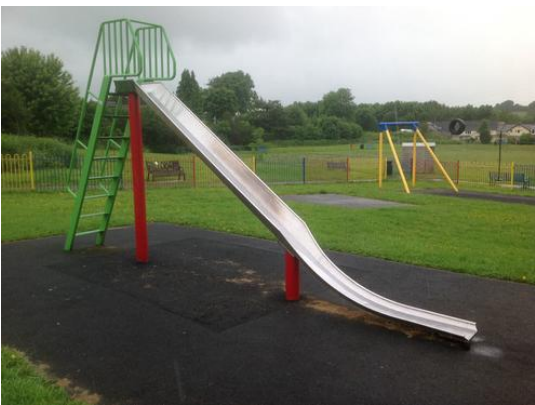
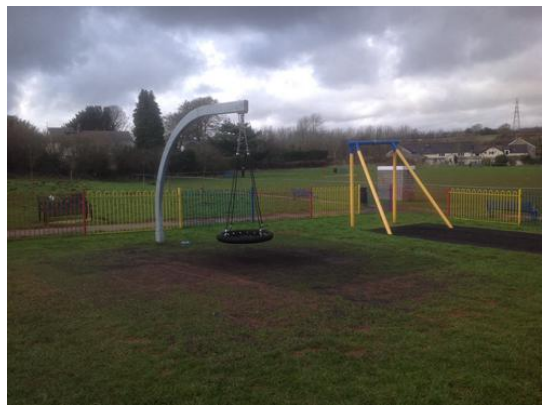
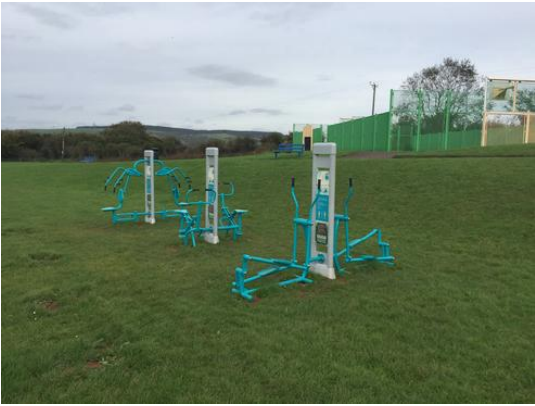
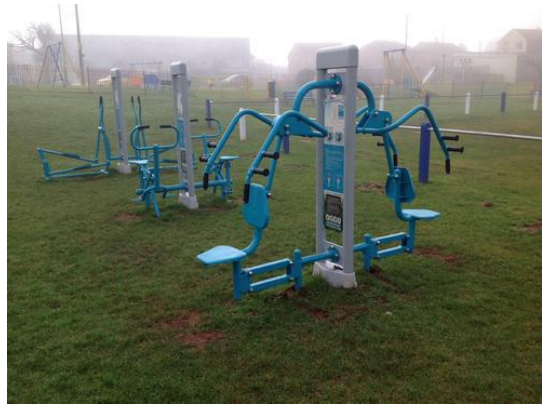
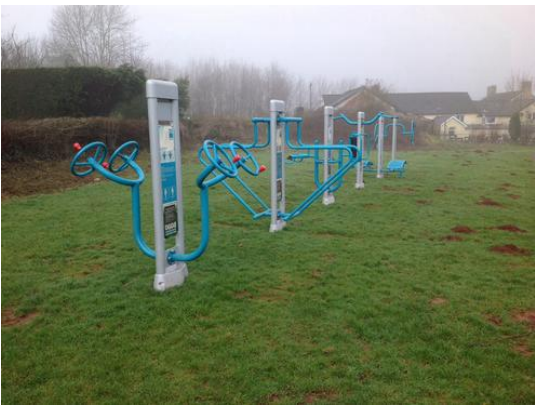
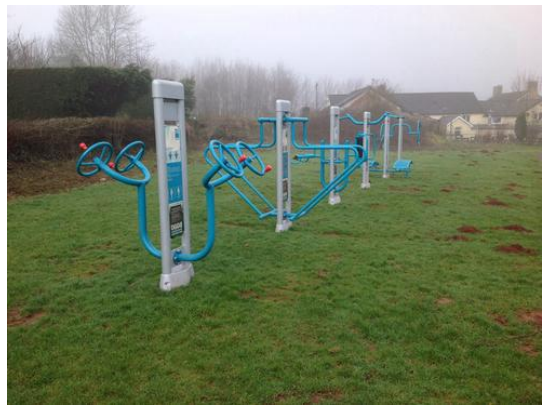
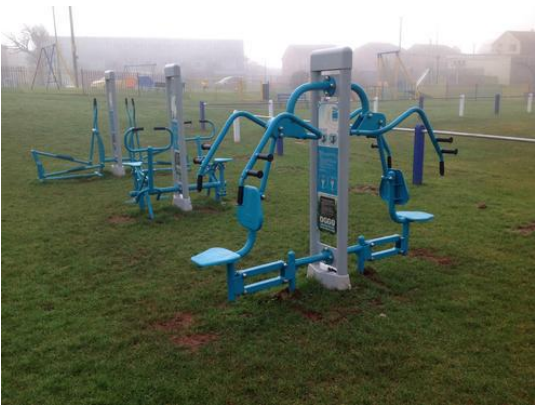
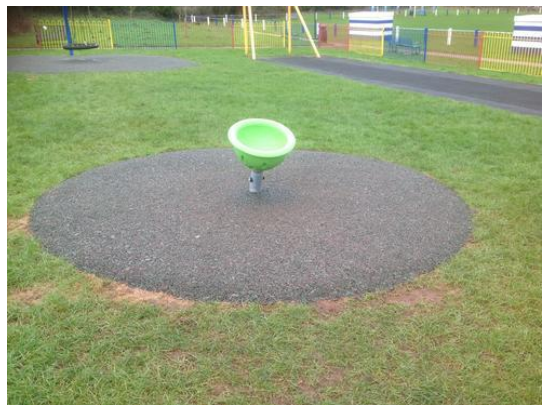
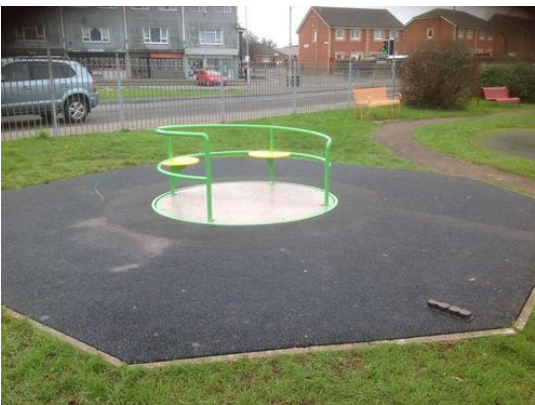
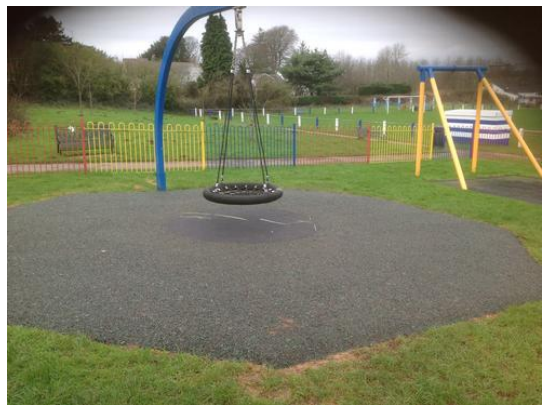
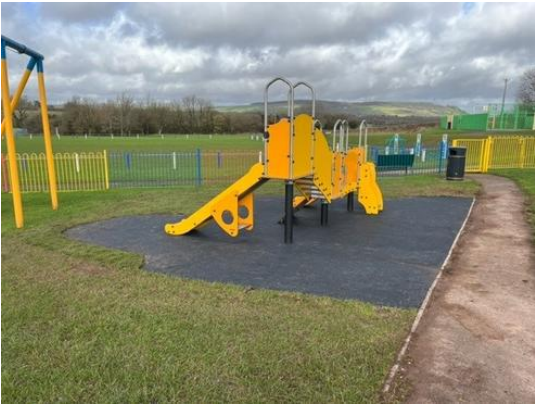
MUGA area supplied by PPL date unknown  
 1 X 2 seat swing supplied and installed by Urban Recreation in 2016  
 1 X Traditional cradle seat swing Wicksteed Leisure  
 1 X Traditional Igloo climber Wicksteed Leisure  
 1 X Wheelchair roundabout supplied and installed Urban Recreation Dec 2018  
 1 X Multiplayer Unit Proludic installed Feb 2022  
 1 X Steel cable ride Record Play  
 1 X Freestanding slide Record Play  
 2 X Spring animals Fahr Industries installed Feb 2022  
 1 X Teen Shelter David Ogilvie Engineering  
 1 X Cantilever Swing supplied Urban Recreation 2016  
 9 X Fitness Items supplied Urban Recreation October 2017  
 1 X Spinning Cup supplied and installed Urban Recreation Dec 2018

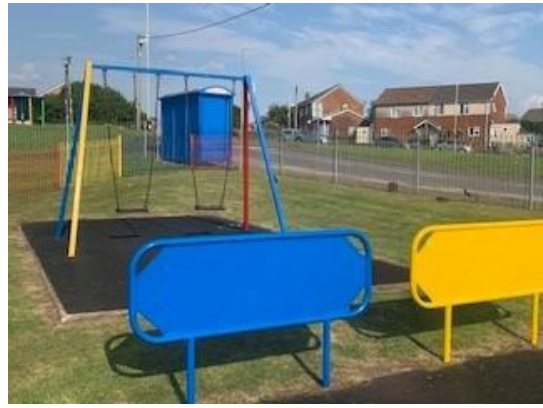
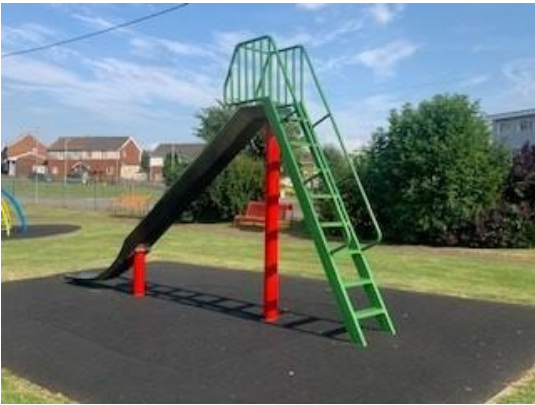
At the time of inspection all the equipment was found to be in a safe and useable condition

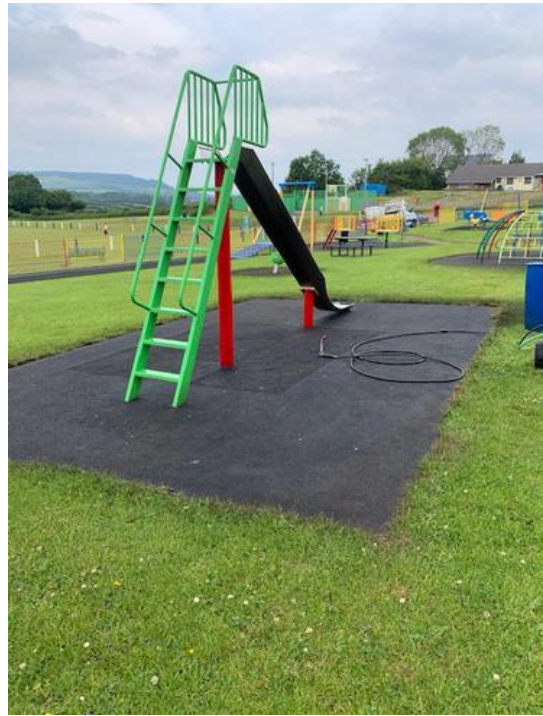
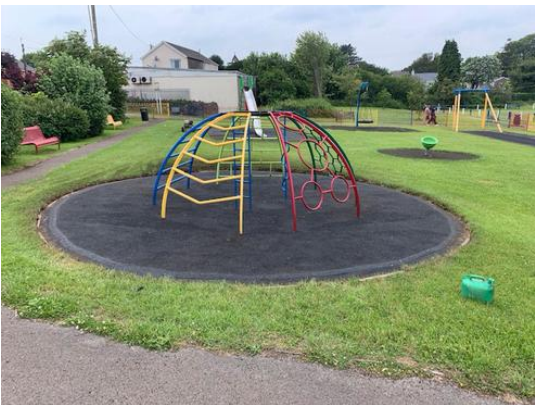
All items of play equipment are located on wet pour rubber safety surfacing

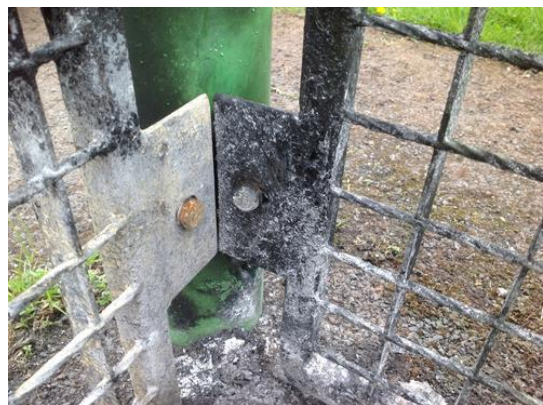
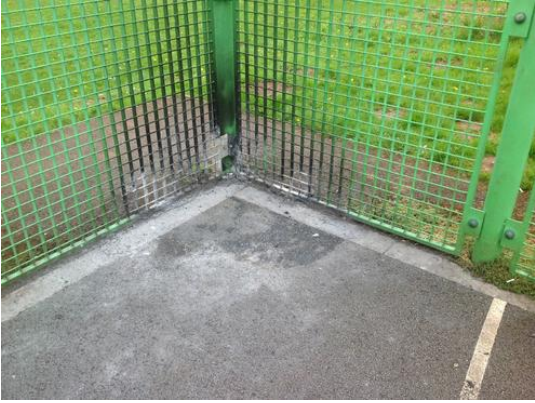
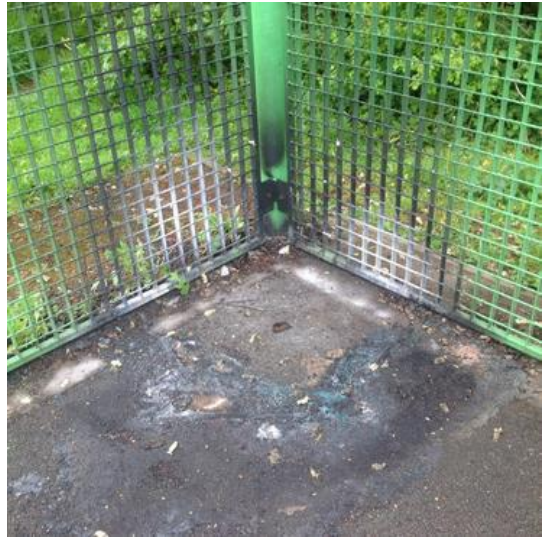
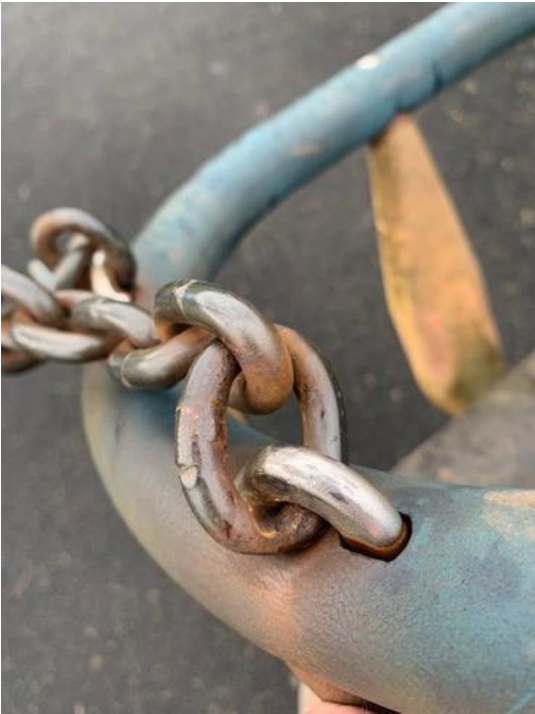
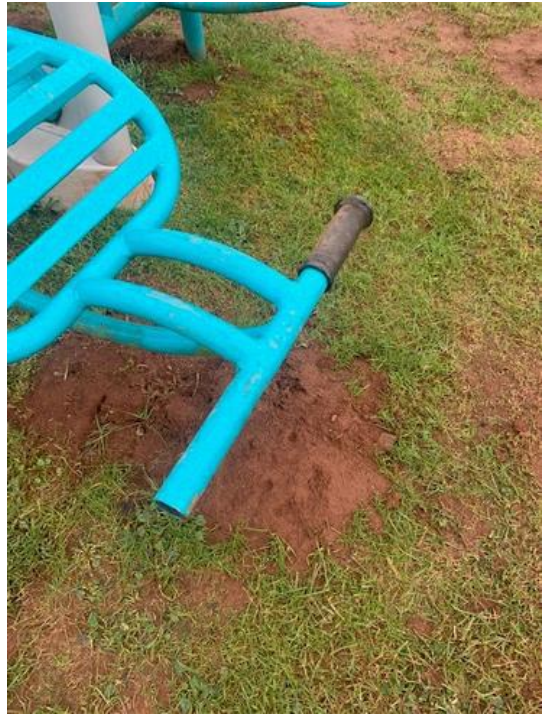
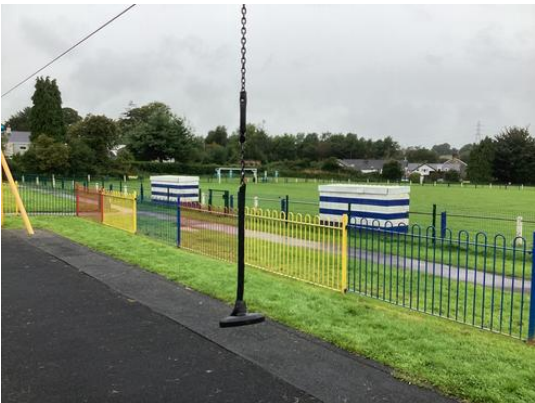
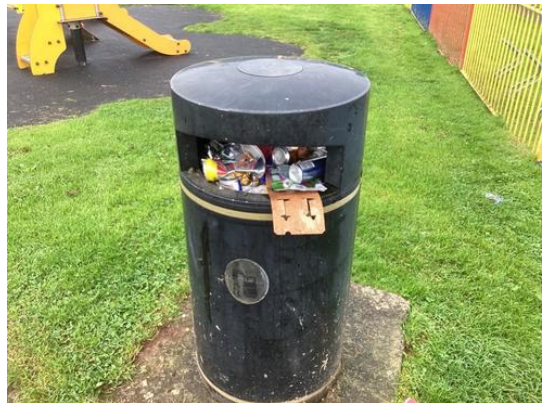
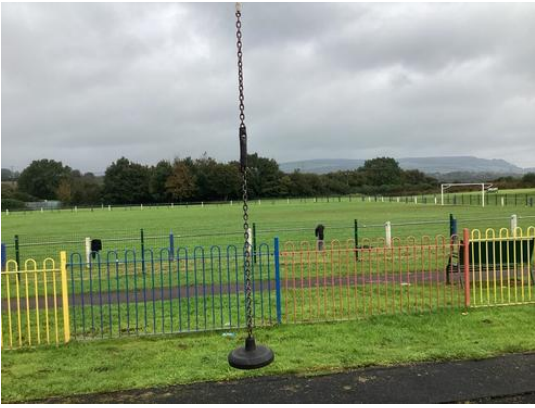
One of the basket swing suspension ropes has been wrapped, monitor

A small fire has caused minor damage to the ball court surface, an additional fire in the opposite corner has caused minor damage to the ball court surface and paintwork on the steel grid

There is some wear on the toddler swing chains, monitor and plan for replacement in the future

There is a rubber cover missing from one of the sit up benches

Access gate is now closing!

The stopper spring on the cable ride has once again started to break, would suggest using a heavier duty spring next time it is changed.

The pendulum seat on the cable ride has damage to the chain cover that should be planned for change.

Work schedules for cable ride and basket swing in next week or two

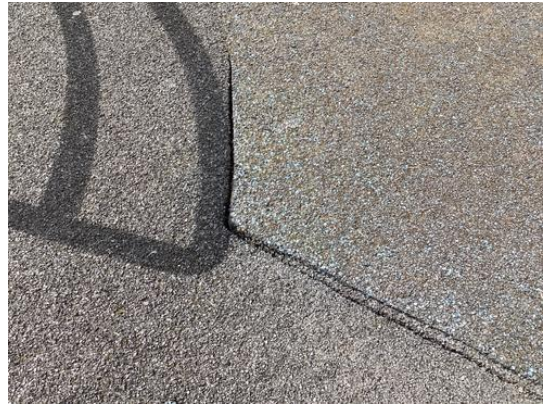
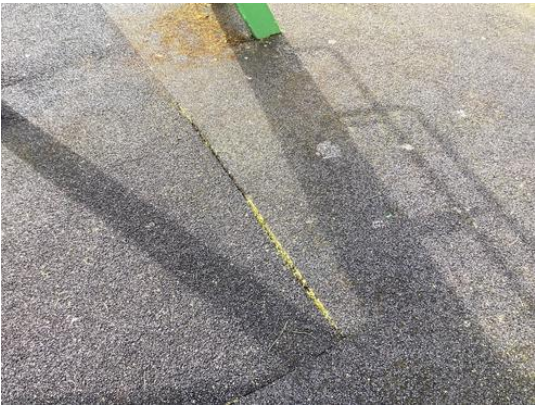
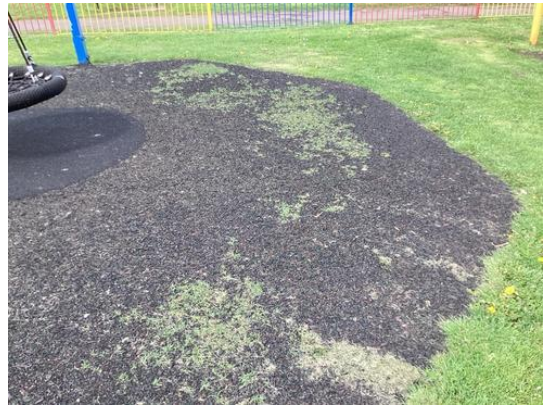
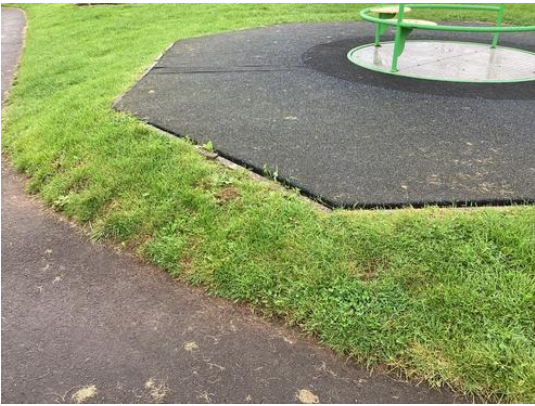
At the time of inspection all surfaces were found to be in a safe and useable condition although there are some areas of joint separation which should be monitored

The basket swing area has some self seeded grass growth that could be treated if possible while it is still manageable

One corner of the roundabout surfacing has been subsiding over the years and continues to drop

monitor items noted
