Play Area / Equipment Operational Inspection

LLANHARRY COMMUNITY COUNCIL

Score	8 / 8 (100%)	Flagged items	0	Actions	0
Document No.					000078
Audit Title					LLANHARRY COMMUNITY COUNCIL
Client / Site					Llanharry Recreation Ground
Conducted on					28.10.2024 14:00 GMT
Prepared by					Jerry Widdas
Location					Llanharry
Personnel					
Jerry Widdas

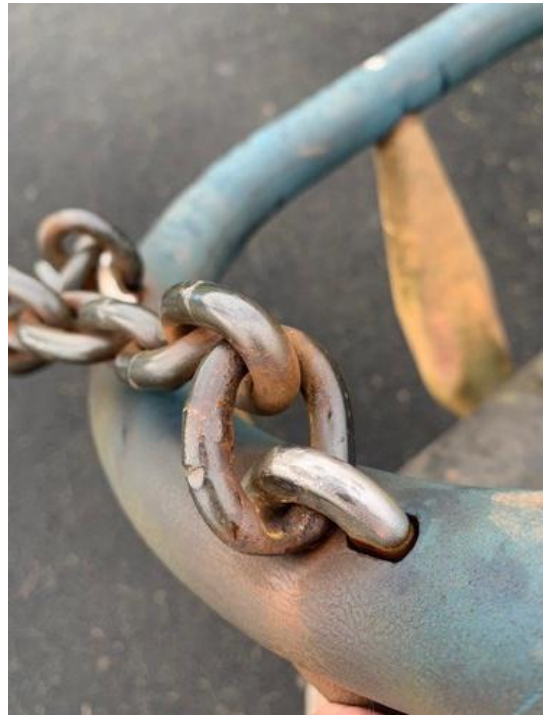
Photo 26

There is some wear on the toddler swing chains, monitor and plan for replacement in the future

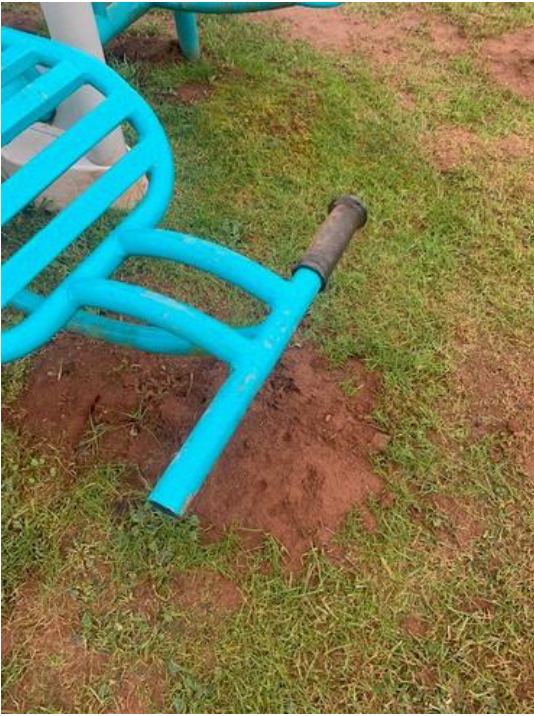
Photo 27

There is a rubber cover missing from one of the sit up benches

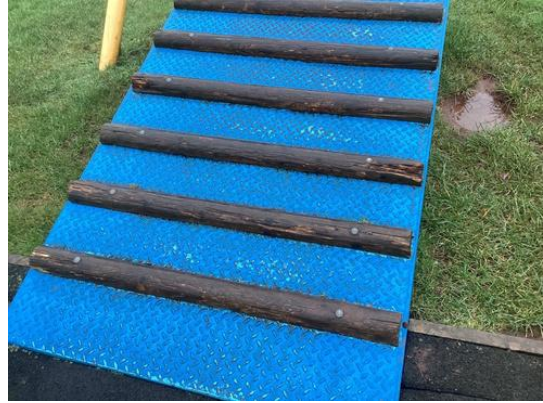
Photo 28

The timber foot treads on the cable ride ramp are starting to deteriorate

monitor timber treads on cable ride ramp

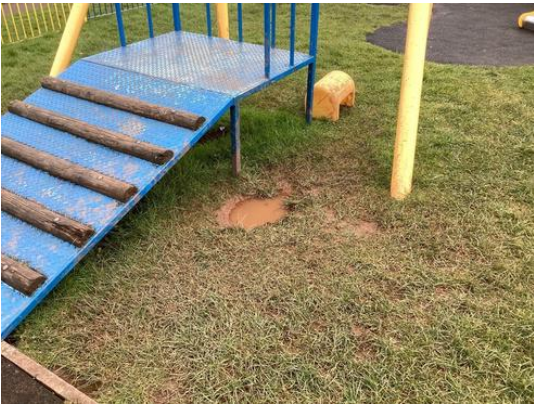
Photo 29

There is a muddy hole next to the cable ride ramp

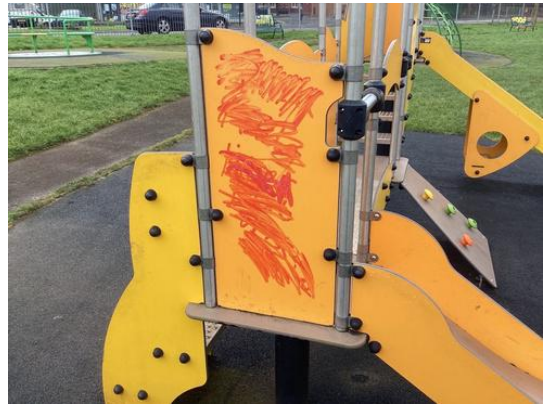
Photo 30

There is some graffiti on the multiplay unit panel

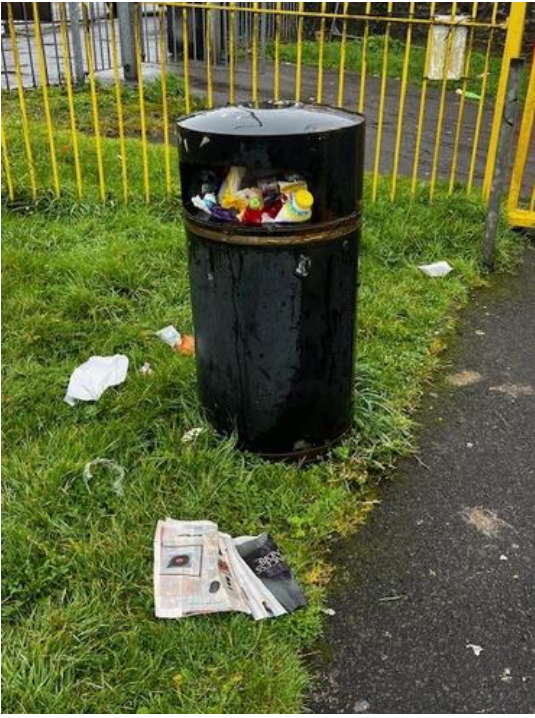
Photo 31

Bin was full and overflowing

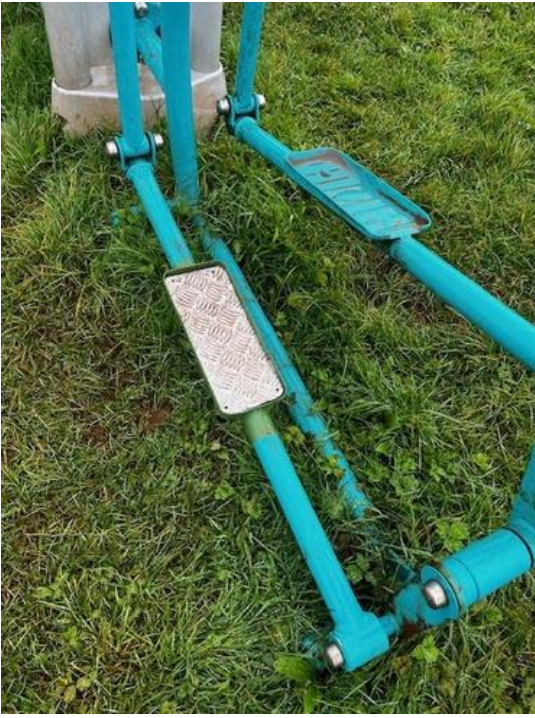
Photo 35

New footplate has been fitted to air skier

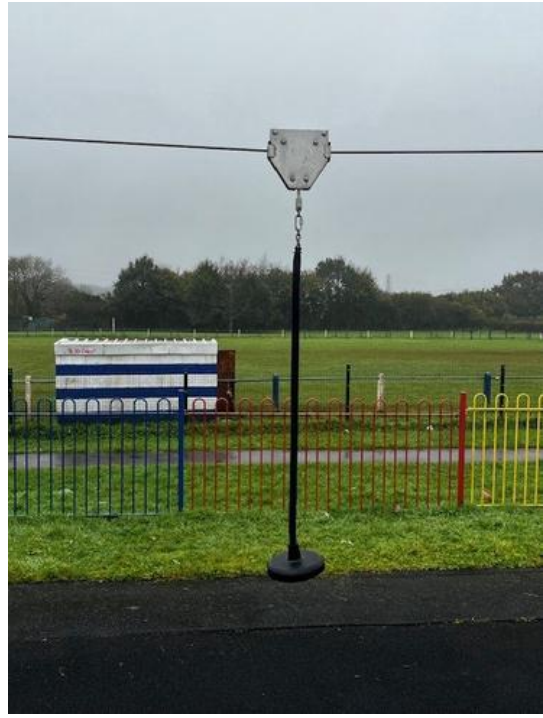
Photo 36

New pendulum seat fitted to cable ride and height adjusted
