Safety Inspection Report

Annual Inspection

Ty Isaf Play Area

03 July 2025

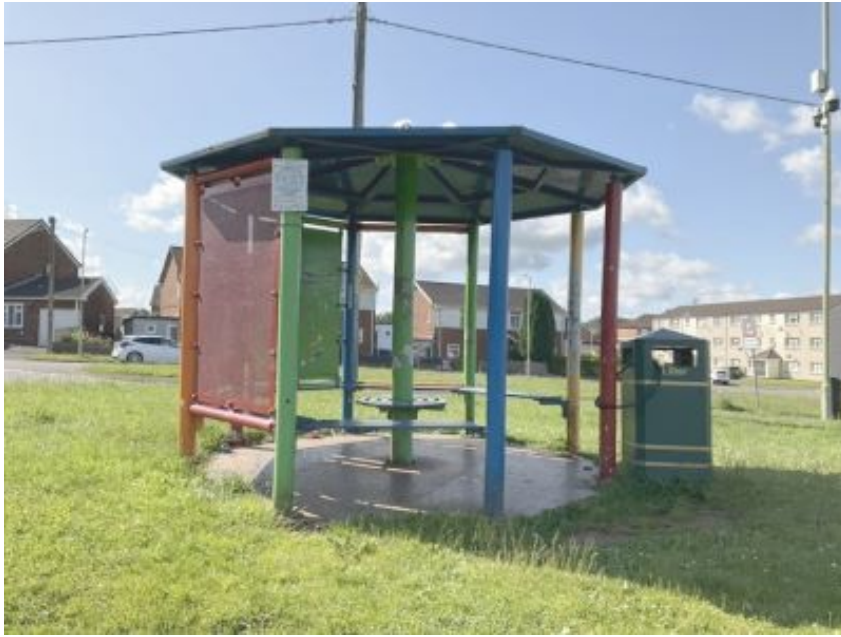
There is graffiti on the unit.

Remove.

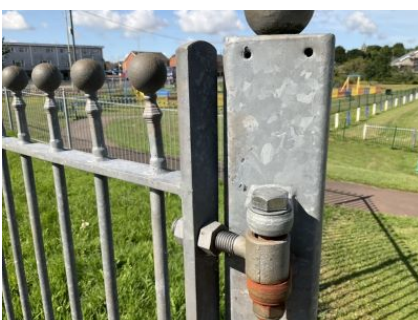
There is a crushing or shearing point on the side of the gate. Where the gaps reduce to less than 12 mm these have been known to cause serious, permanent injury to children, especially on the hinge side where the leverage forces are significant.

Adjust gate / posts / fit new rubber buffer to ensure a spacing of at least 12 mm throughout the range of the gate to remove the entrapment. The 12 mm gap also should apply on the hinge side of the gate.

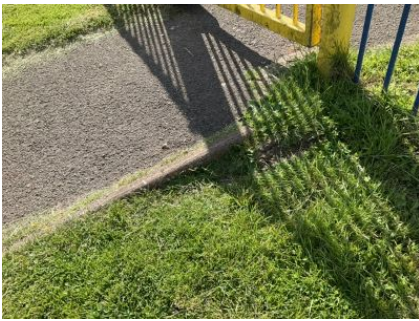
Trip points on the surface.

Make level.

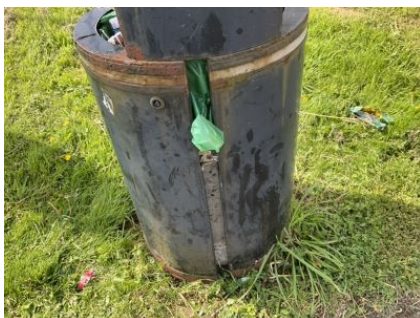
The item is unlocked.

Lock.

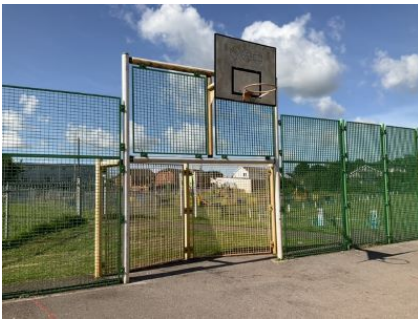
A clearly visible sign must be fitted to all sports related equipment with at least the following: a) equipment is not intended for children less than 36 month, b) "Do not climb on the framework or nets", c) "Do not hang on the ring", d) "Do not wear rings or other jewellery as these can get caught and cause injury", e) name and telephone number of site owner, f) number to call in case of accident.

Fit warning notice.

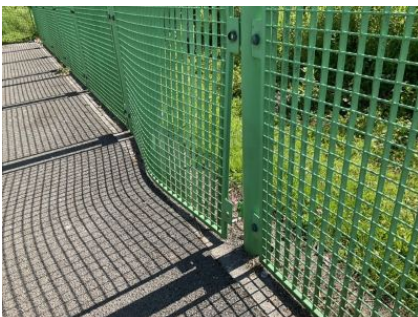
Item is damaged.

Repair.

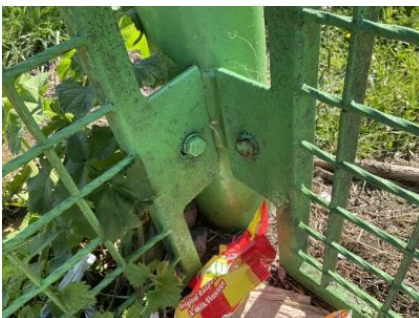
Cap missing.

Replace.

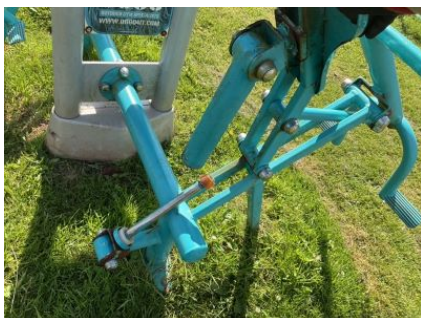
Item is damaged.

Repair.

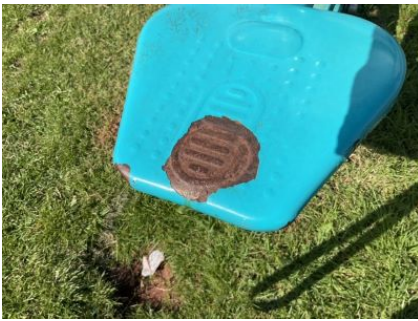
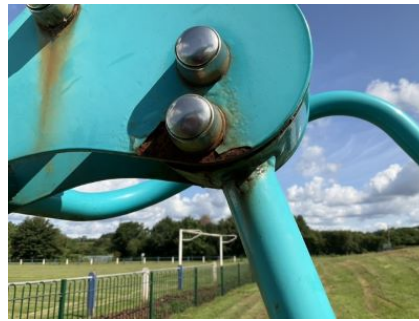
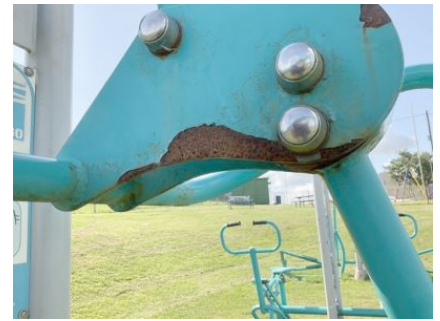
Item has corrosion.

Treat and repair.

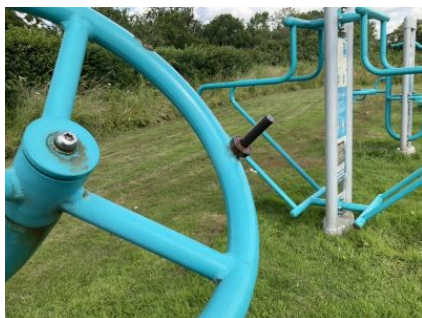
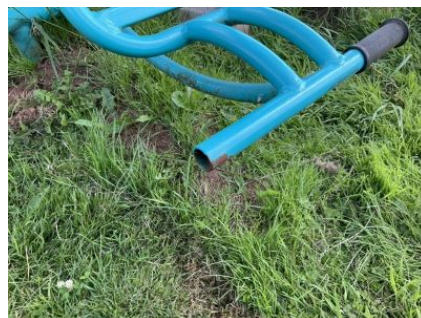
Hand grip is missing.

Replace missing grip.

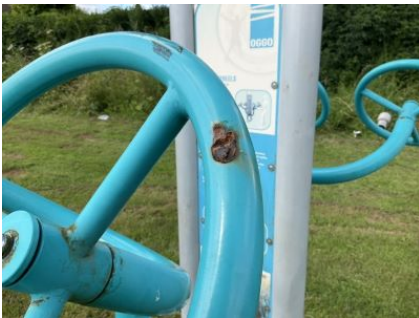
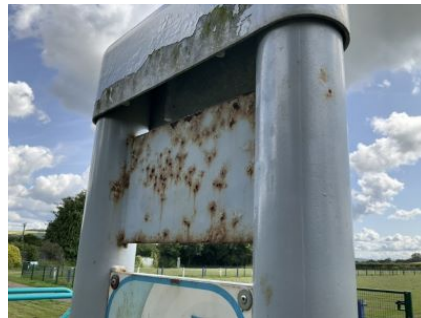
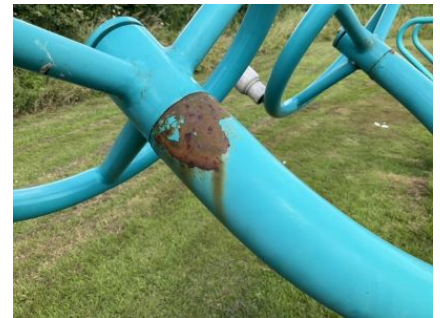
Item has corrosion.

Treat and repair.

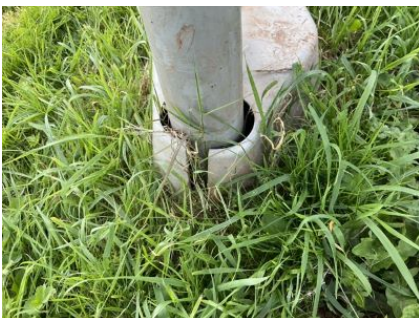
Bolt(s) loose.

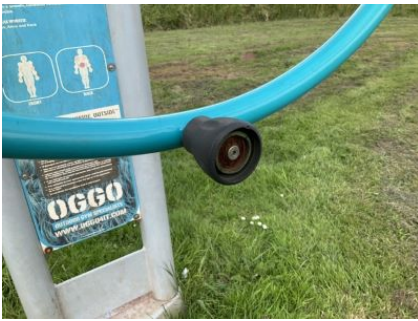
Cap missing.

Replace.

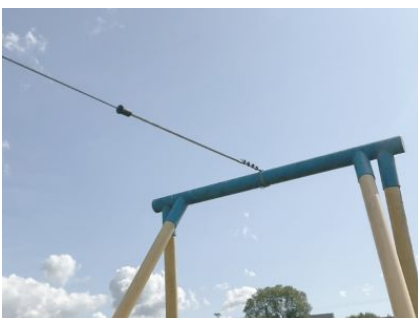
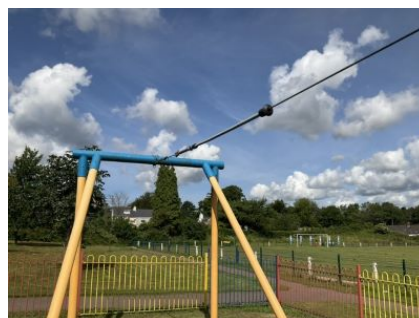
Cables have been known to fail under load due to wear and corrosion. This is generally where the cable enters into a tube, top bar, sleeve or similar, where the wire is in contact and wears and frays over time, but can happen anywhere on the cable. It is important to inspect any hidden parts at least annually. Damaged cables require replacement. This cannot be determined during an annual inspection, and is excluded from our inspection. This can lead to a high risk if no action is taken. Refer to the manufacturer's instructions to ensure the correct check is carried out.

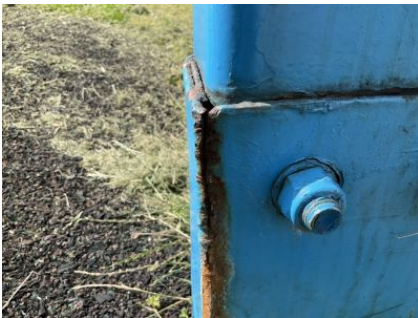
Welds are cracked.

Repair.

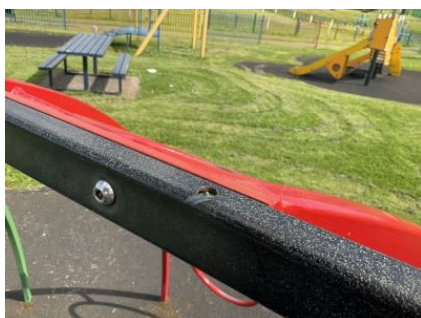
Cap missing.

Replace.

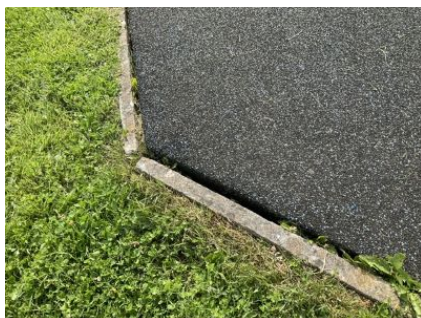
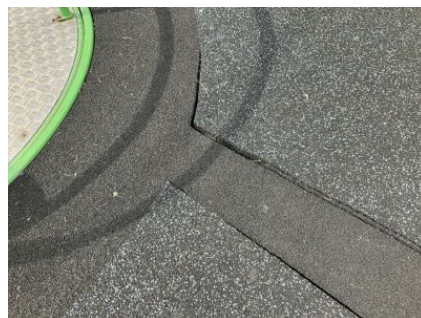
Shrinkage / separation of the surface. This may give a trip hazard.

Repair.

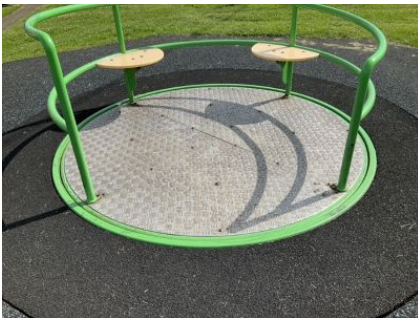
There is wear in the bearings.

Monitor and replace when necessary.

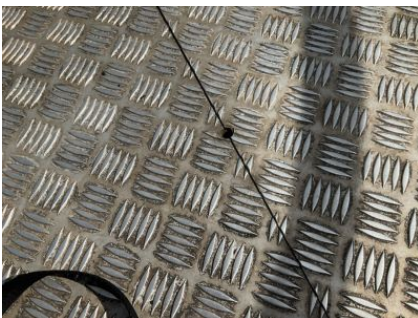
Bolt(s) missing.

Replace missing bolt(s).

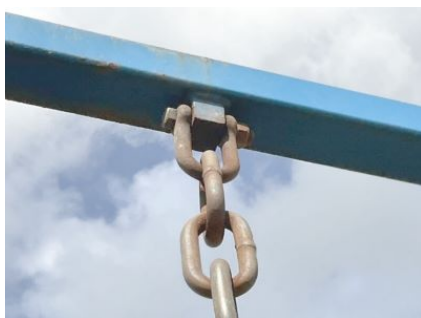
There is wear in the bushes.

Remove shackle bolt and check bush and shackle pin wear, replacing as necessary.

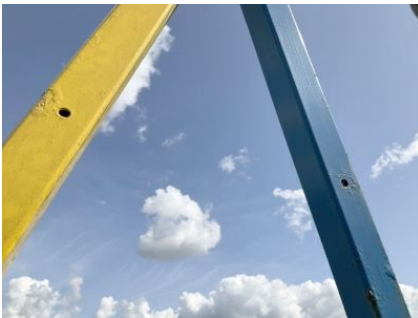
Cap missing.

Replace.

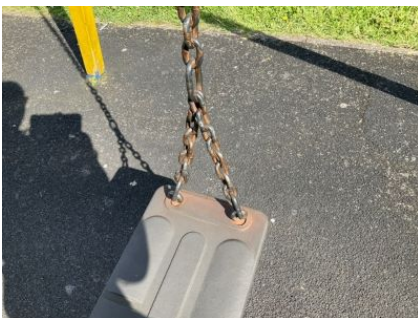
Some chain wear.

Monitor for further deterioration and replace before 40% wear.

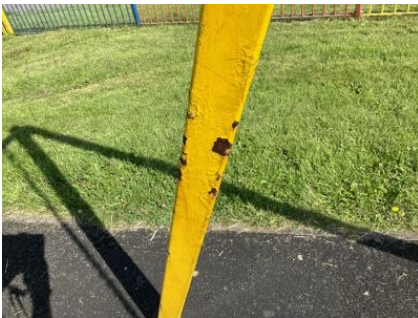
Item has corrosion.

Treat and repair.

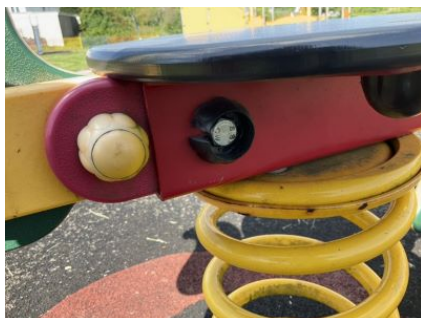
Cap missing.

Replace.
