# Play Area / Equipment Operational Inspection

LLANHARRY COMMUNITY COUNCIL

<b>Score</b>	8 / 8 (100%)	<b>Flagged items</b>	0	<b>Actions</b>	0
<b>Document No.</b>					000078
<b>Audit Title</b>					LLANHARRY COMMUNITY COUNCIL
<b>Client / Site</b>					Llanharry Recreation Ground
<b>Conducted on</b>					27.08.2025 15:42 BST
<b>Prepared by</b>					Jerry Widdas
<b>Location</b>					Llanharry
<b>Personnel</b>					
					Jerry Widdas

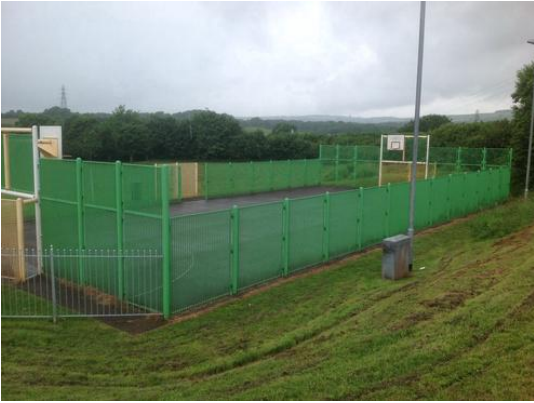
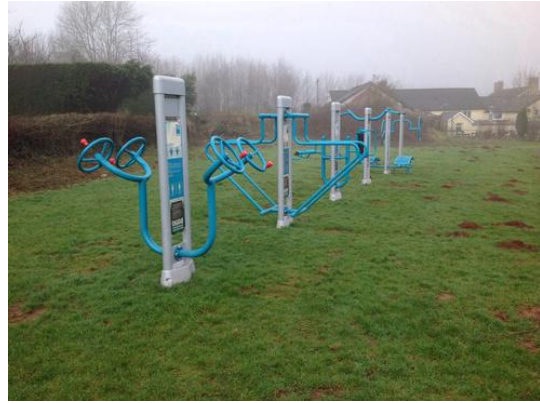
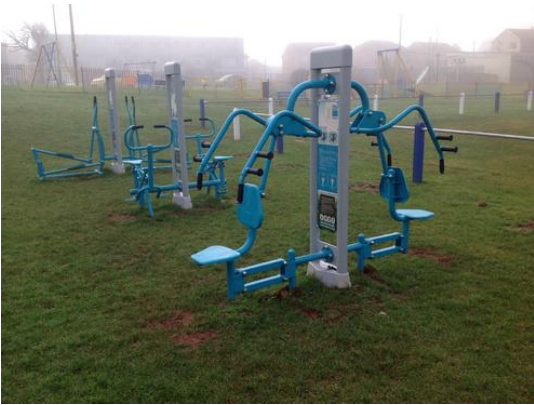
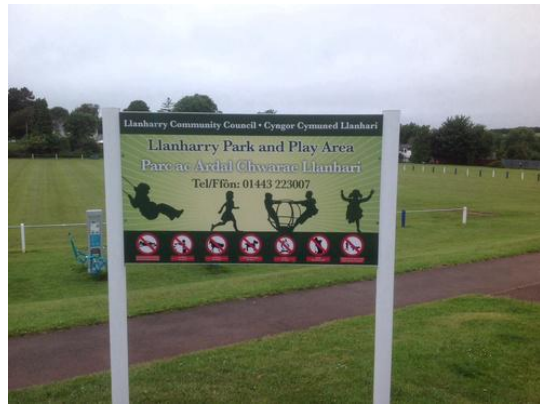
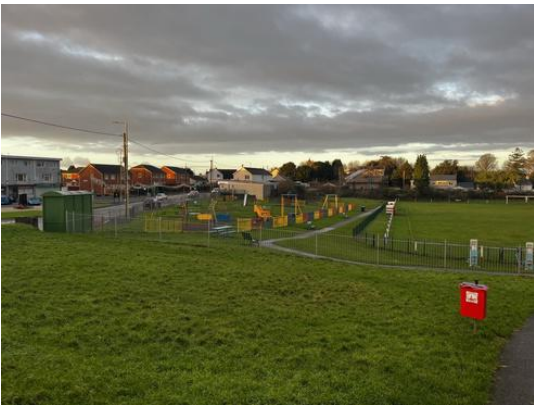
The recreation ground consists of a play area fenced by steel bow top fencing with self closing gates  
 A MUGA kick about area and a youth shelter  
 Both areas are accessed by Tarmac pathways  
 Benches and picnic tables are located within the play area and also outside the play area boundary

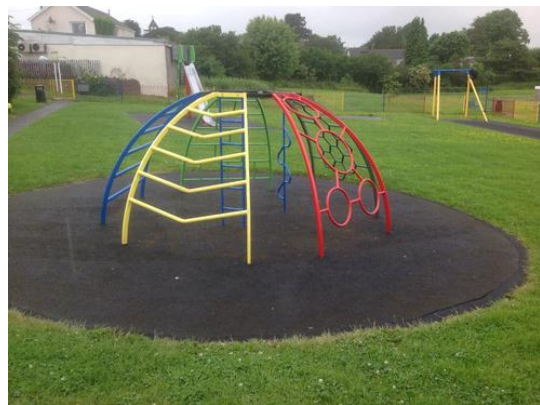
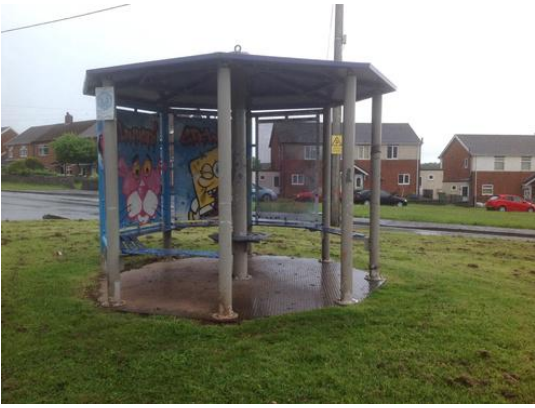
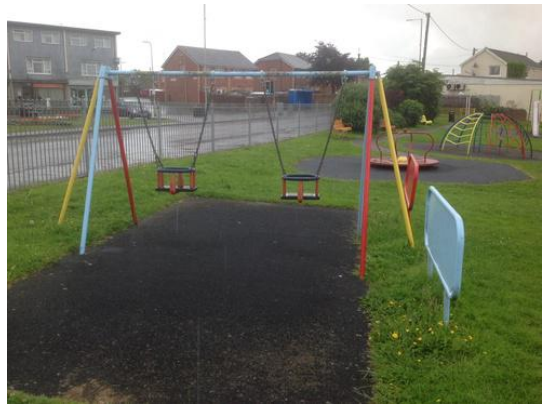
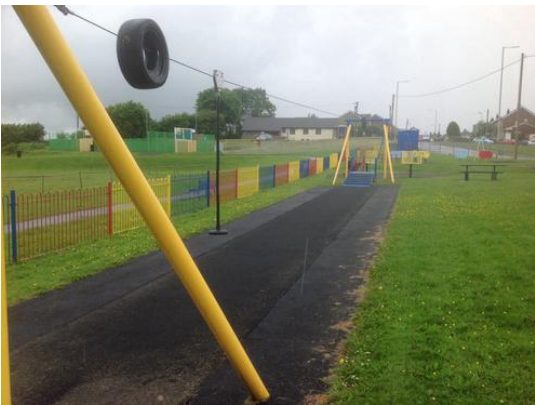
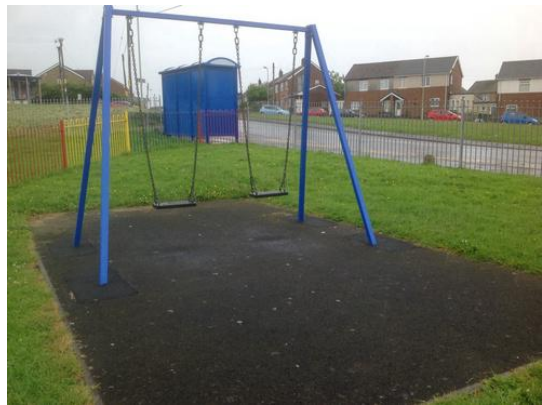
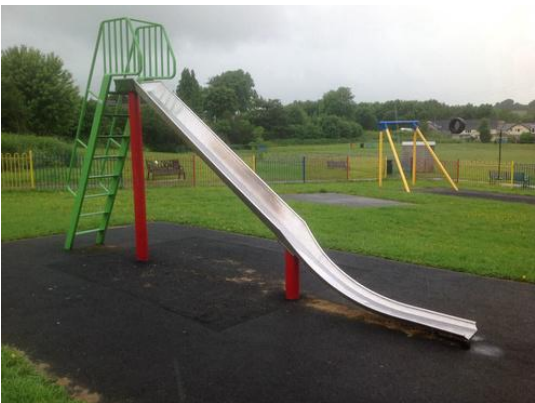
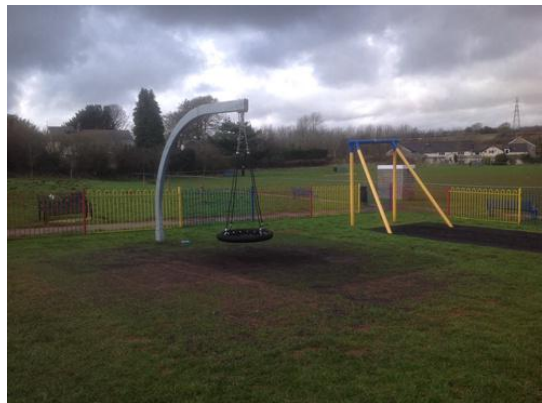
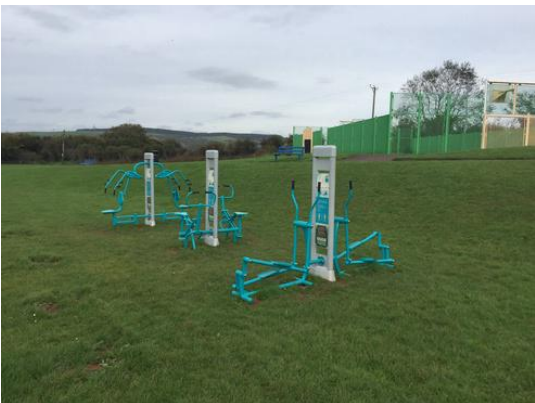
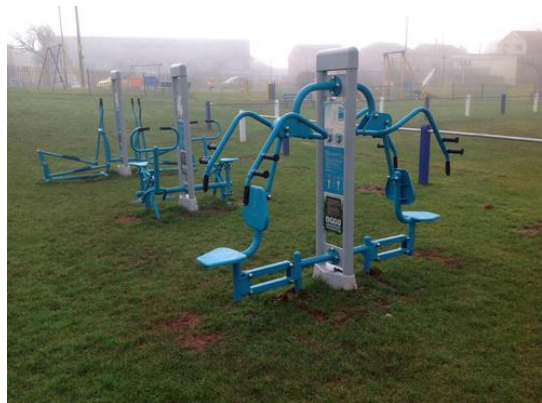
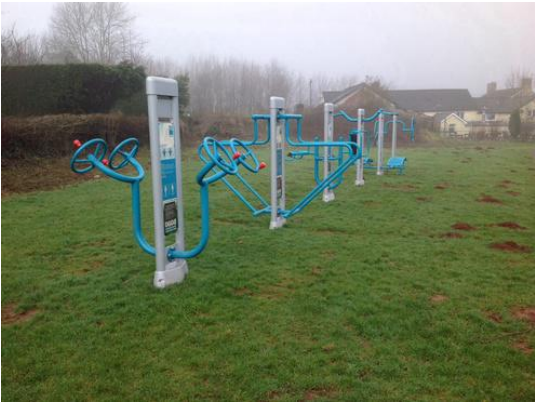
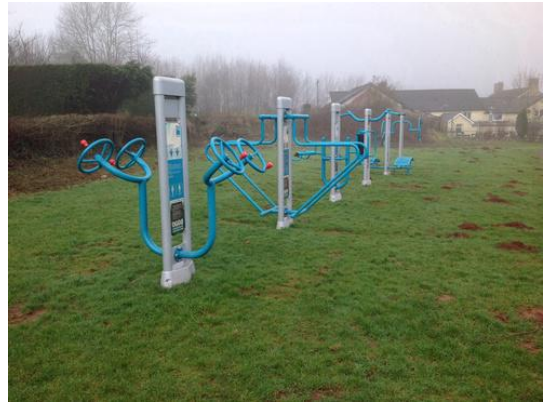
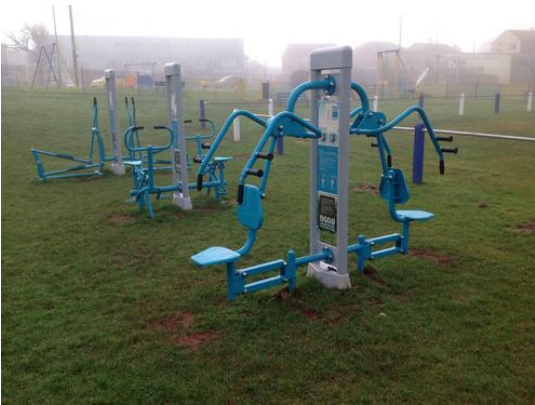
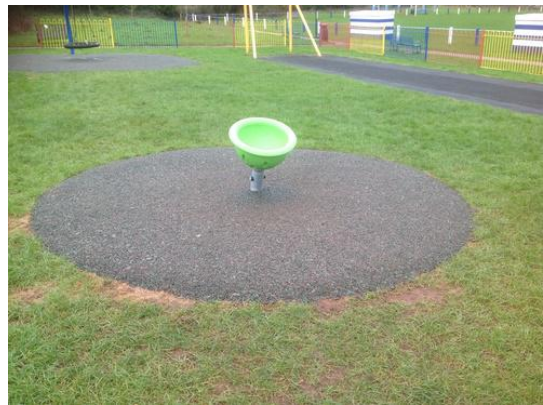
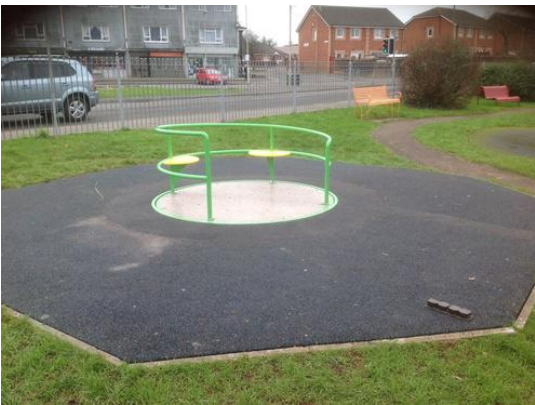
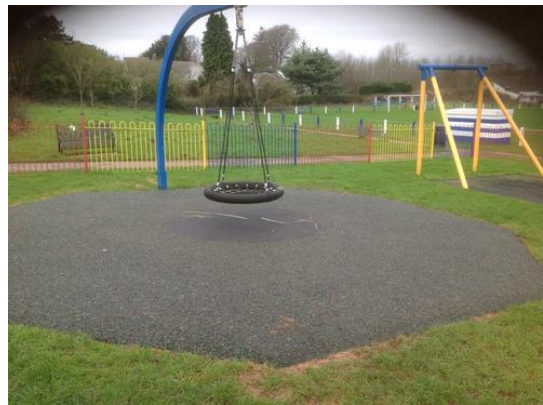
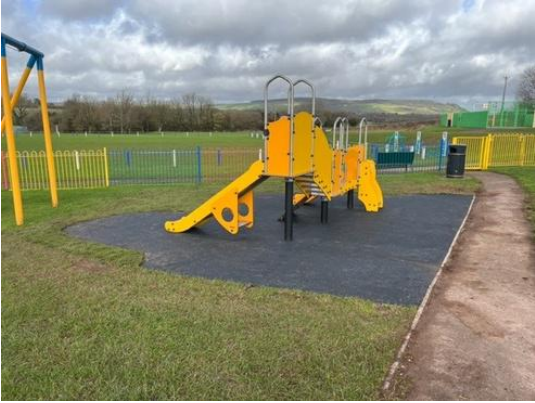
MUGA area supplied by PPL date unknown  
 1 X 2 seat swing supplied and installed by Urban Recreation in 2016  
 1 X Traditional cradle seat swing Wicksteed Leisure  
 1 X Traditional Igloo climber Wicksteed Leisure  
 1 X Wheelchair roundabout supplied and installed Urban Recreation Dec 2018  
 1 X Multiplayer Unit Proludic installed Feb 2022  
 1 X Steel cable ride Record Play  
 1 X Freestanding slide Record Play  
 2 X Spring animals Fahr Industries installed Feb 2022  
 1 X Teen Shelter David Ogilvie Engineering  
 1 X Cantilever Swing supplied Urban Recreation 2016  
 9 X Fitness Items supplied Urban Recreation October 2017  
 1 X Spinning Cup supplied and installed Urban Recreation Dec 2018

At the time of inspection all the equipment was found to be in a safe and useable condition

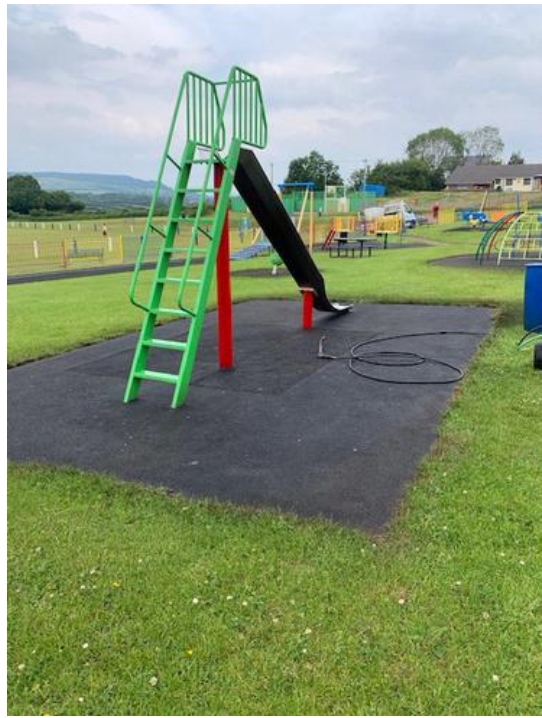
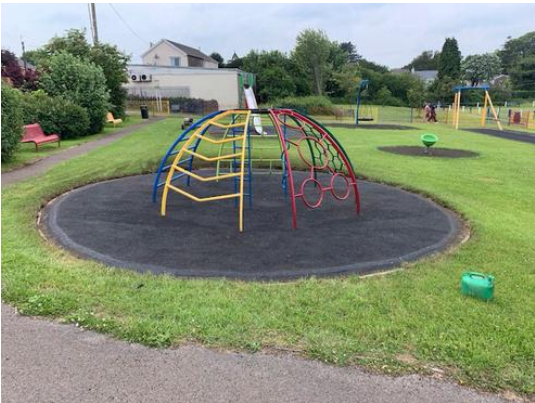
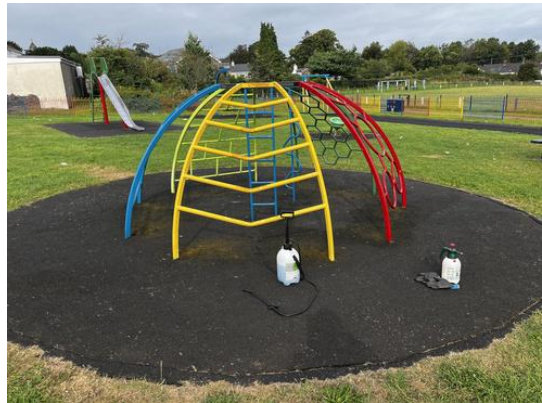
All items of play equipment are located on wet pour rubber safety surfacing. A moss treatment was applied

during the inspection

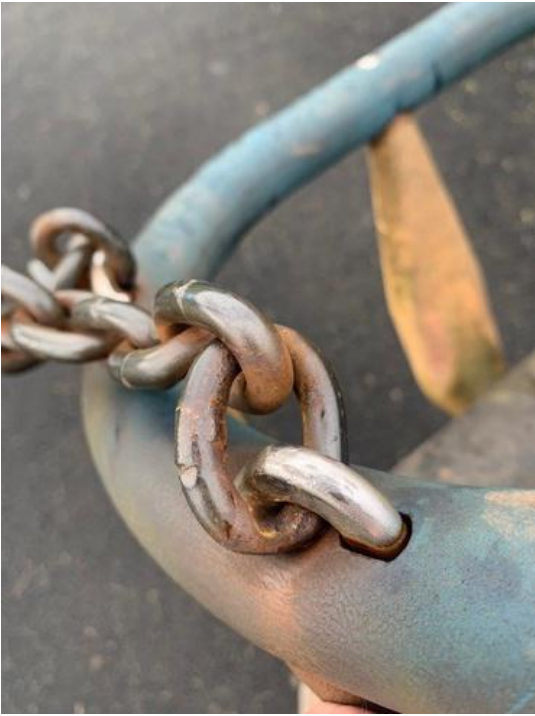
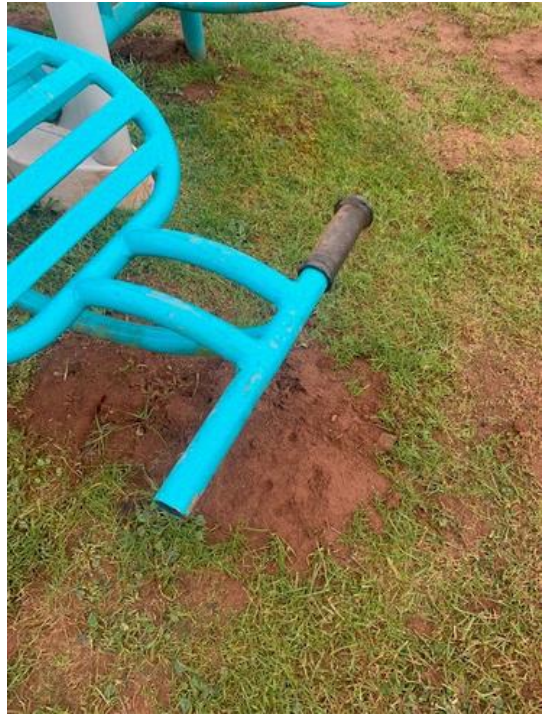
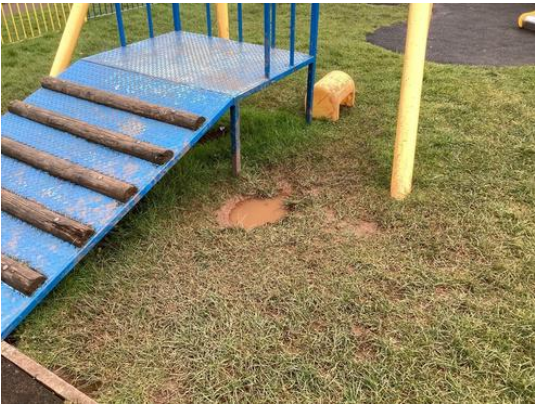
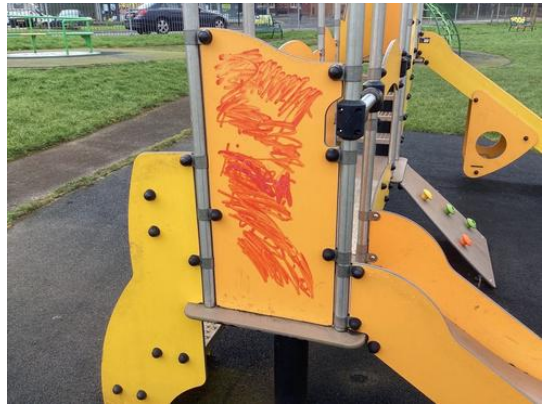
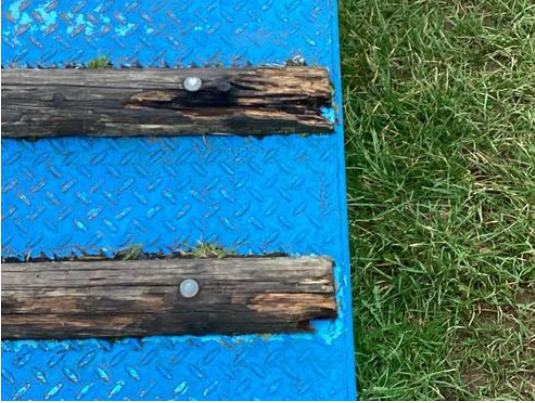
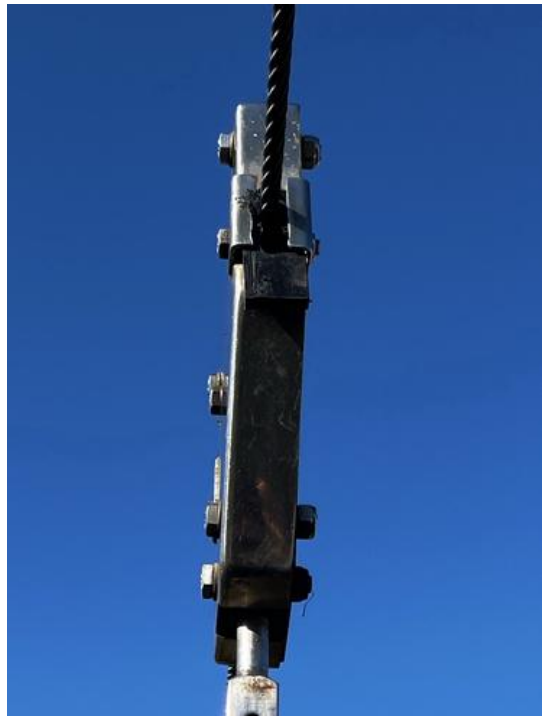
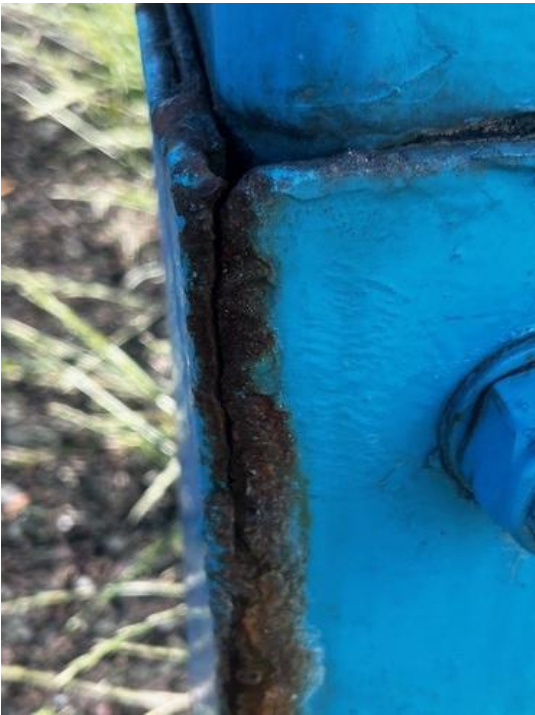
There is some wear on the toddler swing chains, monitor and plan for replacement in the future

There is a rubber cover missing from one of the sit up benches

The timber foot treads on the cable ride ramp are starting to deteriorate

There is a muddy hole next to the cable ride ramp

There is some graffiti on the multiplay unit panel

One of the finger guards on the cableway trolley is very worn and will need replacing in the near future

Weld has cracked on the base of the cantilever swing

Fitness item damper needs repair

monitor timber treads on cable ride ramp

Weld base on cantilever swing  
Fix damper on fitness unit

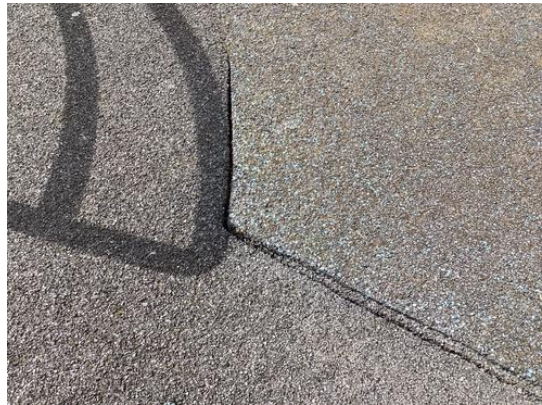
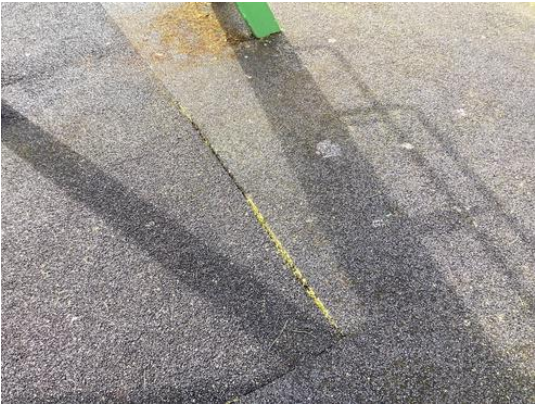
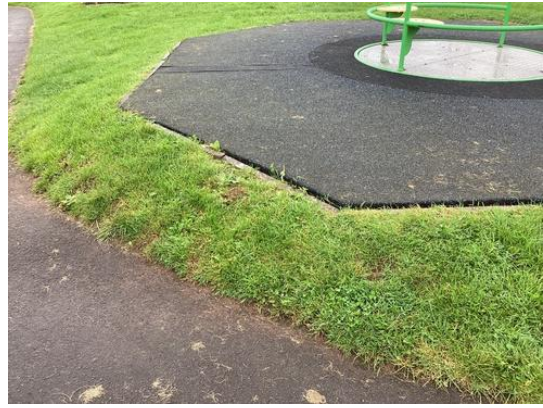
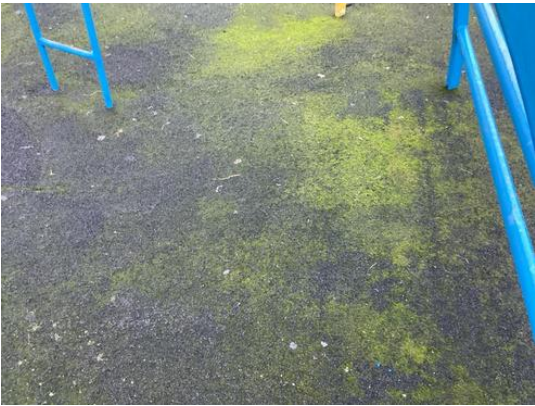
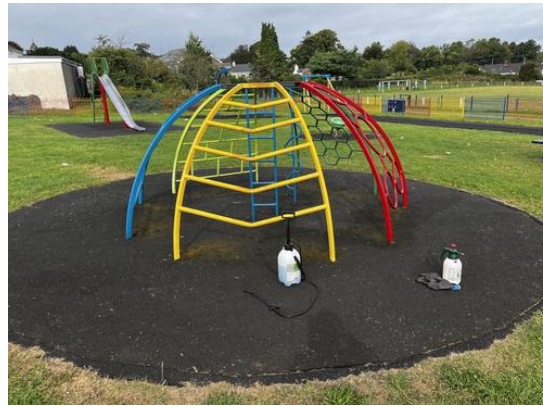
At the time of inspection all surfaces were found to be in a safe and useable condition although there are some areas of joint separation which should be monitored

One corner of the roundabout surfacing has been subsiding over the years and continues to drop monitor

A moss treatment was applied to required areas as part of the inspection and a weed killer was also applied to areas of the basket swing
