Play Area / Equipment Operational Inspection

LLANHARRY COMMUNITY COUNCIL

Client / Site Llanharry Recreation Ground

Conducted on 27.12.2025 12:00 GMT

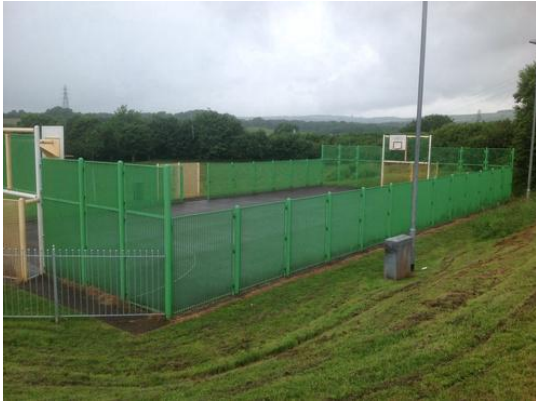
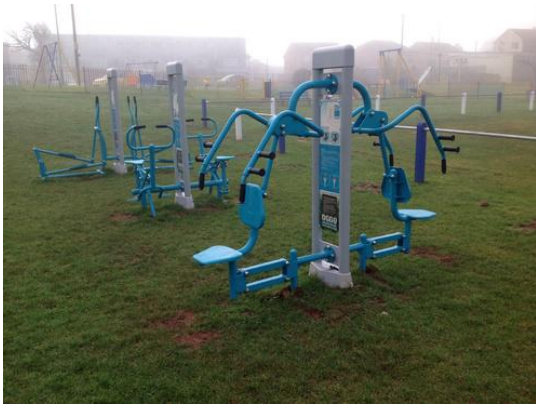
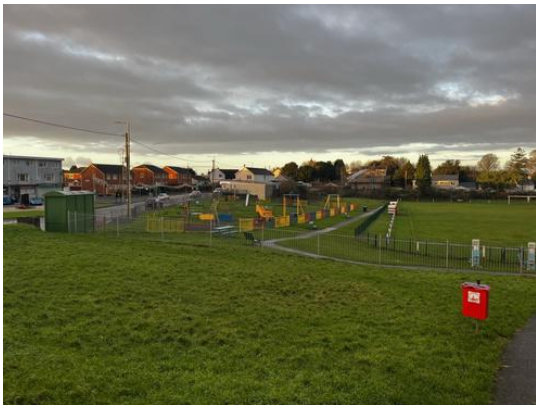
The recreation ground consists of a play area fenced by steel bow top fencing with self closing gates
 A MUGA kick about area and a youth shelter
 Both areas are accessed by Tarmac pathways
 Benches and picnic tables are located within the play area and also outside the play area boundary

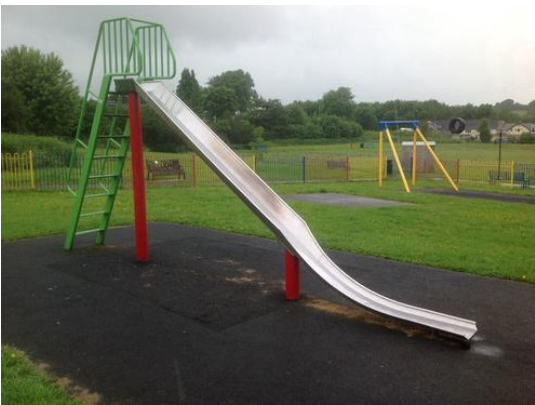
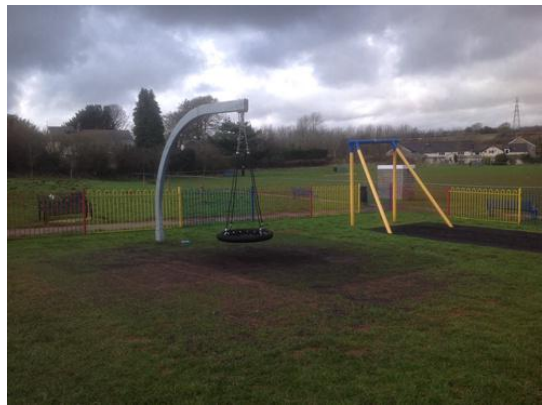
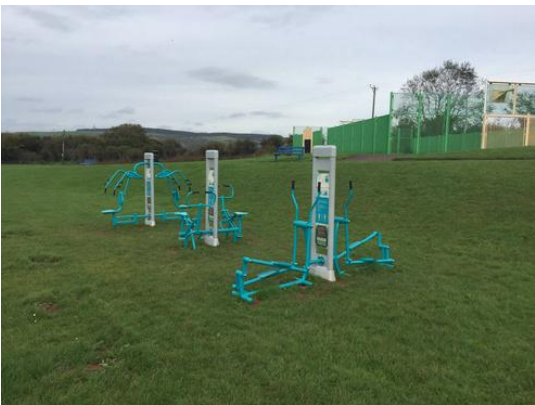
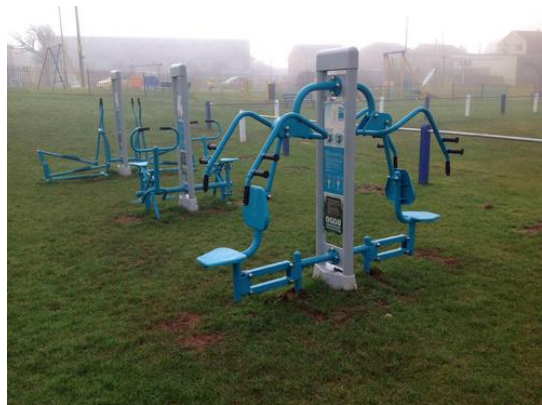
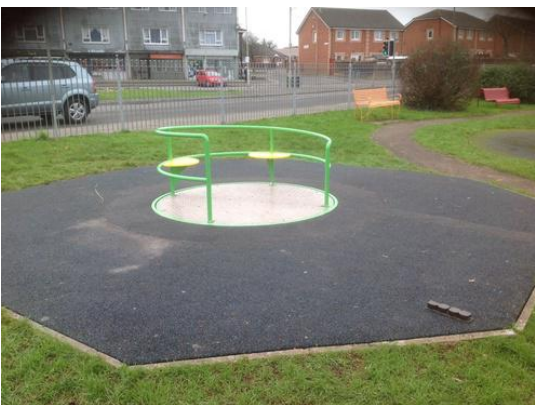
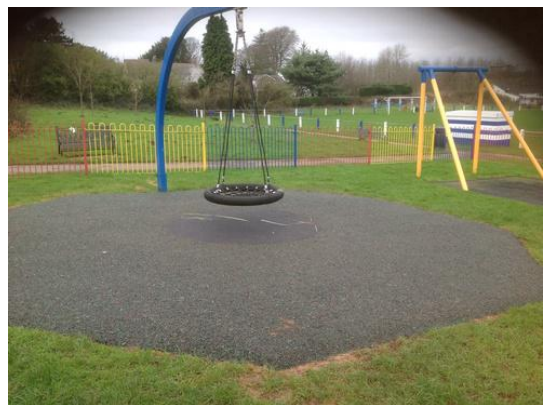
MUGA area supplied by PPL date unknown
 1 X 2 seat swing supplied and installed by Urban Recreation in 2016
 1 X Traditional cradle seat swing Wicksteed Leisure
 1 X Traditional Igloo climber Wicksteed Leisure
 1 X Wheelchair roundabout supplied and installed Urban Recreation Dec 2018
 1 X Multiplayer Unit Proludic installed Feb 2022
 1 X Steel cable ride Record Play
 1 X Freestanding slide Record Play
 2 X Spring animals Fahr Industries installed Feb 2022
 1 X Teen Shelter David Ogilvie Engineering
 1 X Cantilever Swing supplied Urban Recreation 2016
 9 X Fitness Items supplied Urban Recreation October 2017
 1 X Spinning Cup supplied and installed Urban Recreation Dec 2018

At the time of inspection all the equipment was found to be in a safe and useable condition

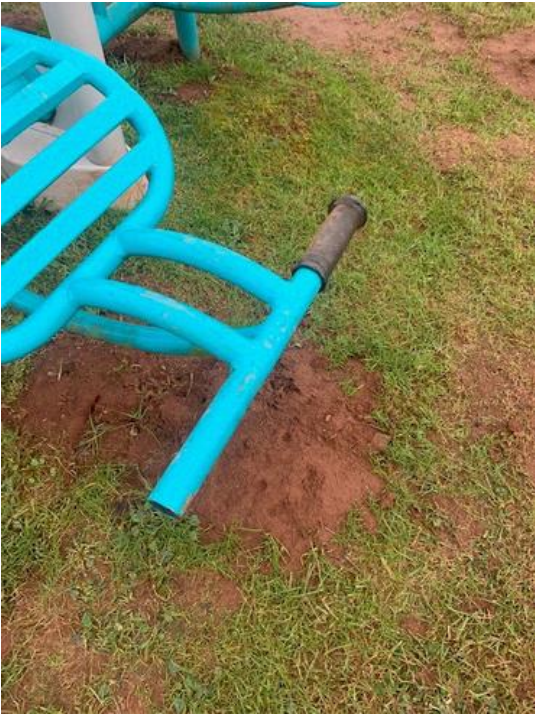
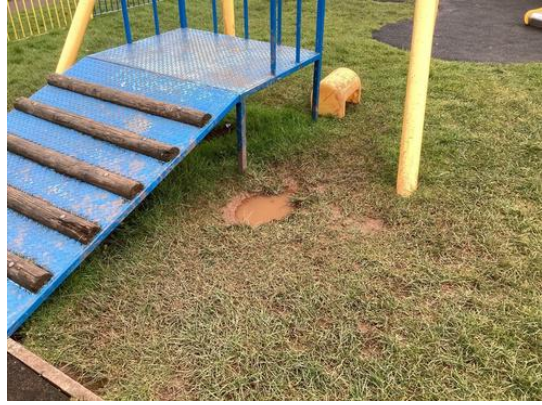
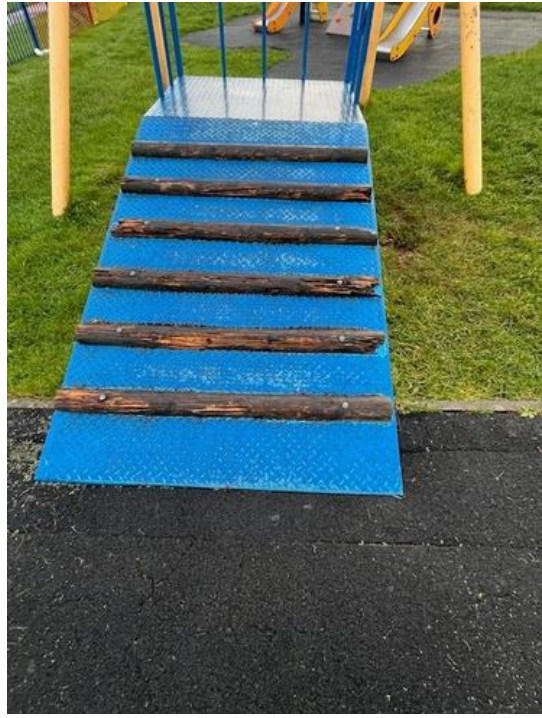
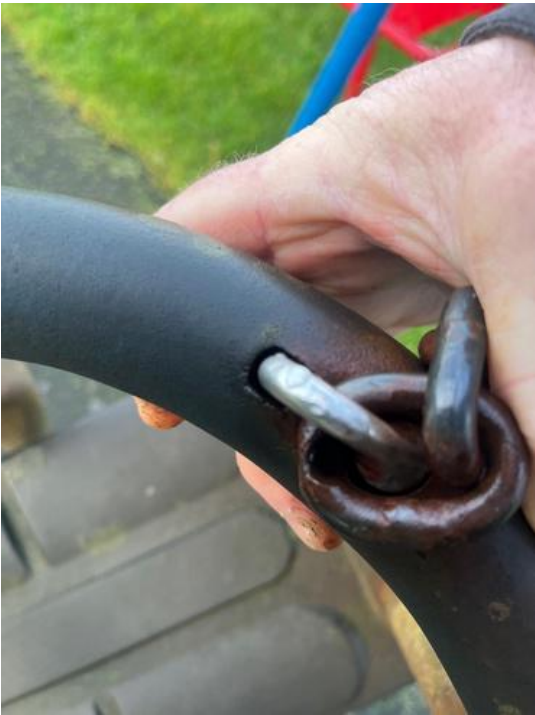
There is some wear on the toddler swing chains, these are at the point that they need to be replaced

There is a rubber cover missing from one of the sit up benches

The timber foot treads on the cable ride ramp are starting to deteriorate

There is a muddy hole next to the cable ride ramp

There is some graffiti on the multiplay unit panel

One of the finger guards on the cableway trolley is very worn and will need replacing in the near future

Date to be scheduled for replacement of timber treads on cable rides, finger guards on trolley, toddler seat swing chains
