# Play Area / Equipment Operational Inspection

LLANHARRY COMMUNITY COUNCIL

**Client / Site** Llanharry Recreation Ground

**Conducted on** 28.11.2025 11:30 GMT

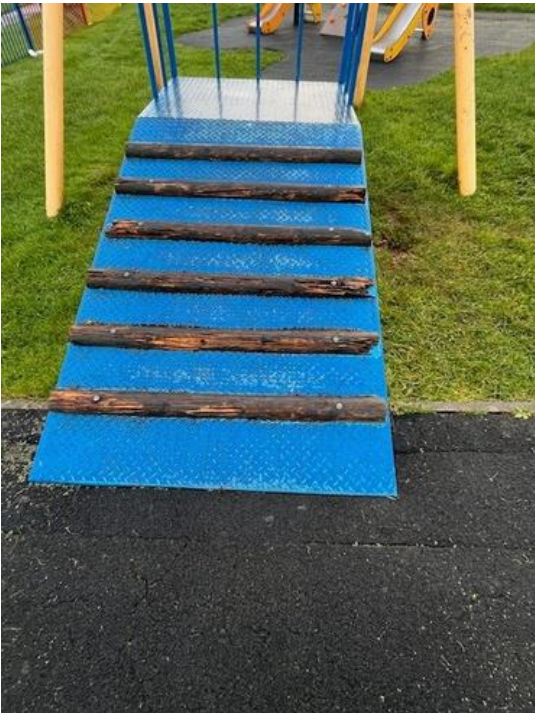
There is some wear on the toddler swing chains, monitor and plan for replacement in the future

There is a rubber cover missing from one of the sit up benches

The timber foot treads on the cable ride ramp are starting to deteriorate

There is a muddy hole next to the cable ride ramp

There is some graffiti on the multiplay unit panel

One of the finger guards on the cableway trolley is very worn and will need replacing in the near future

monitor timber treads on cable ride ramp

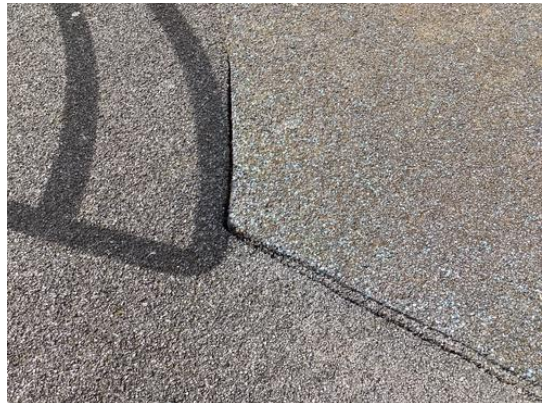
At the time of inspection all surfaces were found to be in a safe and useable condition although there are some areas of joint separation which should be monitored

One corner of the roundabout surfacing has been subsiding over the years and continues to drop monitor
