Play Area / Equipment Operational Inspection

LLANHARRY COMMUNITY COUNCIL

Score	8 / 8 (100%)	Flagged items	0	Actions	0
Document No.					000078
Audit Title					LLANHARRY COMMUNITY COUNCIL
Client / Site					Llanharry Recreation Ground
Conducted on					31.10.2025 08:00 GMT
Prepared by					Jerry Widdas
Location					Llanharry
Personnel					Jerry Widdas

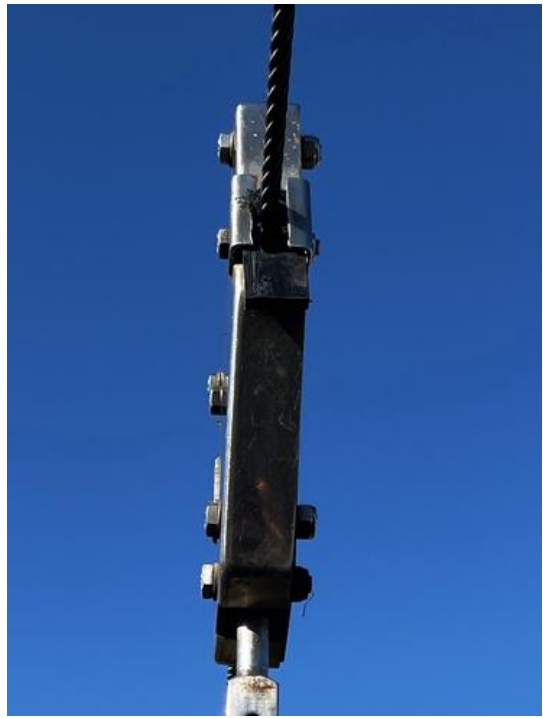
There is some wear on the toddler swing chains, monitor and plan for replacement in the future

There is a rubber cover missing from one of the sit up benches

The timber foot treads on the cable ride ramp are starting to deteriorate

There is a muddy hole next to the cable ride ramp

There is some graffiti on the multiplay unit panel

One of the finger guards on the cableway trolley is very worn and will need replacing in the near future

monitor timber treads on cable ride ramp

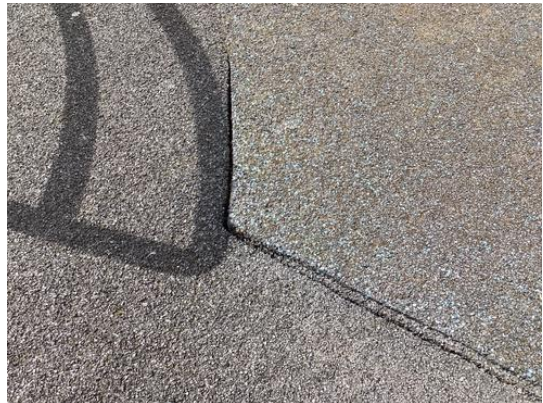
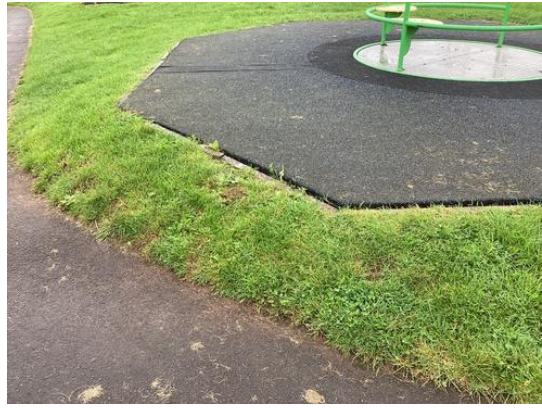
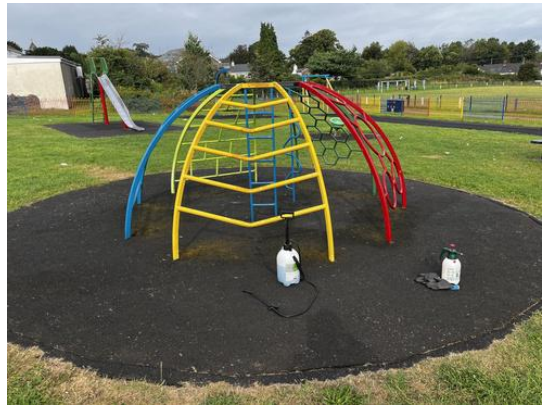
At the time of inspection all surfaces were found to be in a safe and useable condition although there are some areas of joint separation which should be monitored

One corner of the roundabout surfacing has been subsiding over the years and continues to drop monitor

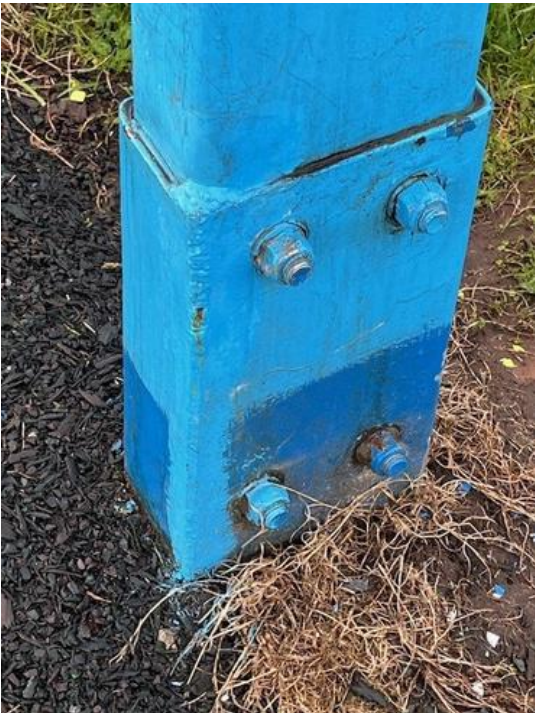
Photo 37

Cracked weld at base of cantilever has been fixed

crush points on gates have been fixed
broken damper on fitness equipment has been fixed
