Play Area / Equipment Operational Inspection

LLANHARRY COMMUNITY COUNCIL

Score	8 / 8 (100%)	Flagged items	0	Actions	0
Document No.					000078
Audit Title					LLANHARRY COMMUNITY COUNCIL
Client / Site					Llanharry Recreation Ground
Conducted on					26.02.2026 23:00 GMT
Prepared by					Jerry Widdas
Location					Llanharry
Personnel					
					Jerry Widdas

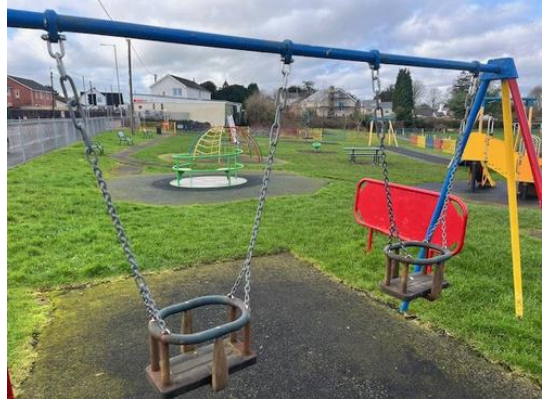
New cable guards, ramp treads and swing chains fitted
Schedule inspection for 27th March
