Play Area / Equipment Operational Inspection

LLANHARRY COMMUNITY COUNCIL

Client / Site Llanharry Recreation Ground

Conducted on 31.01.2026 09:30 GMT

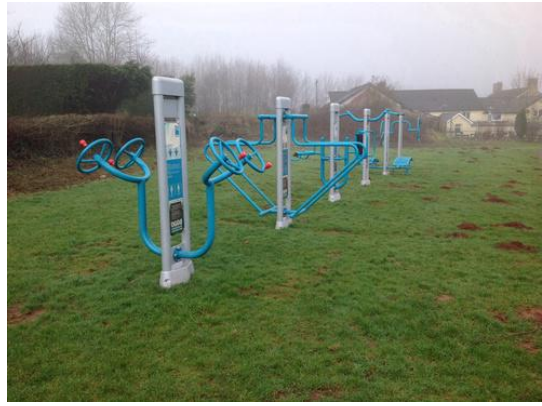
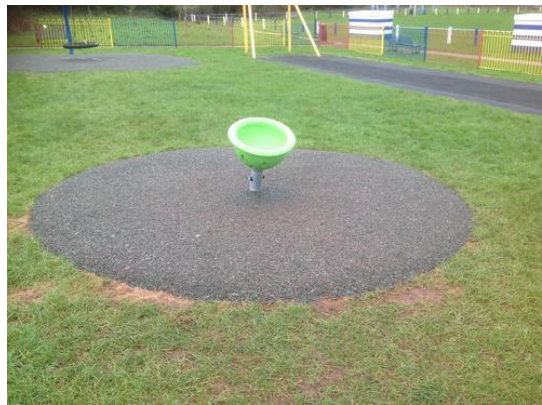
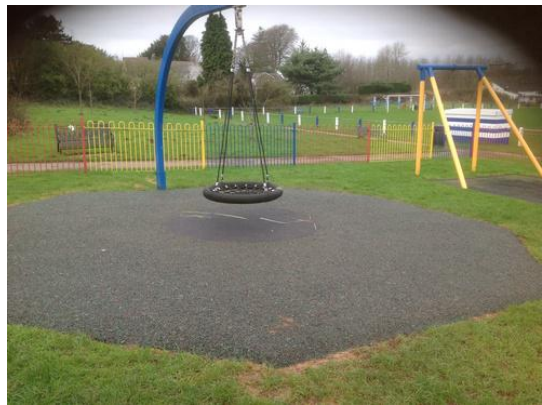
MUGA area supplied by PPL date unknown
 1 X 2 seat swing supplied and installed by Urban Recreation in 2016
 1 X Traditional cradle seat swing Wicksteed Leisure
 1 X Traditional Igloo climber Wicksteed Leisure
 1 X Wheelchair roundabout supplied and installed Urban Recreation Dec 2018
 1 X Multiplayer Unit Proludic installed Feb 2022
 1 X Steel cable ride Record Play
 1 X Freestanding slide Record Play
 2 X Spring animals Fahr Industries installed Feb 2022
 1 X Teen Shelter David Ogilvie Engineering
 1 X Cantilever Swing supplied Urban Recreation 2016
 9 X Fitness Items supplied Urban Recreation October 2017
 1 X Spinning Cup supplied and installed Urban Recreation Dec 2018

At the time of inspection all the equipment was found to be in a safe and useable condition

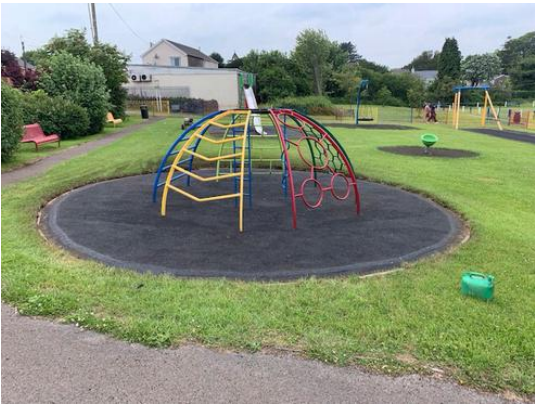
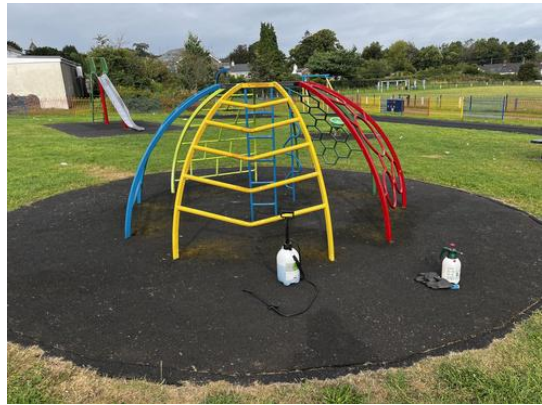
All items of play equipment are located on wet pour rubber safety surfacing.

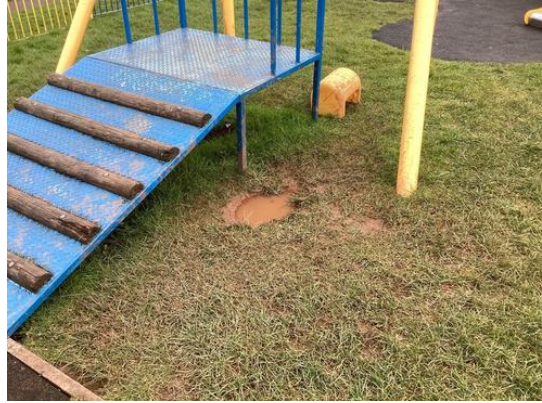
There is some wear on the toddler swing chains, these are at the point that they need to be replaced

There is a rubber cover missing from one of the sit up benches

The timber foot treads on the cable ride ramp are starting to deteriorate

There is a muddy hole next to the cable ride ramp

There is some graffiti on the multiplay unit panel

One of the finger guards on the cableway trolley is very worn and will need replacing in the near future

Date to be scheduled for replacement of timber treads on cable rides, finger guards on trolley, toddler seat swing chains
