# Play Area / Equipment Operational Inspection

LLANHARRY COMMUNITY COUNCIL

<b>Score</b>	8 / 8 (100%)	<b>Flagged items</b>	0	<b>Actions</b>	0
<b>Document No.</b>					000078
<b>Audit Title</b>					LLANHARRY COMMUNITY COUNCIL
<b>Client / Site</b>					Llanharry Recreation Ground
<b>Conducted on</b>					28.04.2026 09:30 BST
<b>Prepared by</b>					Jerry Widdas
<b>Location</b>					Llanharry
<b>Personnel</b>					
Jerry Widdas

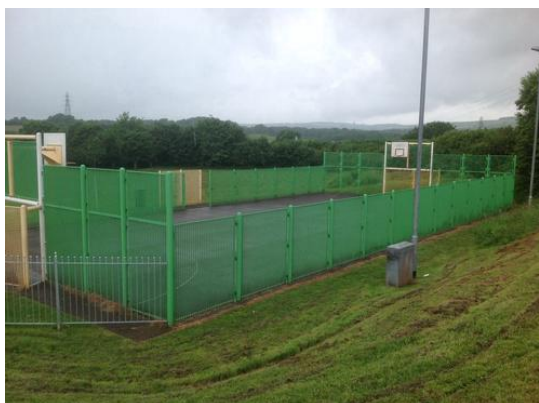
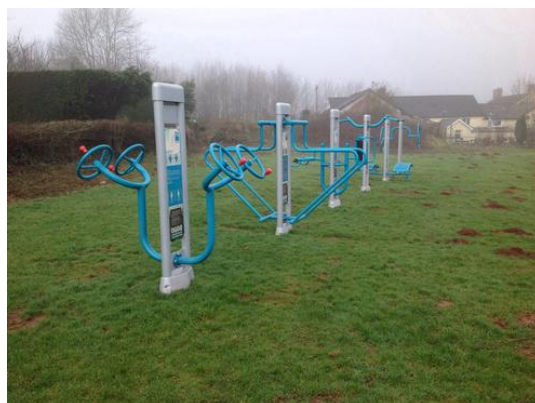
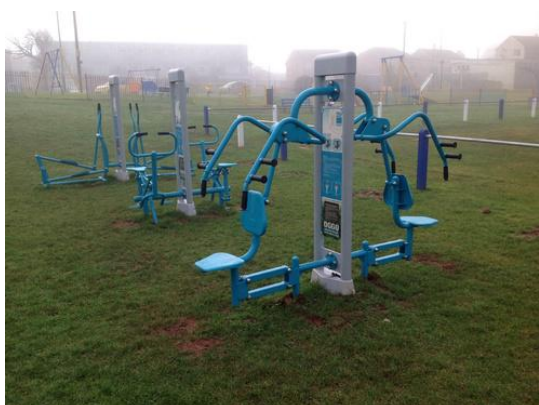
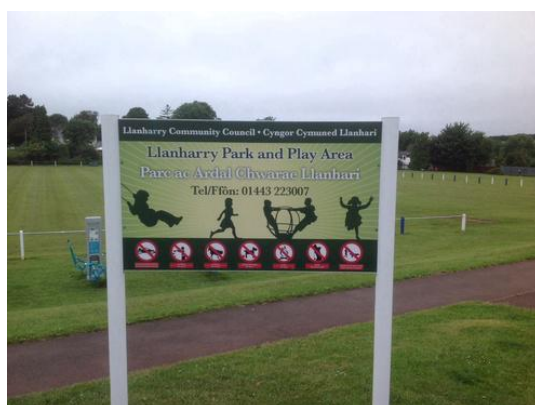
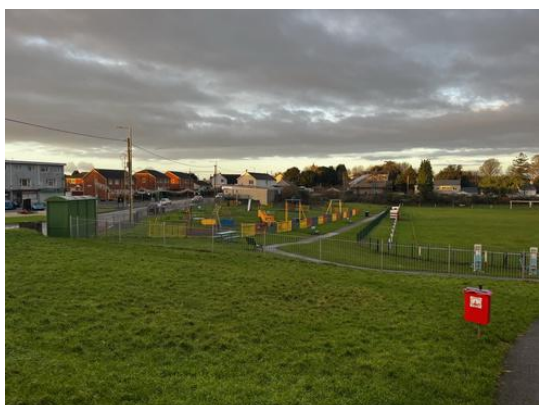
The recreation ground consists of a play area fenced by steel bow top fencing with self closing gates  
 A MUGA kick about area and a youth shelter  
 Both areas are accessed by Tarmac pathways  
 Benches and picnic tables are located within the play area and also outside the play area boundary

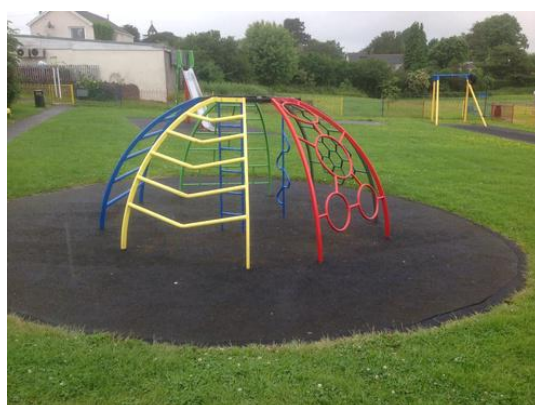
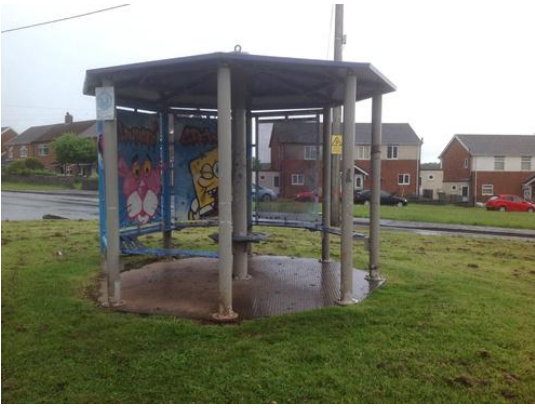
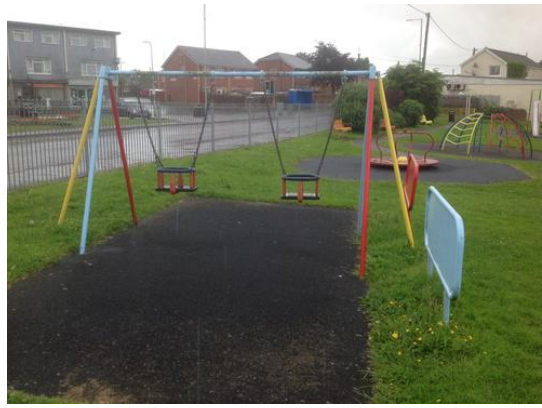
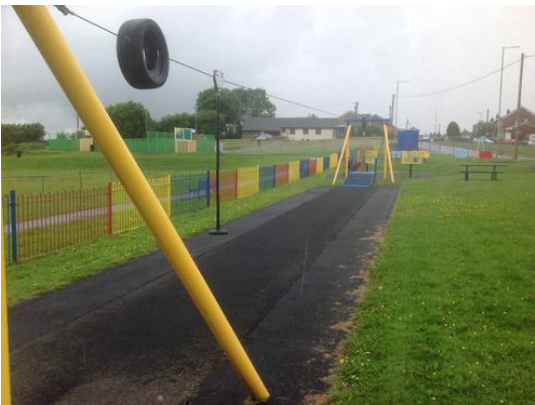
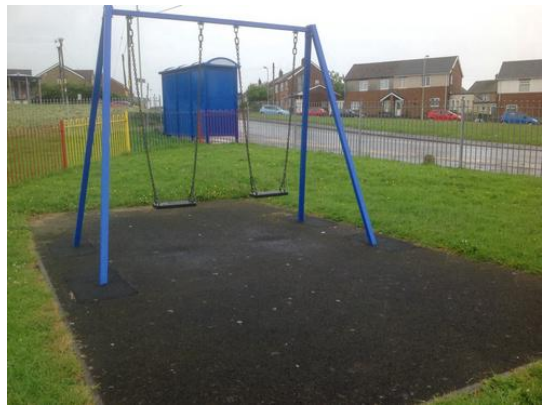
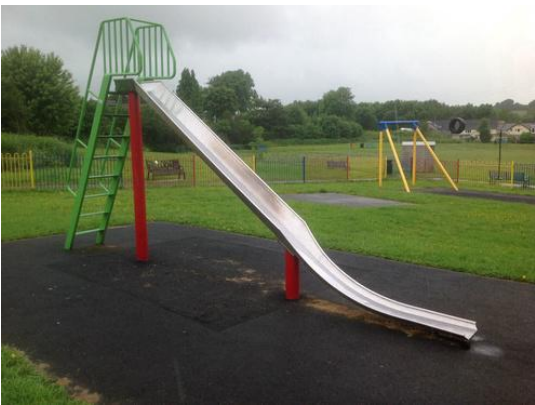
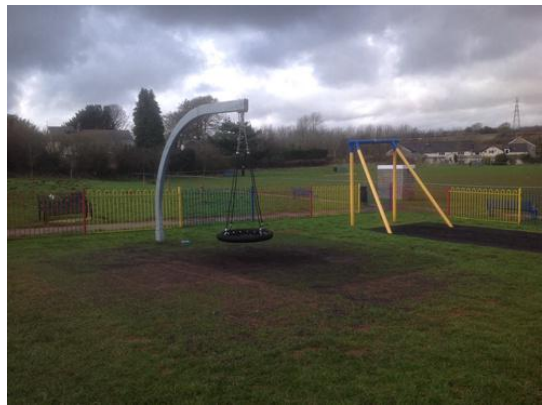
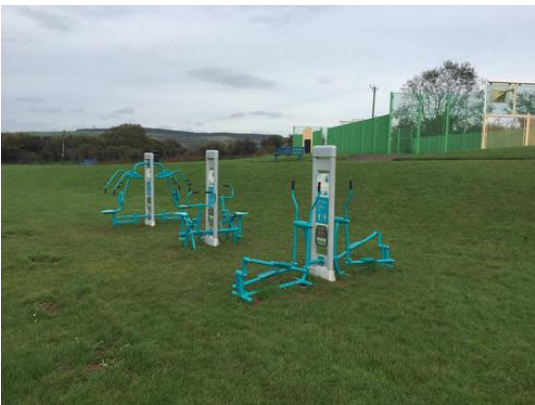
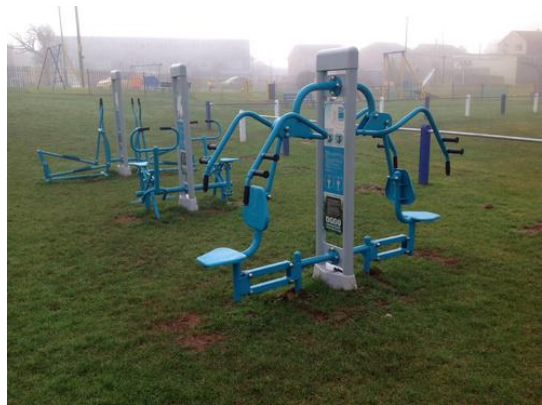
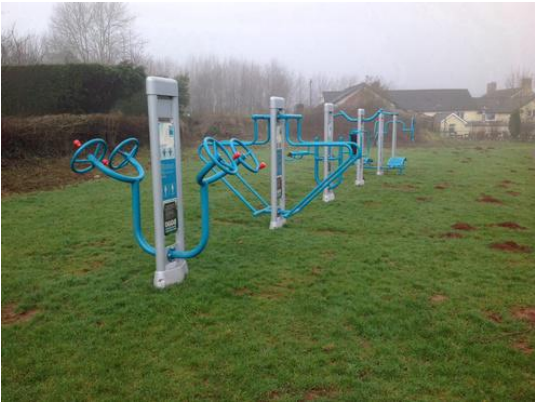
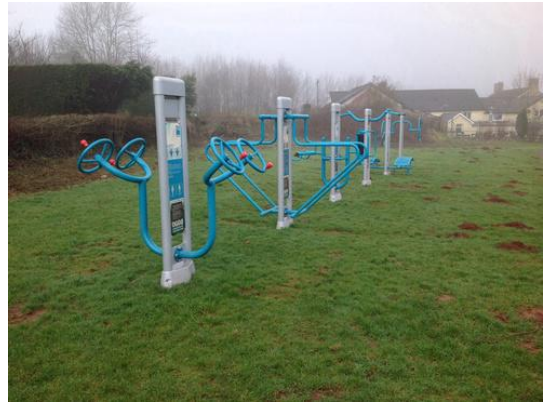
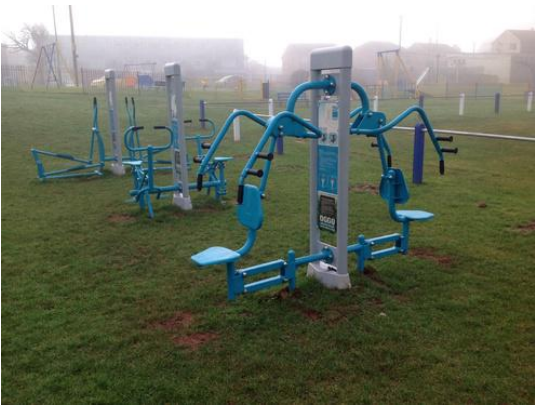
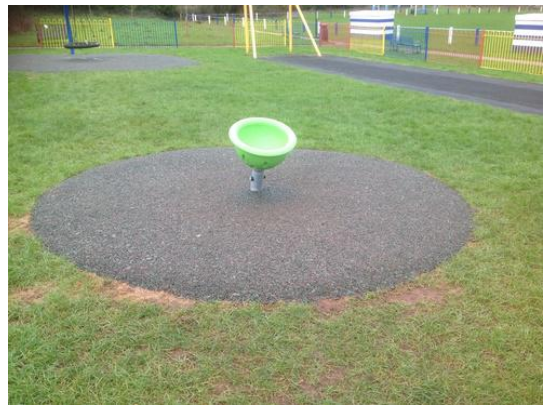
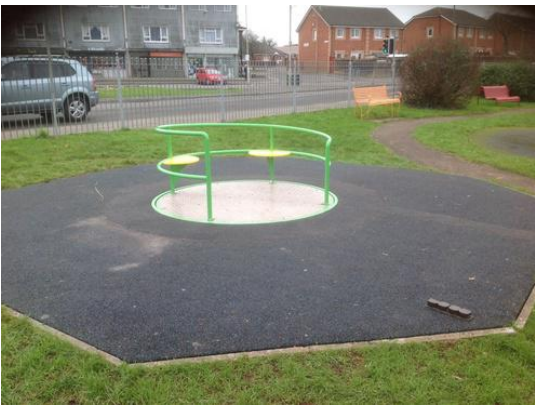
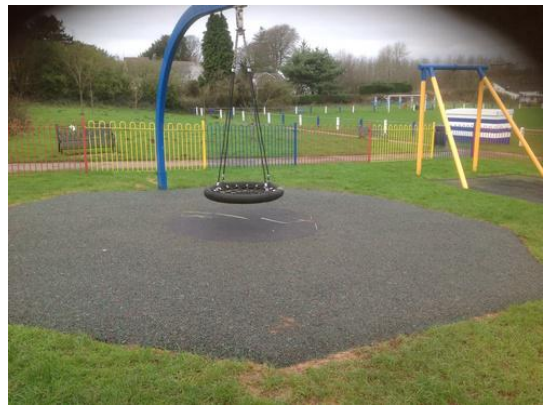
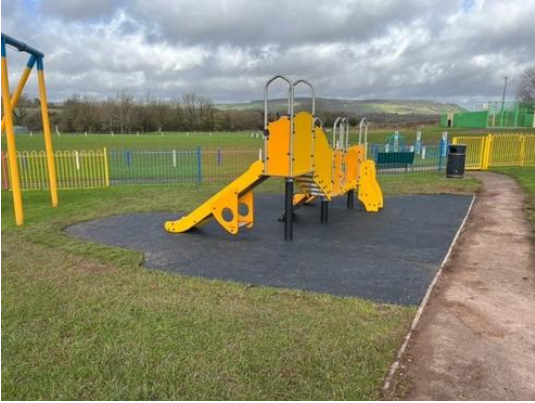
MUGA area supplied by PPL date unknown  
 1 X 2 seat swing supplied and installed by Urban Recreation in 2016  
 1 X Traditional cradle seat swing Wicksteed Leisure  
 1 X Traditional Igloo climber Wicksteed Leisure  
 1 X Wheelchair roundabout supplied and installed Urban Recreation Dec 2018  
 1 X Multiplayer Unit Proludic installed Feb 2022  
 1 X Steel cable ride Record Play  
 1 X Freestanding slide Record Play  
 2 X Spring animals Fahr Industries installed Feb 2022  
 1 X Teen Shelter David Ogilvie Engineering  
 1 X Cantilever Swing supplied Urban Recreation 2016  
 9 X Fitness Items supplied Urban Recreation October 2017  
 1 X Spinning Cup supplied and installed Urban Recreation Dec 2018

At the time of inspection all the equipment was found to be in a safe and useable condition
