# Play Area / Equipment Operational Inspection

LLANHARRY COMMUNITY COUNCIL

<b>Score</b>	8 / 8 (100%)	<b>Flagged items</b>	0	<b>Actions</b>	0
<b>Document No.</b>					000078
<b>Audit Title</b>					LLANHARRY COMMUNITY COUNCIL
<b>Client / Site</b>					Llanharry Recreation Ground
<b>Conducted on</b>					24.03.2026 07:30 GMT
<b>Prepared by</b>					Jerry Widdas
<b>Location</b>					Llanharry
<b>Personnel</b>					
					Jerry Widdas

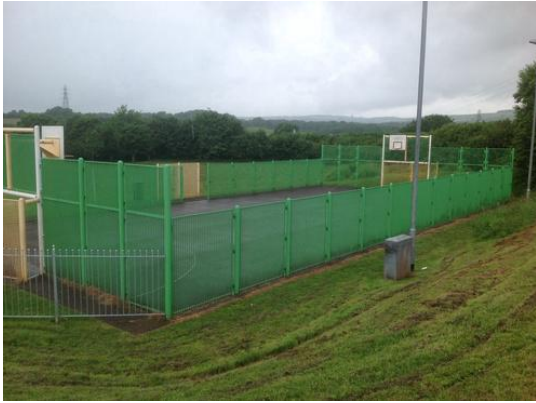
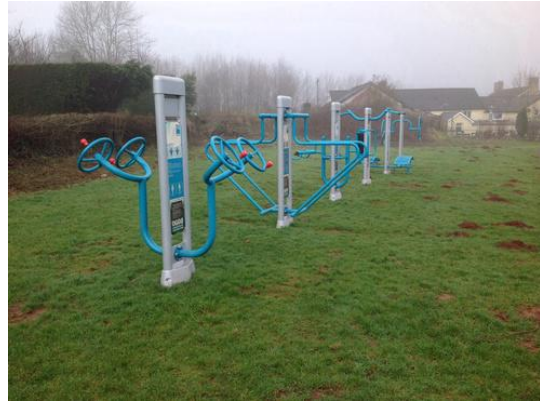
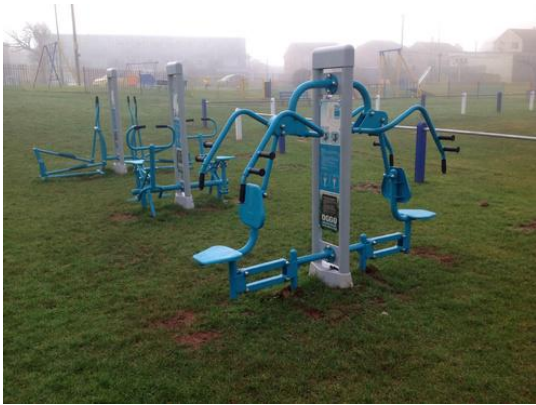
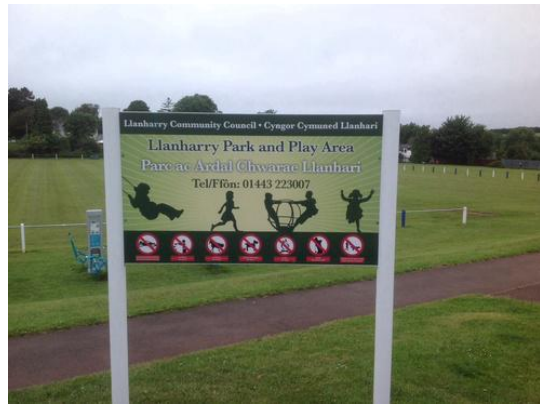
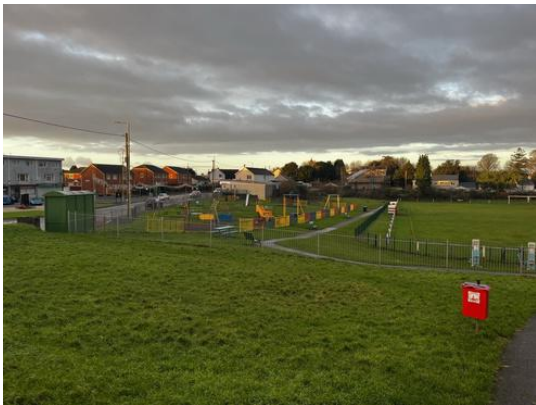
The recreation ground consists of a play area fenced by steel bow top fencing with self closing gates  
 A MUGA kick about area and a youth shelter  
 Both areas are accessed by Tarmac pathways  
 Benches and picnic tables are located within the play area and also outside the play area boundary

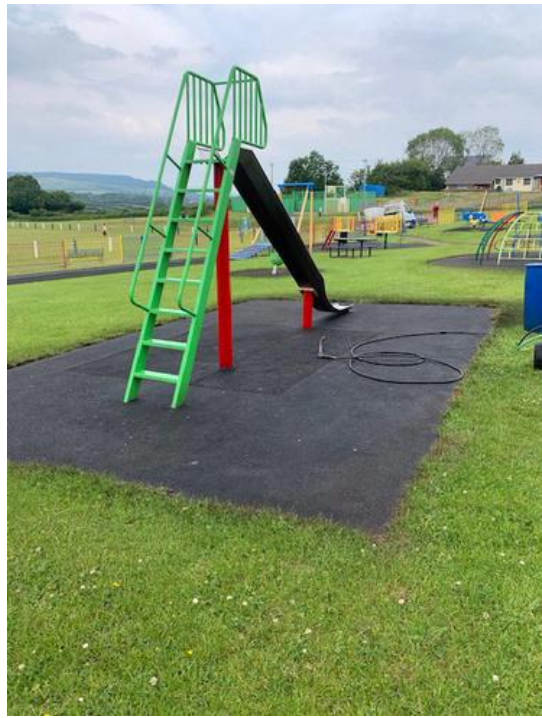
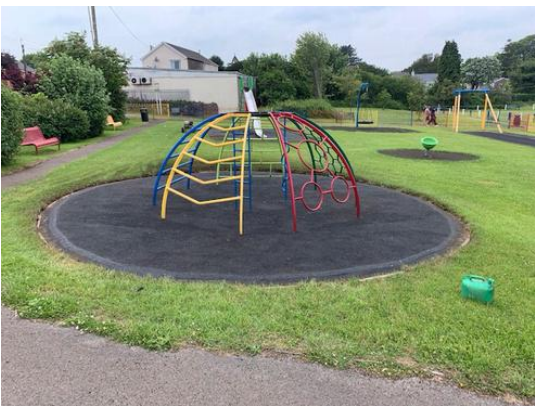
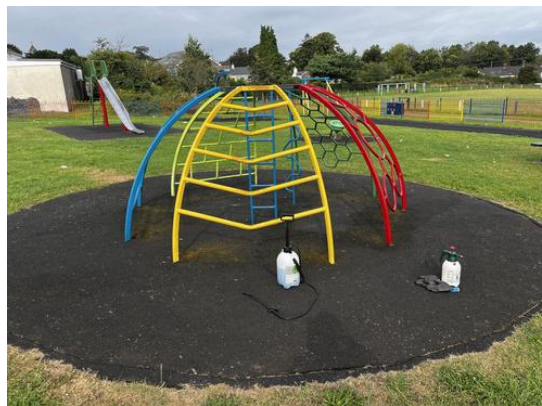
All items of play equipment are located on wet pour rubber safety surfacing.

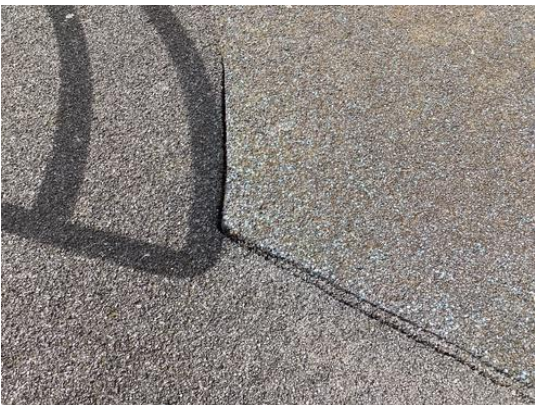
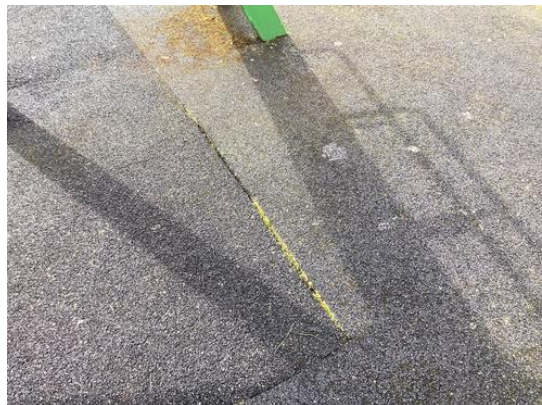
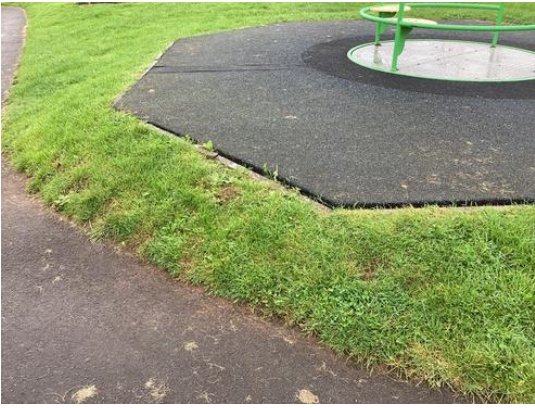
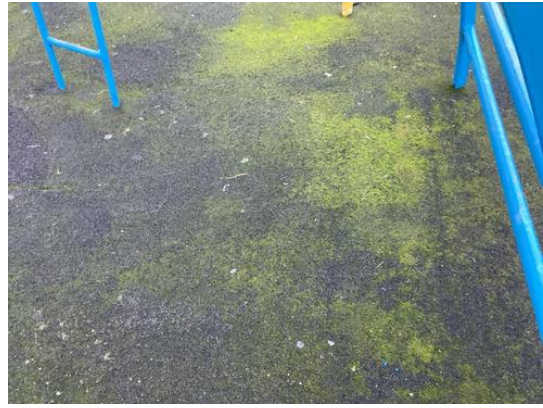
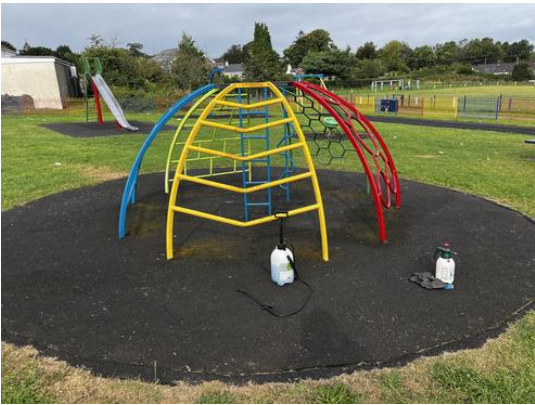
There is a muddy hole next to the cable ride ramp

At the time of inspection all surfaces were found to be in a safe and useable condition although there are some areas of joint separation which should be monitored

One corner of the roundabout surfacing has been subsiding over the years and continues to drop monitor

Moss treatment should be applied as soon as weather is dry enough April/May

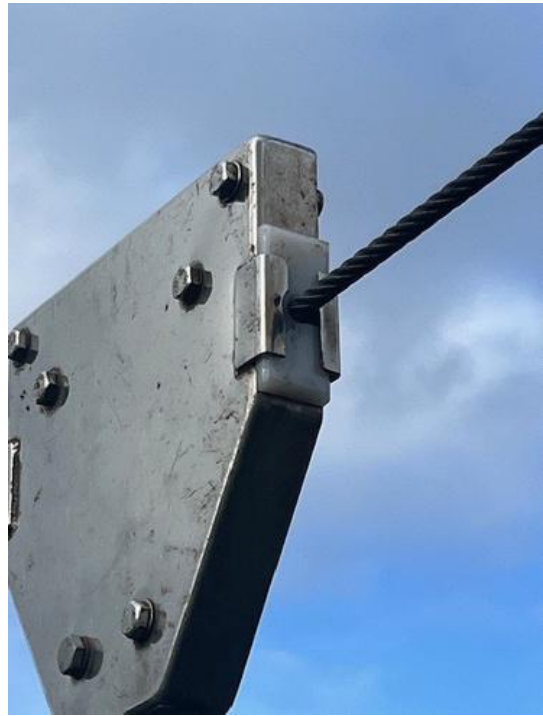
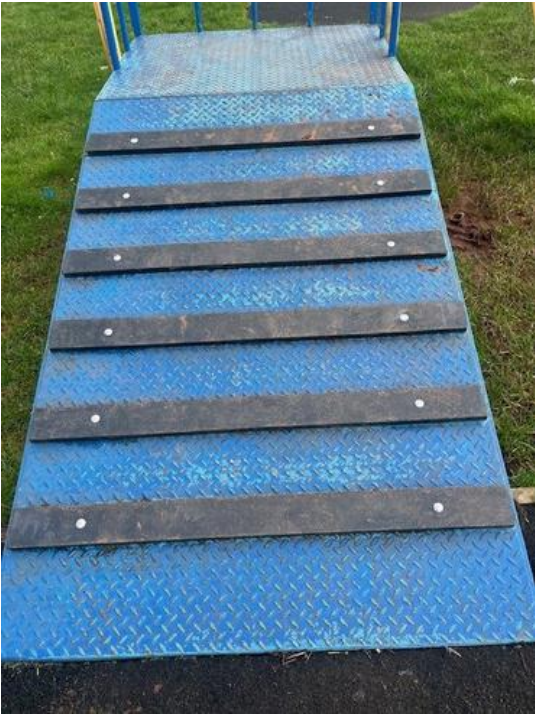
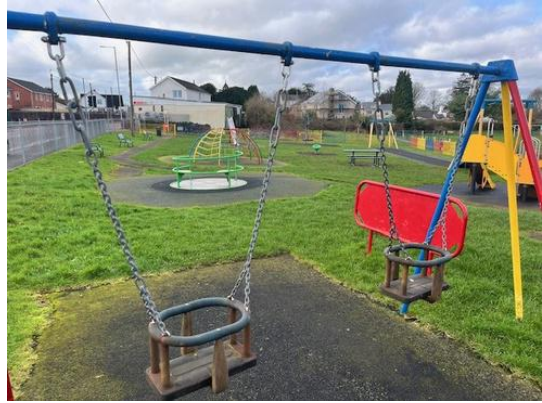
New cable guards, ramp treads and swing chains fitted  
Schedule inspection for 27th April
