# Play Area / Equipment Operational Inspection

LLANHARRY COMMUNITY COUNCIL

<b>Score</b>	7 / 8 (87.5%)	<b>Flagged items</b>	0	<b>Actions</b>	0
<b>Document No.</b>					000078
<b>Audit Title</b>					LLANHARRY COMMUNITY COUNCIL
<b>Client / Site</b>					Llanharry Recreation Ground
<b>Conducted on</b>					21.05.2026 07:30 BST
<b>Prepared by</b>					Jerry Widdas
<b>Location</b>					Llanharry
<b>Personnel</b>					
					Jerry Widdas

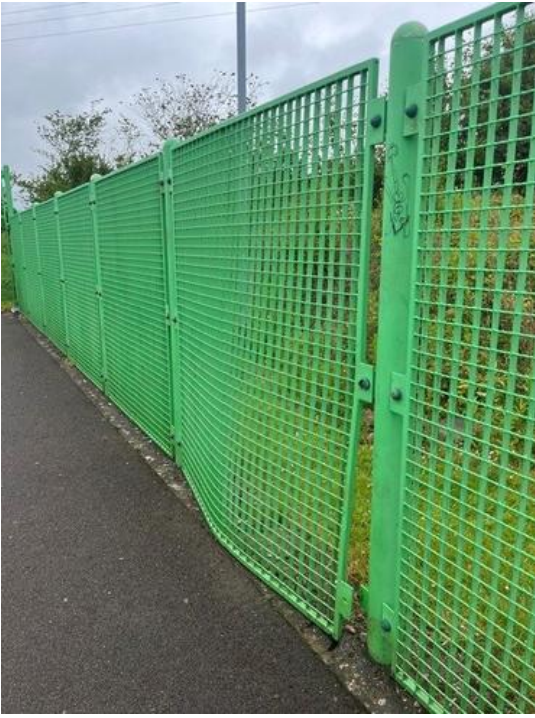
Photo 25

There is a muddy hole next to the cable ride ramp  
Damage has been caused to one of the MUGA panels  
There is underlying corrosion on one of the cradle seats, monitor  
The bearing on the basket swing joint has disintegrated, replace

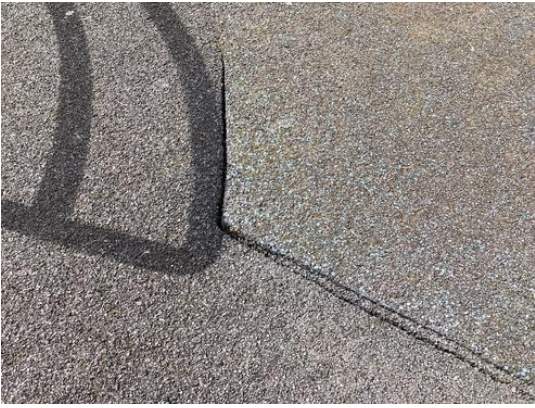
Photo 29

At the time of inspection all surfaces were found to be in a safe and useable condition although there are some areas of joint separation which should be monitored

One corner of the roundabout surfacing has been subsiding over the years and continues to drop monitor

Moss treatment should be applied as soon as weather is dry enough April/May
