Safety Inspection Report

Annual Inspection

Ty Isaf Play Area

Llanharry Community Council

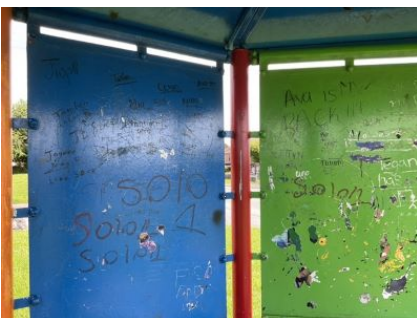
There is graffiti on the unit.

Remove.

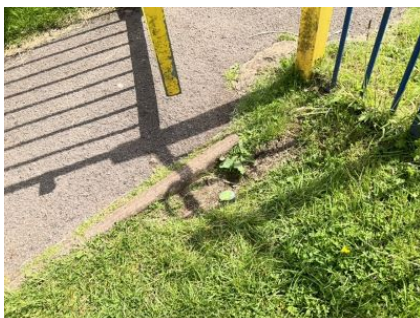
Trip points on the surface.

Make level.

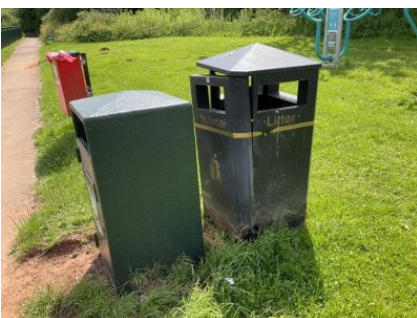
Item has corrosion.

Remove redundant bin.

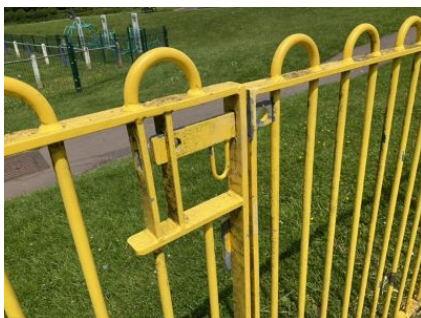
The item is unlocked.

Lock.

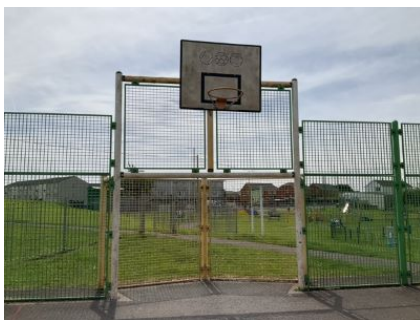
A clearly visible sign must be fitted to all sports related equipment with at least the following: a) equipment is not intended for children less than 36 month, b) "Do not climb on the framework or nets", c) "Do not hang on the ring", d) "Do not wear rings or other jewellery as these can get caught and cause injury", e) name and telephone number of site owner, f) number to call in case of accident.

Fit warning notice.

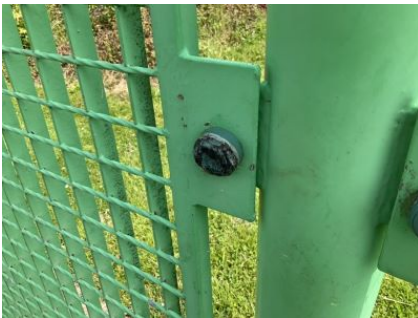
Item is damaged.

Repair.

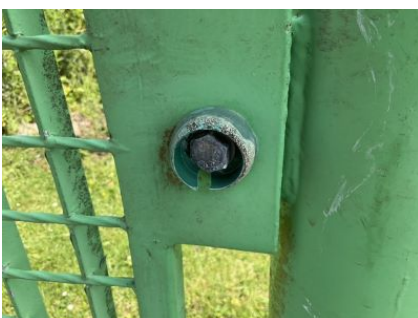
Cap missing.

Replace.

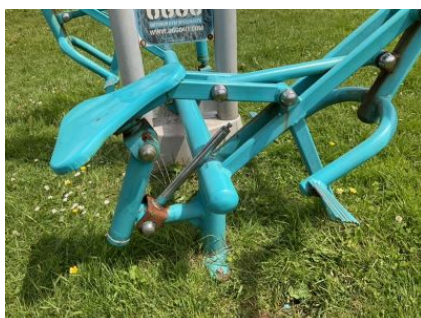
Item is damaged.

Repair.

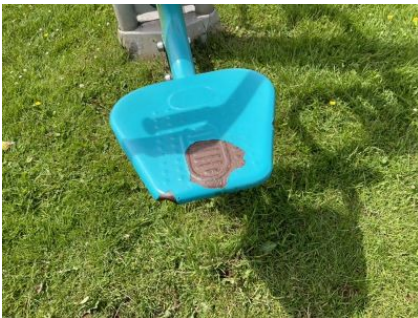
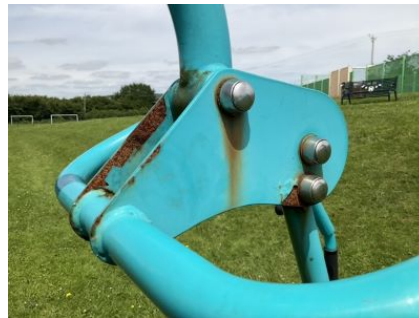
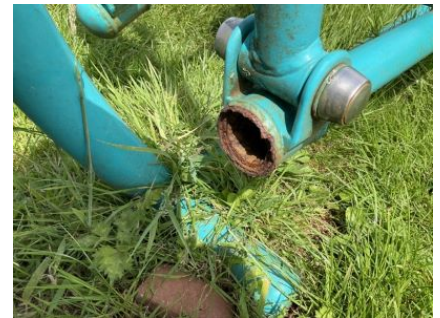
Item has corrosion.

Treat and repair.

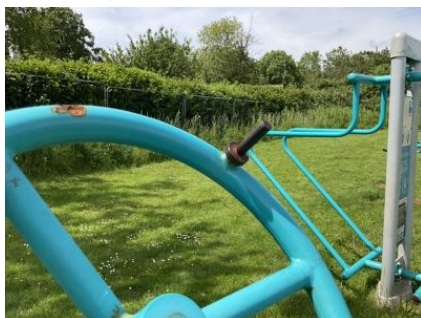
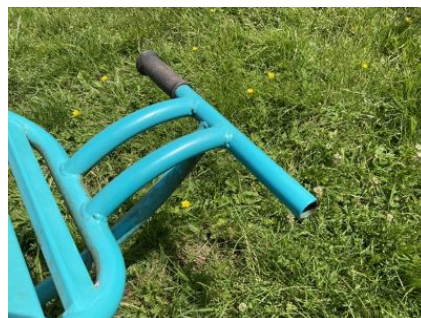
Hand grip is missing.

Replace missing grip.

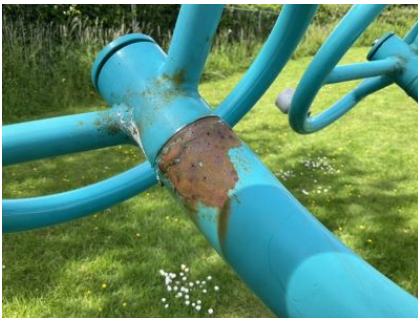
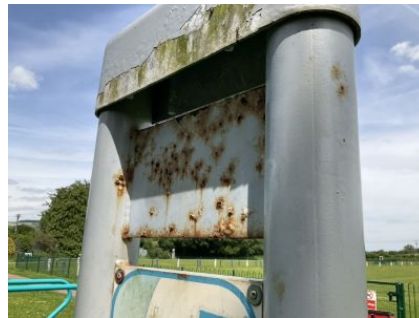
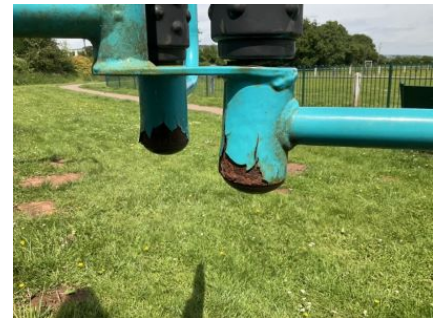
Item has corrosion.

Treat and repair.

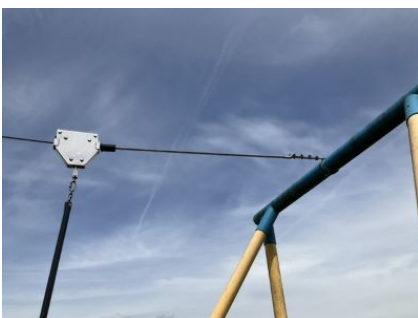
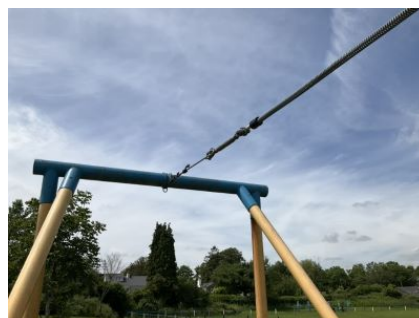
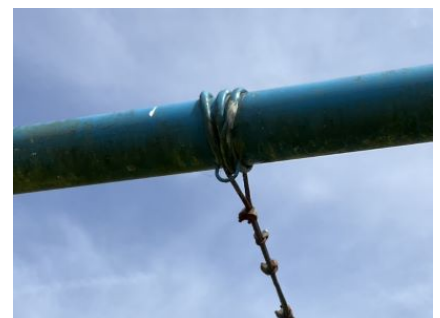
Cables have been known to fail under load due to wear and corrosion. This is generally where the cable enters into a tube, top bar, sleeve or similar, where the wire is in contact and wears and frays over time, but can happen anywhere on the cable. It is important to inspect any hidden parts at least annually. Damaged cables require replacement. This cannot be determined during an annual inspection, and is excluded from our inspection. This can lead to a high risk if no action is taken. Refer to the manufacturer's instructions to ensure the correct check is carried out.

Conduct an appropriate dismantling inspection according to the manufacturer's instructions, and at least annually. The trolley mechanism can be checked at the same time.

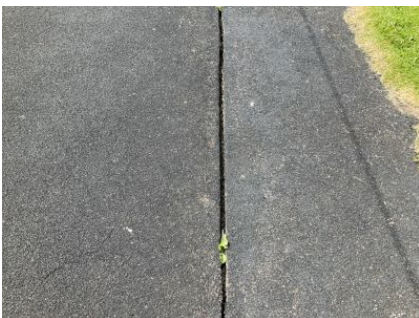
Shrinkage / separation of the surface. This may give a trip hazard.

Repair.

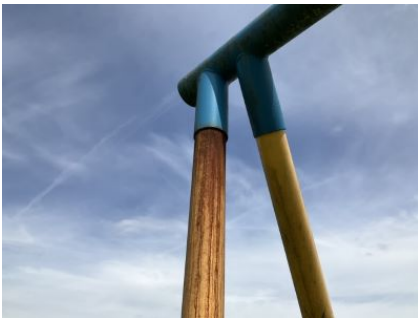
Item has corrosion.

Treat and repair.

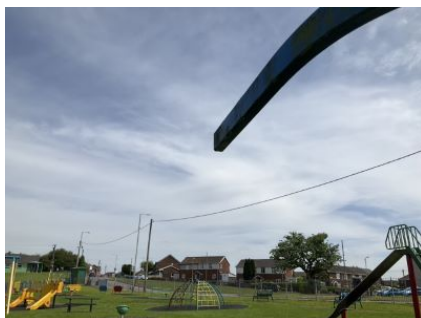
Item has some parts missing.

Replace the missing parts.

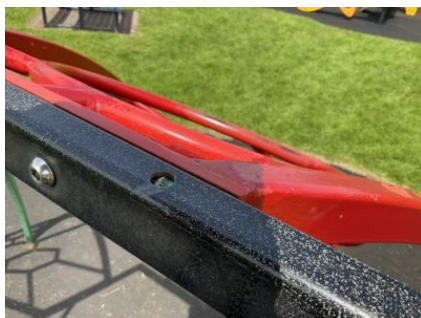
Cap missing.

Replace.

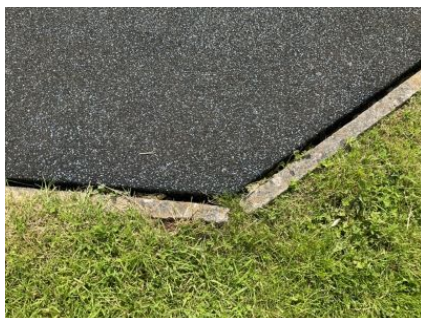
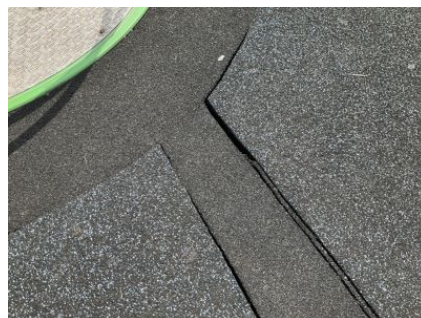
Shrinkage / separation of the surface. This may give a trip hazard.

Repair.

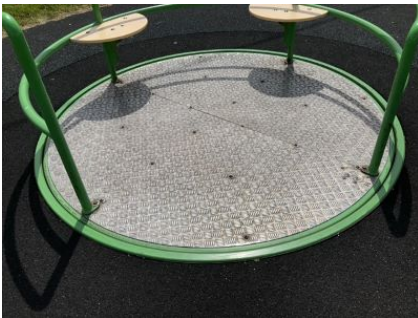
There is wear in the bearings.

Monitor and replace when necessary.

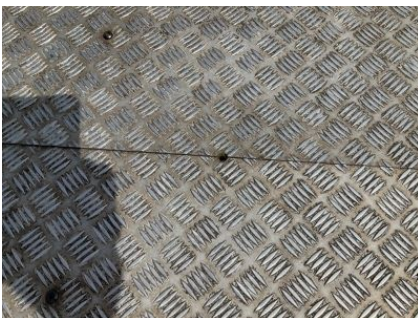
Bolt(s) missing.

Replace missing bolt(s).

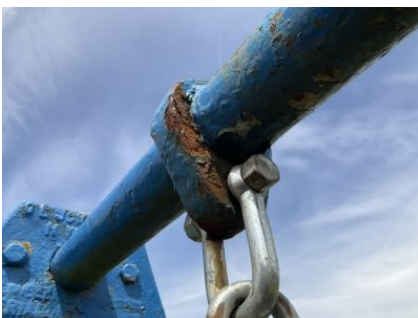
Item has corrosion.

Treat and repair.

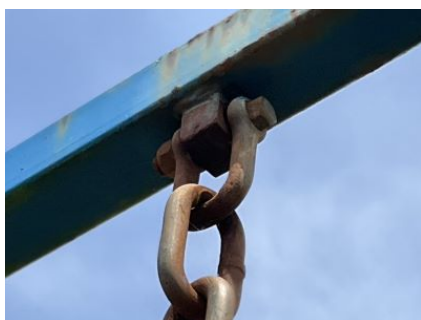
There is wear in the bushes.

Remove shackle bolt and check bush and shackle pin wear, replacing as necessary.

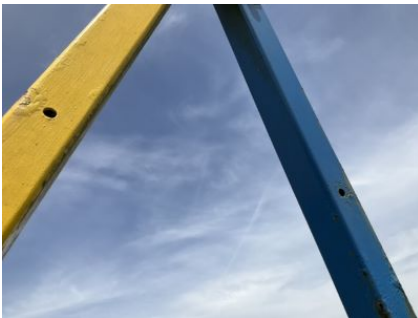
Cap missing.

Replace.

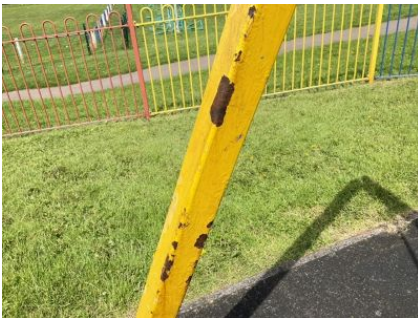
Item has corrosion.

Treat and repair.

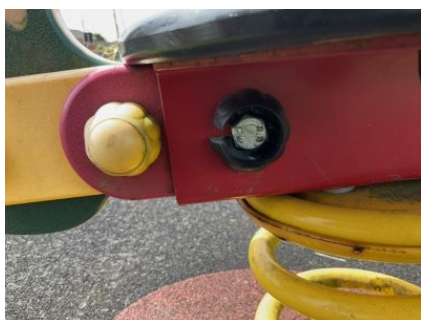
Cap missing.

Replace.
