Play Area / Equipment Operational Inspection

LLANHARRY COMMUNITY COUNCIL

Score	8 / 8 (100%)	Flagged items	0	Actions	0
Document No.					000078
Audit Title					LLANHARRY COMMUNITY COUNCIL
Client / Site					Llanharry Recreation Ground
Conducted on					02.02.2024 08:12 GMT
Prepared by					Jerry Widdas
Location					Llanharry
Personnel					
					Jerry Widdas

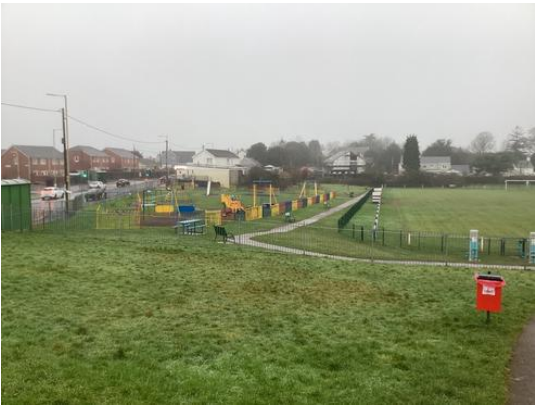
The recreation ground consists of a play area fenced by steel bow top fencing with self closing gates
 A MUGA kick about area and a youth shelter
 Both areas are accessed by Tarmac pathways
 Benches and picnic tables are located within the play area and also outside the play area boundary

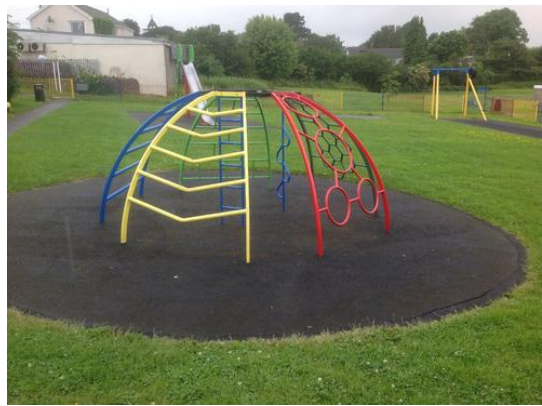
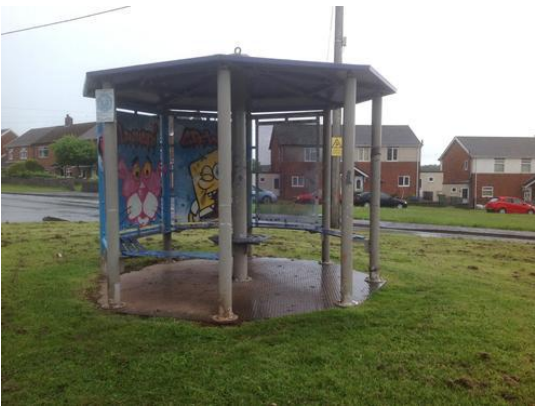
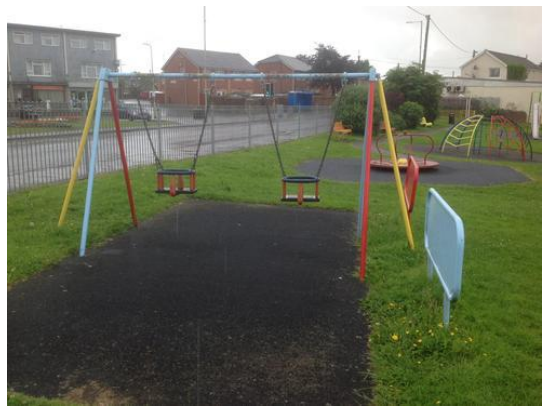
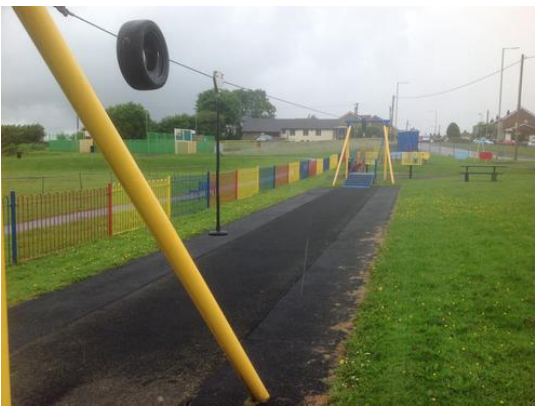
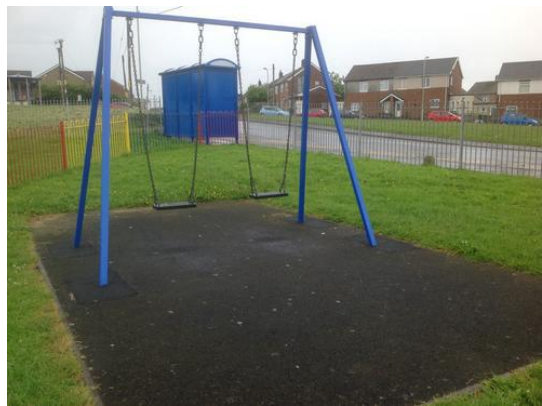
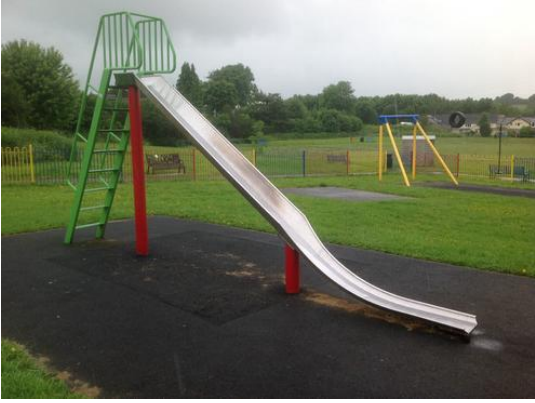
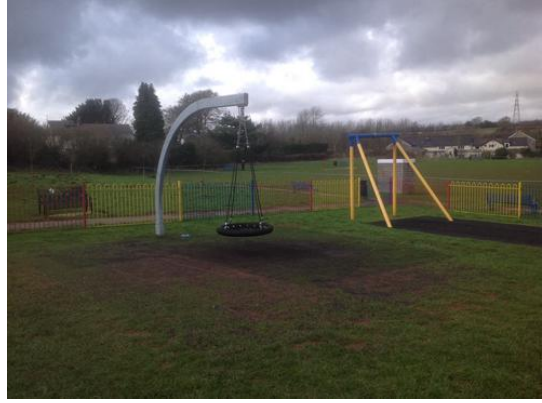
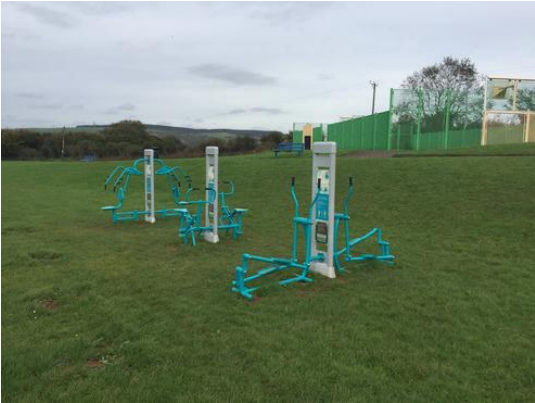
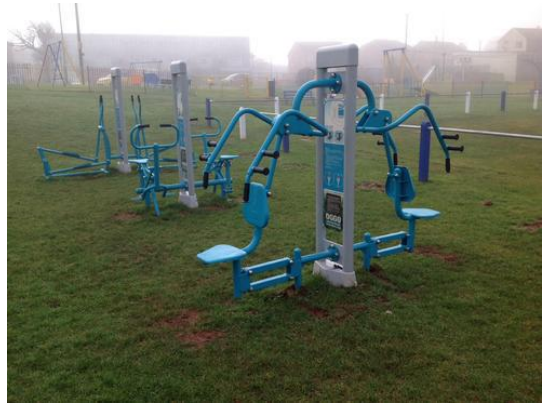
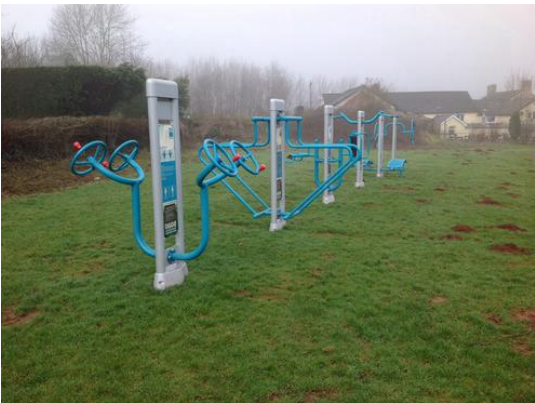
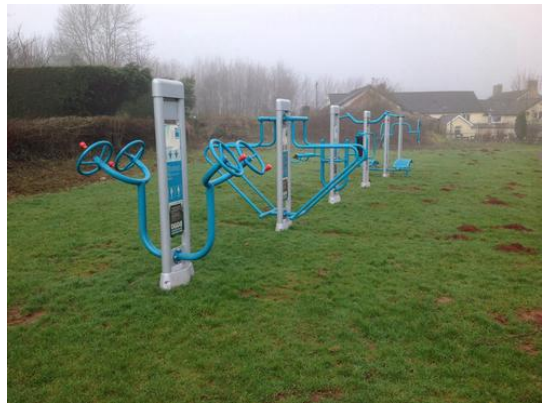
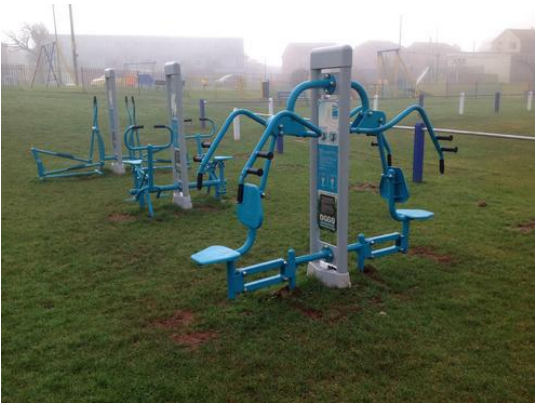
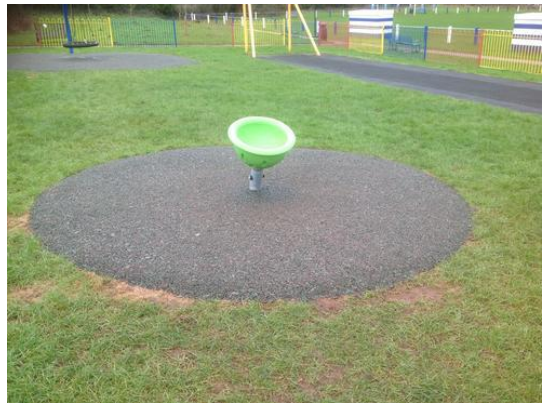
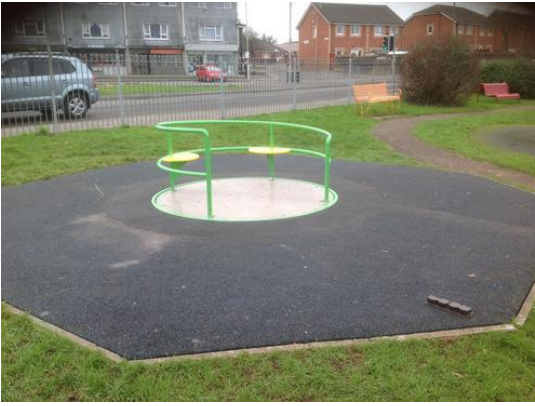
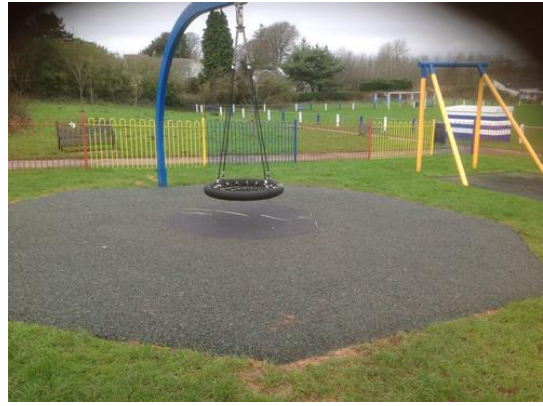
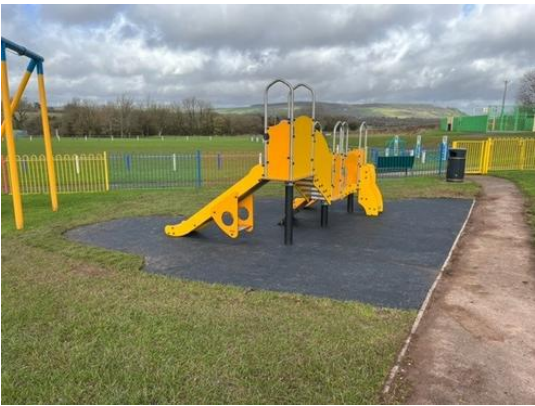
MUGA area supplied by PPL date unknown
 1 X 2 seat swing supplied and installed by Urban Recreation in 2016
 1 X Traditional cradle seat swing Wicksteed Leisure
 1 X Traditional Igloo climber Wicksteed Leisure
 1 X Wheelchair roundabout supplied and installed Urban Recreation Dec 2018
 1 X Multiplayer Unit Proludic installed Feb 2022
 1 X Steel cable ride Record Play
 1 X Freestanding slide Record Play
 2 X Spring animals Fahr Industries installed Feb 2022
 1 X Teen Shelter David Ogilvie Engineering
 1 X Cantilever Swing supplied Urban Recreation 2016
 9 X Fitness Items supplied Urban Recreation October 2017
 1 X Spinning Cup supplied and installed Urban Recreation Dec 2018

At the time of inspection all the equipment was found to be in a safe and useable condition

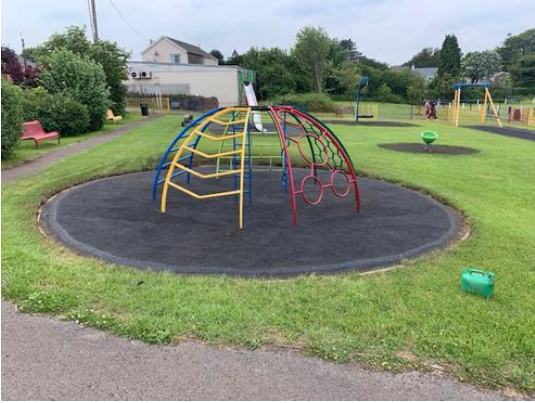
All items of play equipment are located on wet pour rubber safety surfacing

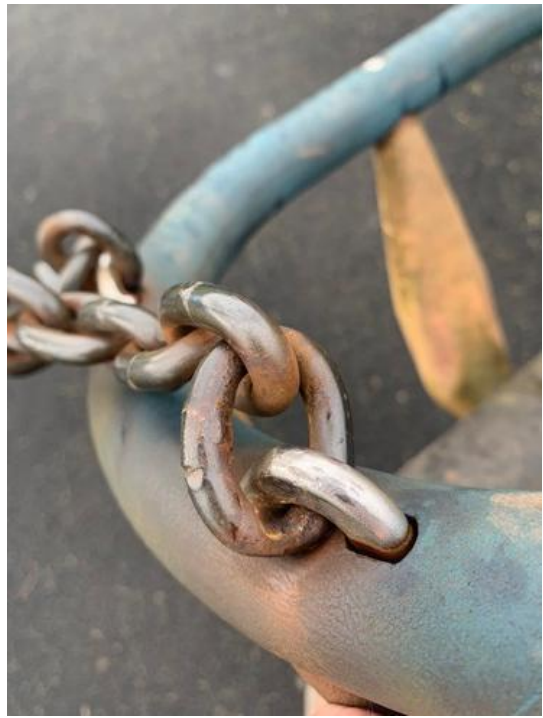
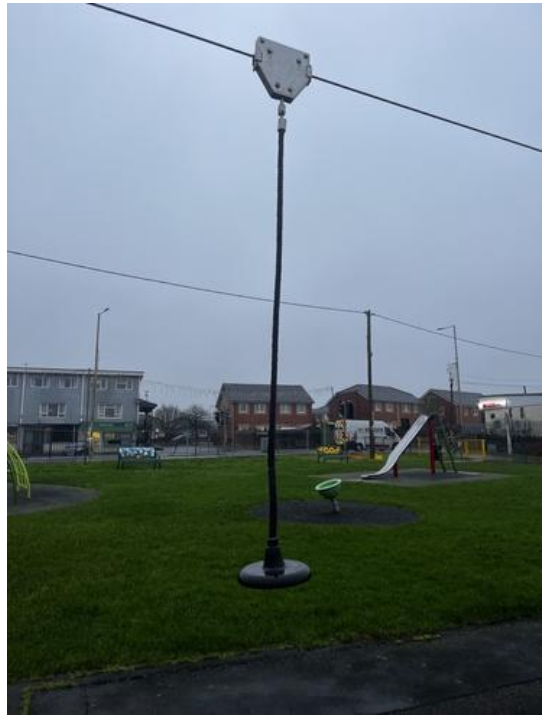
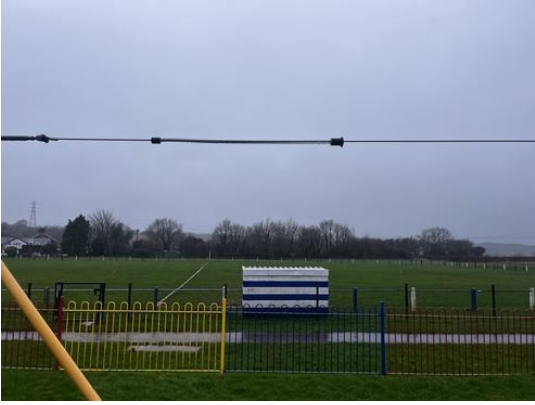
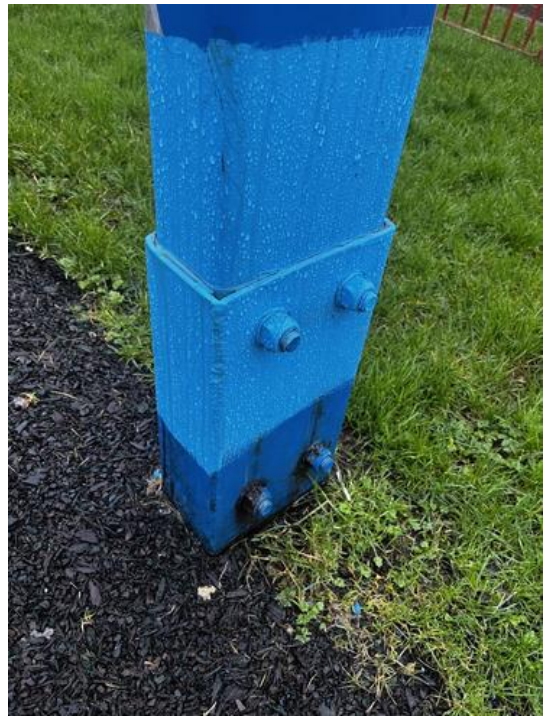
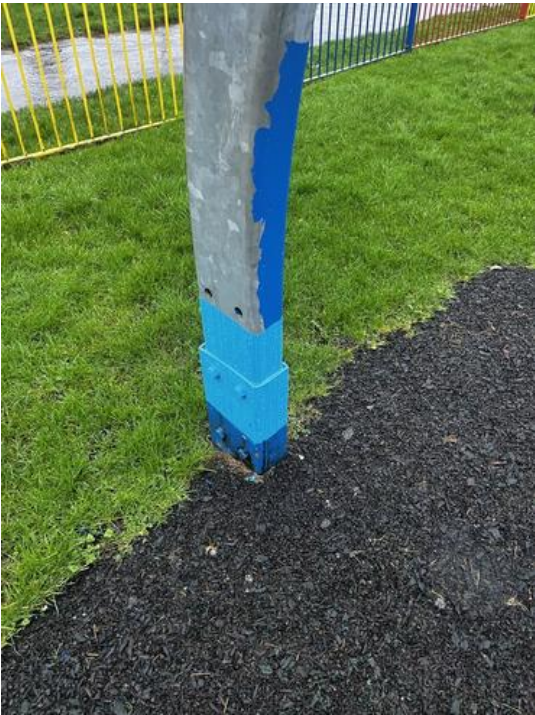
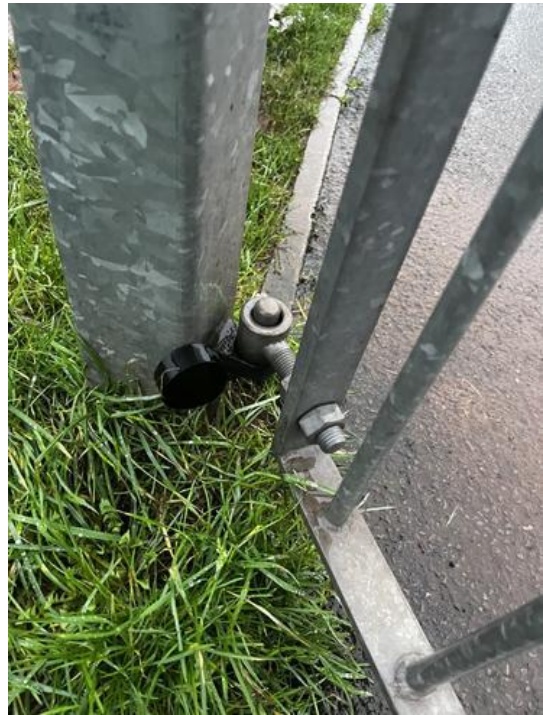
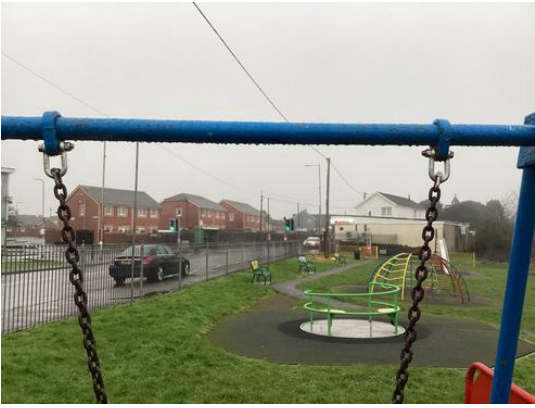
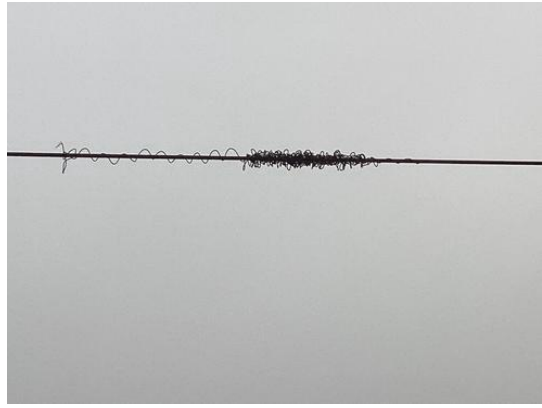
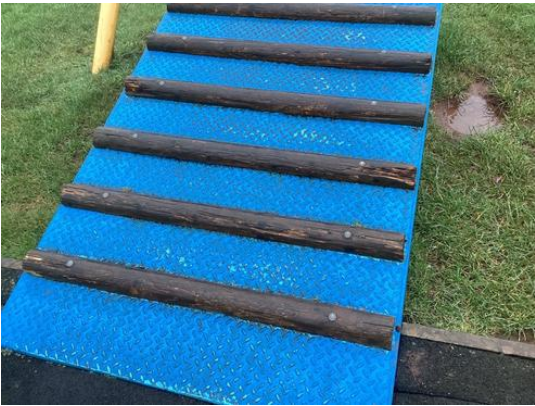
There is some wear on the toddler swing chains, monitor and plan for replacement in the future

There is a rubber cover missing from one of the sit up benches

The cable ride spring has been changed for heavy duty

The pendulum seat has been changed for a rope suspension

The cantilever basket swing has had the post fixings tightened and the seam has been welded

The access gate by car park has had a rubber buffer attached to remove the crush point

Swing shackles and bushes on the toddler swing have been changed and oiled

The cable on the cable ride has stripped and needs replacing

The timber foot treads on the cable ride ramp are starting to deteriorate

monitor timber treads on cable ride ramp

Replace cable on cable ride asap

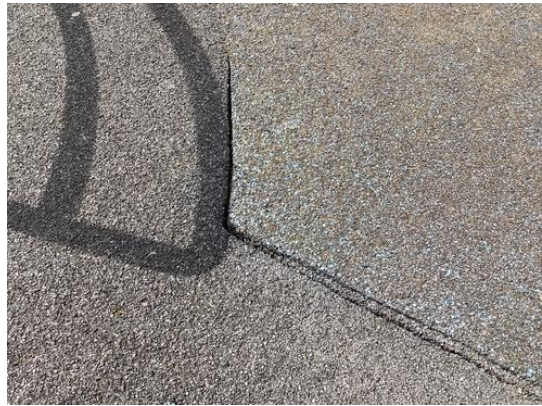
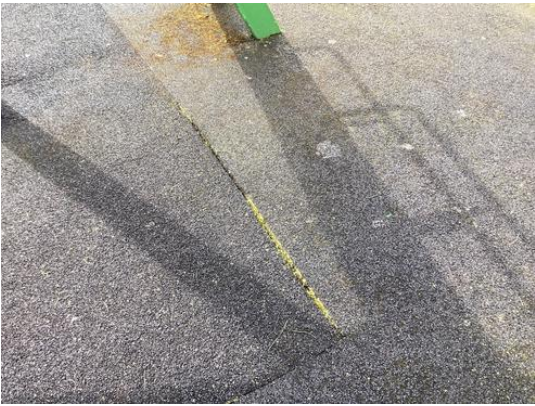
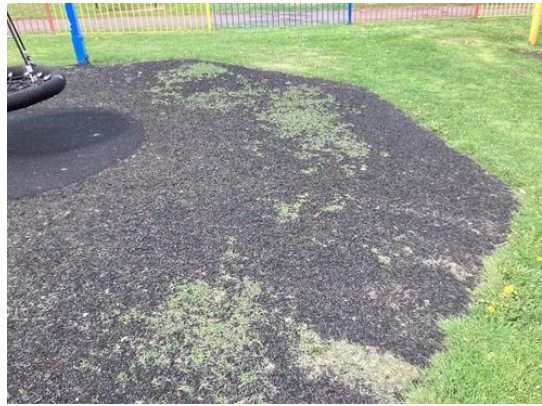
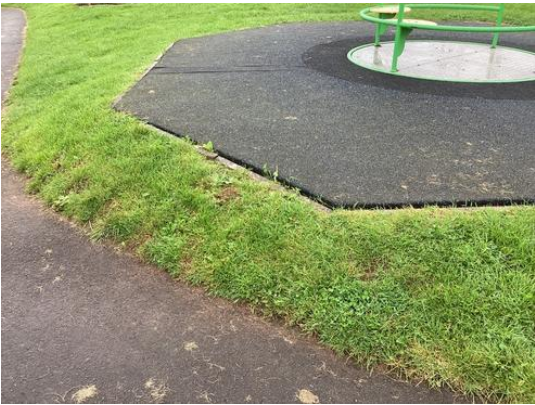
At the time of inspection all surfaces were found to be in a safe and useable condition although there are some areas of joint separation which should be monitored

The basket swing surface has been treated to remove grass growth

One corner of the roundabout surfacing has been subsiding over the years and continues to drop

Schedule to treat rubber surface with moss killer first dry opportunity in March
