Play Area / Equipment Operational Inspection

LLANHARRY COMMUNITY COUNCIL

Score	8 / 8 (100%)	Flagged items	0	Actions	0
Document No.					000078
Audit Title					LLANHARRY COMMUNITY COUNCIL
Client / Site					Llanharry Recreation Ground
Conducted on					30.04.2025 08:00 BST
Prepared by					Jerry Widdas
Location					Llanharry
Personnel					
					Jerry Widdas

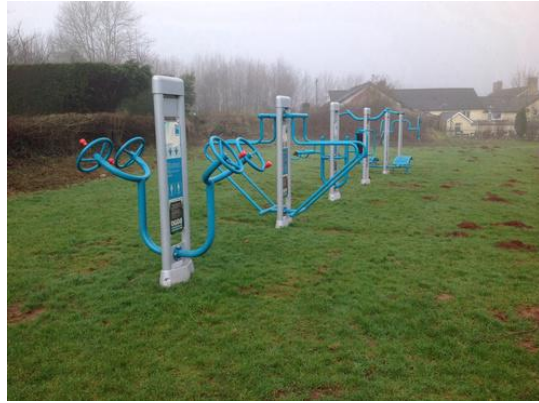
Photo 1

The recreation ground consists of a play area fenced by steel bow top fencing with self closing gates
 A MUGA kick about area and a youth shelter
 Both areas are accessed by Tarmac pathways
 Benches and picnic tables are located within the play area and also outside the play area boundary

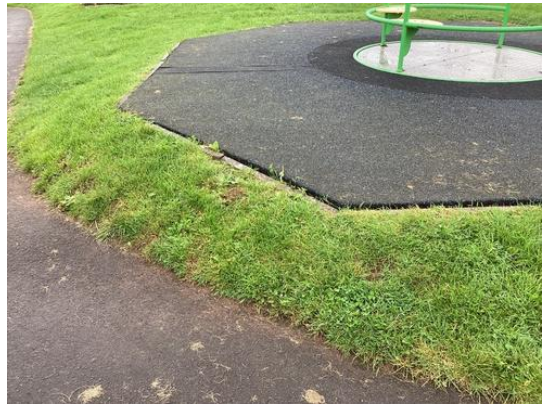
Photo 31

At the time of inspection all surfaces were found to be in a safe and useable condition although there are some areas of joint separation which should be monitored
