Play Area / Equipment Operational Inspection

LLANHARRY COMMUNITY COUNCIL

Score	100%	Failed items	0	Actions	0
Document No.					000078
Audit Title	LLANHARRY COMMUNITY COUNCIL				
Client / Site	Llanharry Recreation Ground				
Conducted on	2 Mar 2022 09:30 GMT				
Prepared by	Jerry Widdas				
Location	Llanharry				
Personnel	Jerry Widdas

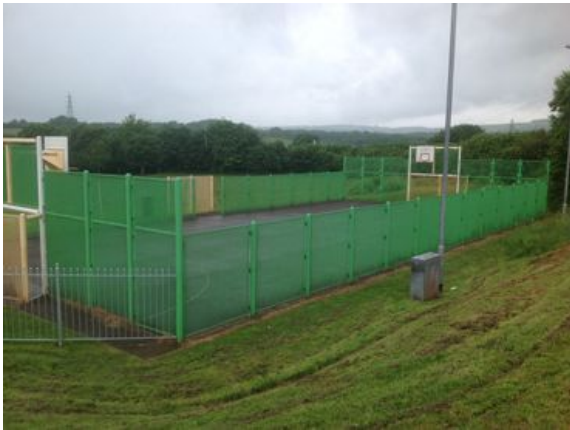
Photo 1

The recreation ground consists of a play area fenced by steel bow top fencing with self closing gates
 A MUGA kick about area and a youth shelter
 Both areas are accessed by Tarmac pathways
 Benches and picnic tables are located within the play area and also outside the play area boundary

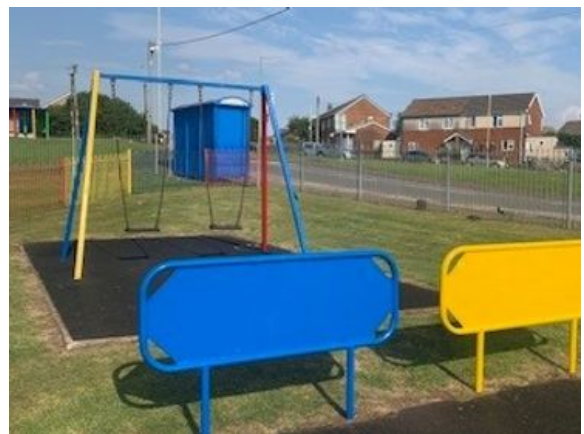
Photo 24

At the time of inspection all the equipment was found to be in a safe and useable condition
