Play Area / Equipment Operational Inspection

LLANHARRY COMMUNITY COUNCIL

Score	8 / 8 (100%)	Flagged items	0	Actions	0
Document No.					000078
Audit Title					LLANHARRY COMMUNITY COUNCIL
Client / Site					Llanharry Recreation Ground
Conducted on					28.10.2024 14:00 GMT
Prepared by					Jerry Widdas
Location					Llanharry
Personnel					
Jerry Widdas

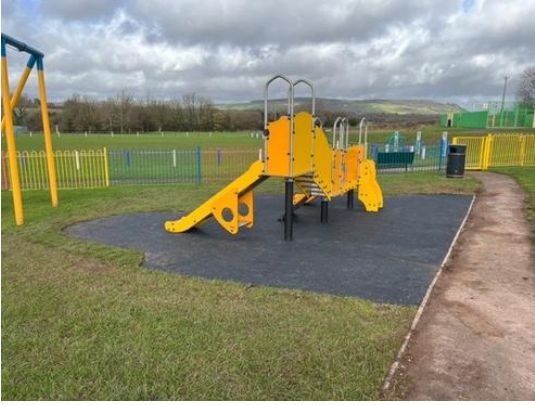
Photo 23

At the time of inspection all the equipment was found to be in a safe and useable condition
