Safety Inspection Report

Annual Inspection

Ty Isaf Play Area

03 July 2025

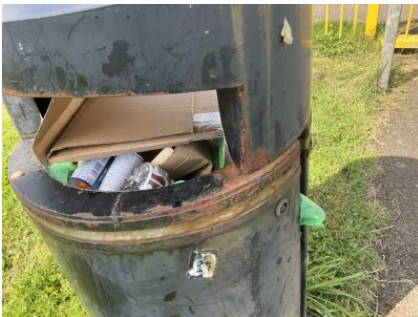
Item has corrosion.

Treat and repair.

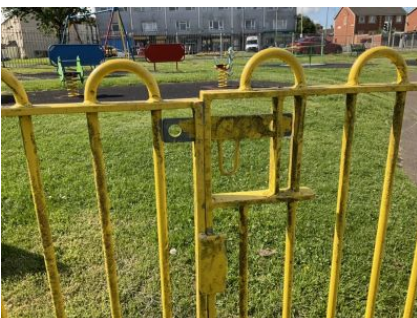
Description	Tasks	Risk score
The item is unlocked.	Lock.

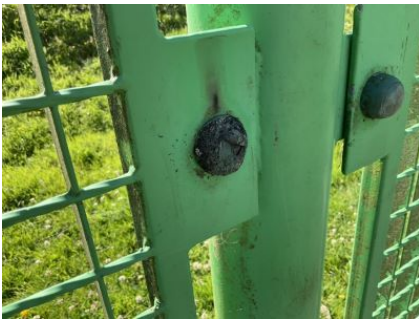
Cap missing.

Replace.

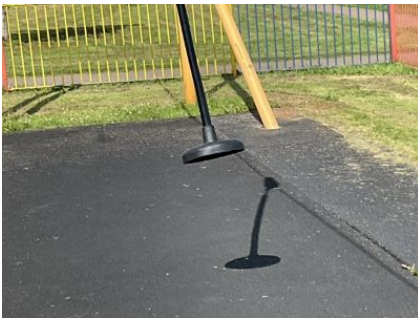
Cables have been known to fail under load due to wear and corrosion. This is generally where the cable enters into a tube, top bar, sleeve or similar, where the wire is in contact and wears and frays over time, but can happen anywhere on the cable. It is important to inspect any hidden parts at least annually. Damaged cables require replacement. This cannot be determined during an annual inspection, and is excluded from our inspection. This can lead to a high risk if no action is taken. Refer to the manufacturer's instructions to ensure the correct check is carried out.

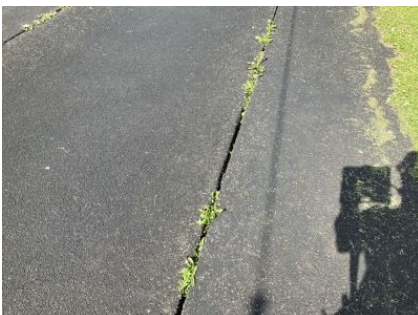
Shrinkage / separation of the surface. This may give a trip hazard.

Repair.

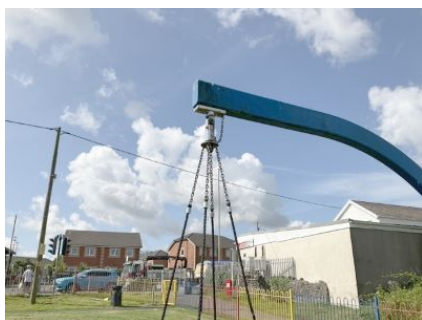
Welds are cracked.

Repair.

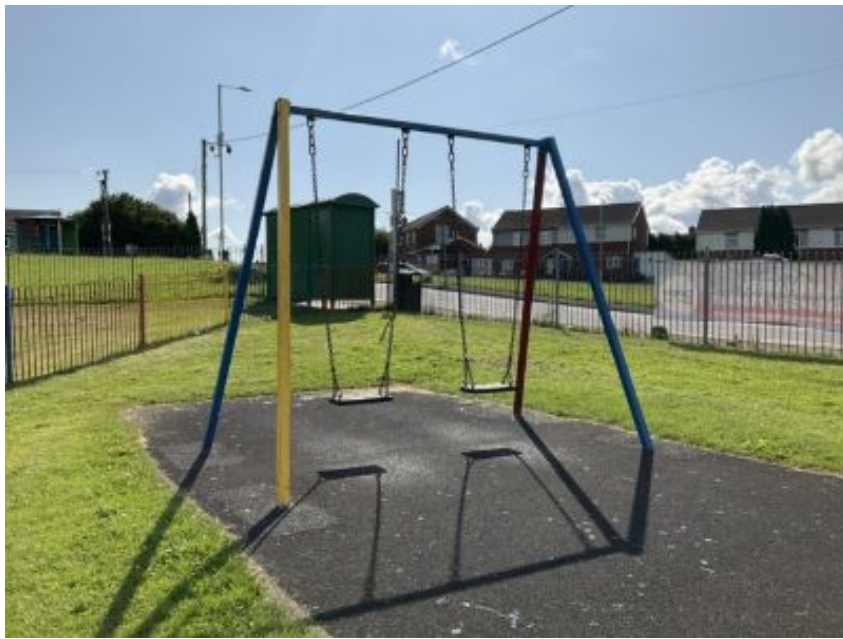
Swing - Junior - 1 Bay 2 Seat

There is wear in the bushes.

Cap missing.

Some chain wear.

Item has corrosion.

Remove shackle bolt and check bush and shackle pin wear, replacing as necessary.

Replace.

Monitor for further deterioration and replace before 40% wear.

Treat and repair.

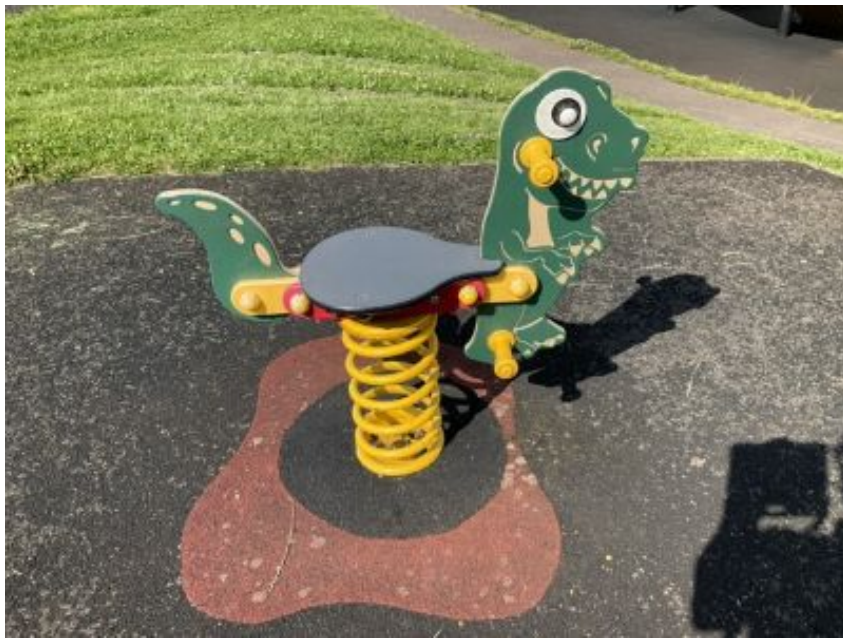
Rocker - Tyrannosaurus Rex

Cap missing.

Replace.
