Safety Inspection Report

Annual Inspection

Ty Isaf Play Area

Llanharry Community Council

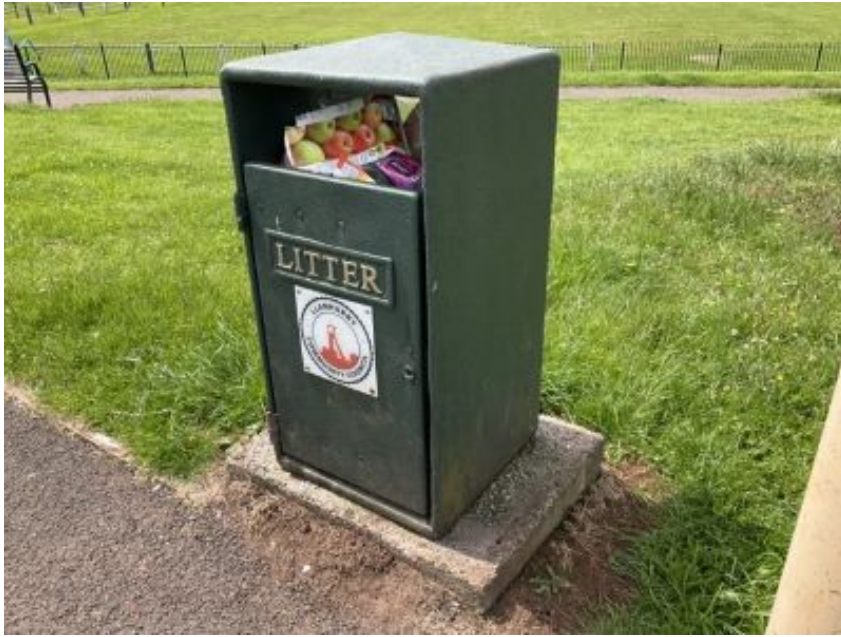
Litter Bin

Item has corrosion.

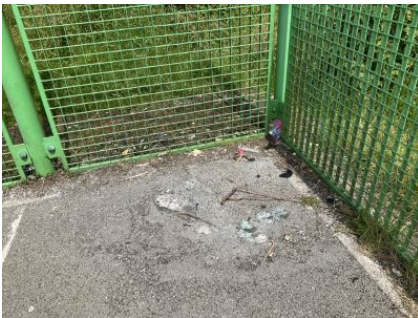
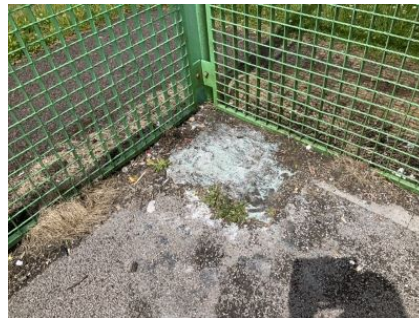
MUGA

Item is damaged.

Cap missing.

Repair.

Replace.

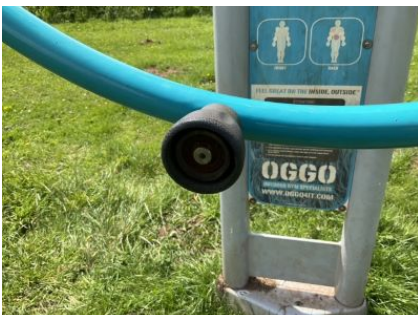
Fitness Zone

Hand grip is missing.

Item has corrosion.

Cap missing.

Replace missing grip.

Treat and repair.

Replace.

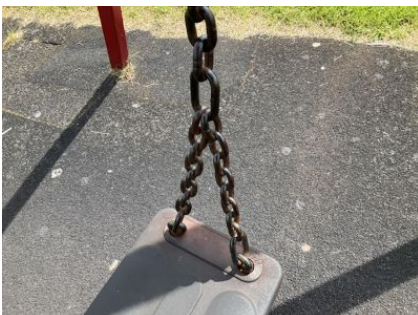
Swing - Junior - 1 Bay 2 Seat

Item has corrosion.

Treat and repair.

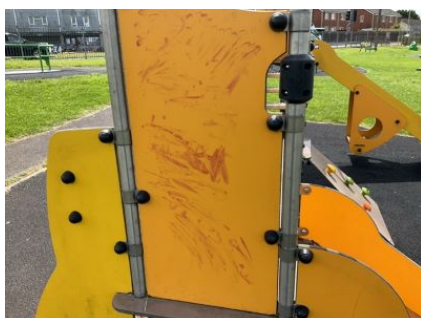
Cap missing.

Replace.
